Rubblization / Reconstruction I-39

Steve Robinson
D-5 Acting Materials Engineer
Mixtures Control Engineer

I-39 N.W. of Bloomington-Normal in McLean County

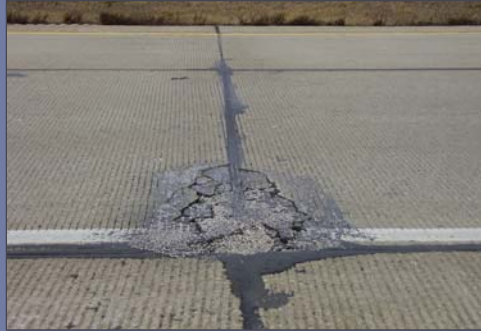
Pavement Distress

- Durability Cracking
- High Level Infrequent Transverse Cracking
- Medium to High level

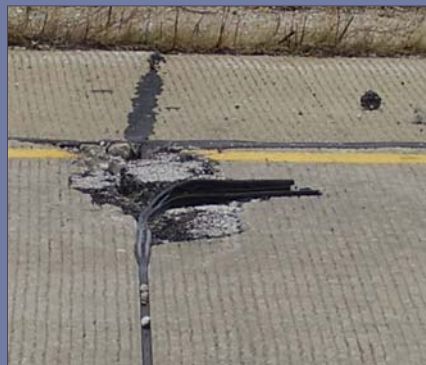
Joint Deterioration

- Frequent / Spalling
- > 6 inches

Centerline Deterioration

- High Level / Spalling
- > 6 inches

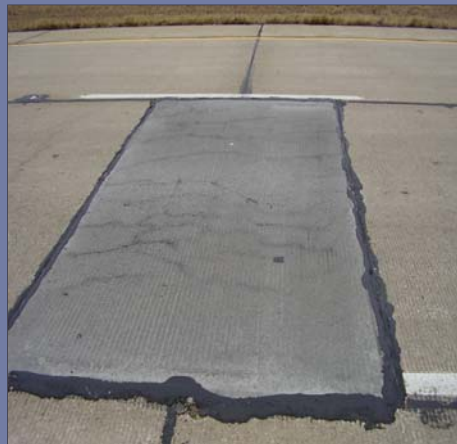
I-39 Patching

Class B Patching
Six Patching Contracts
since 2009 totaling
\$2,090,000

Operations and Day Labor
Patching also
