# *A History of Paving at the Indianapolis Motor Speedway*

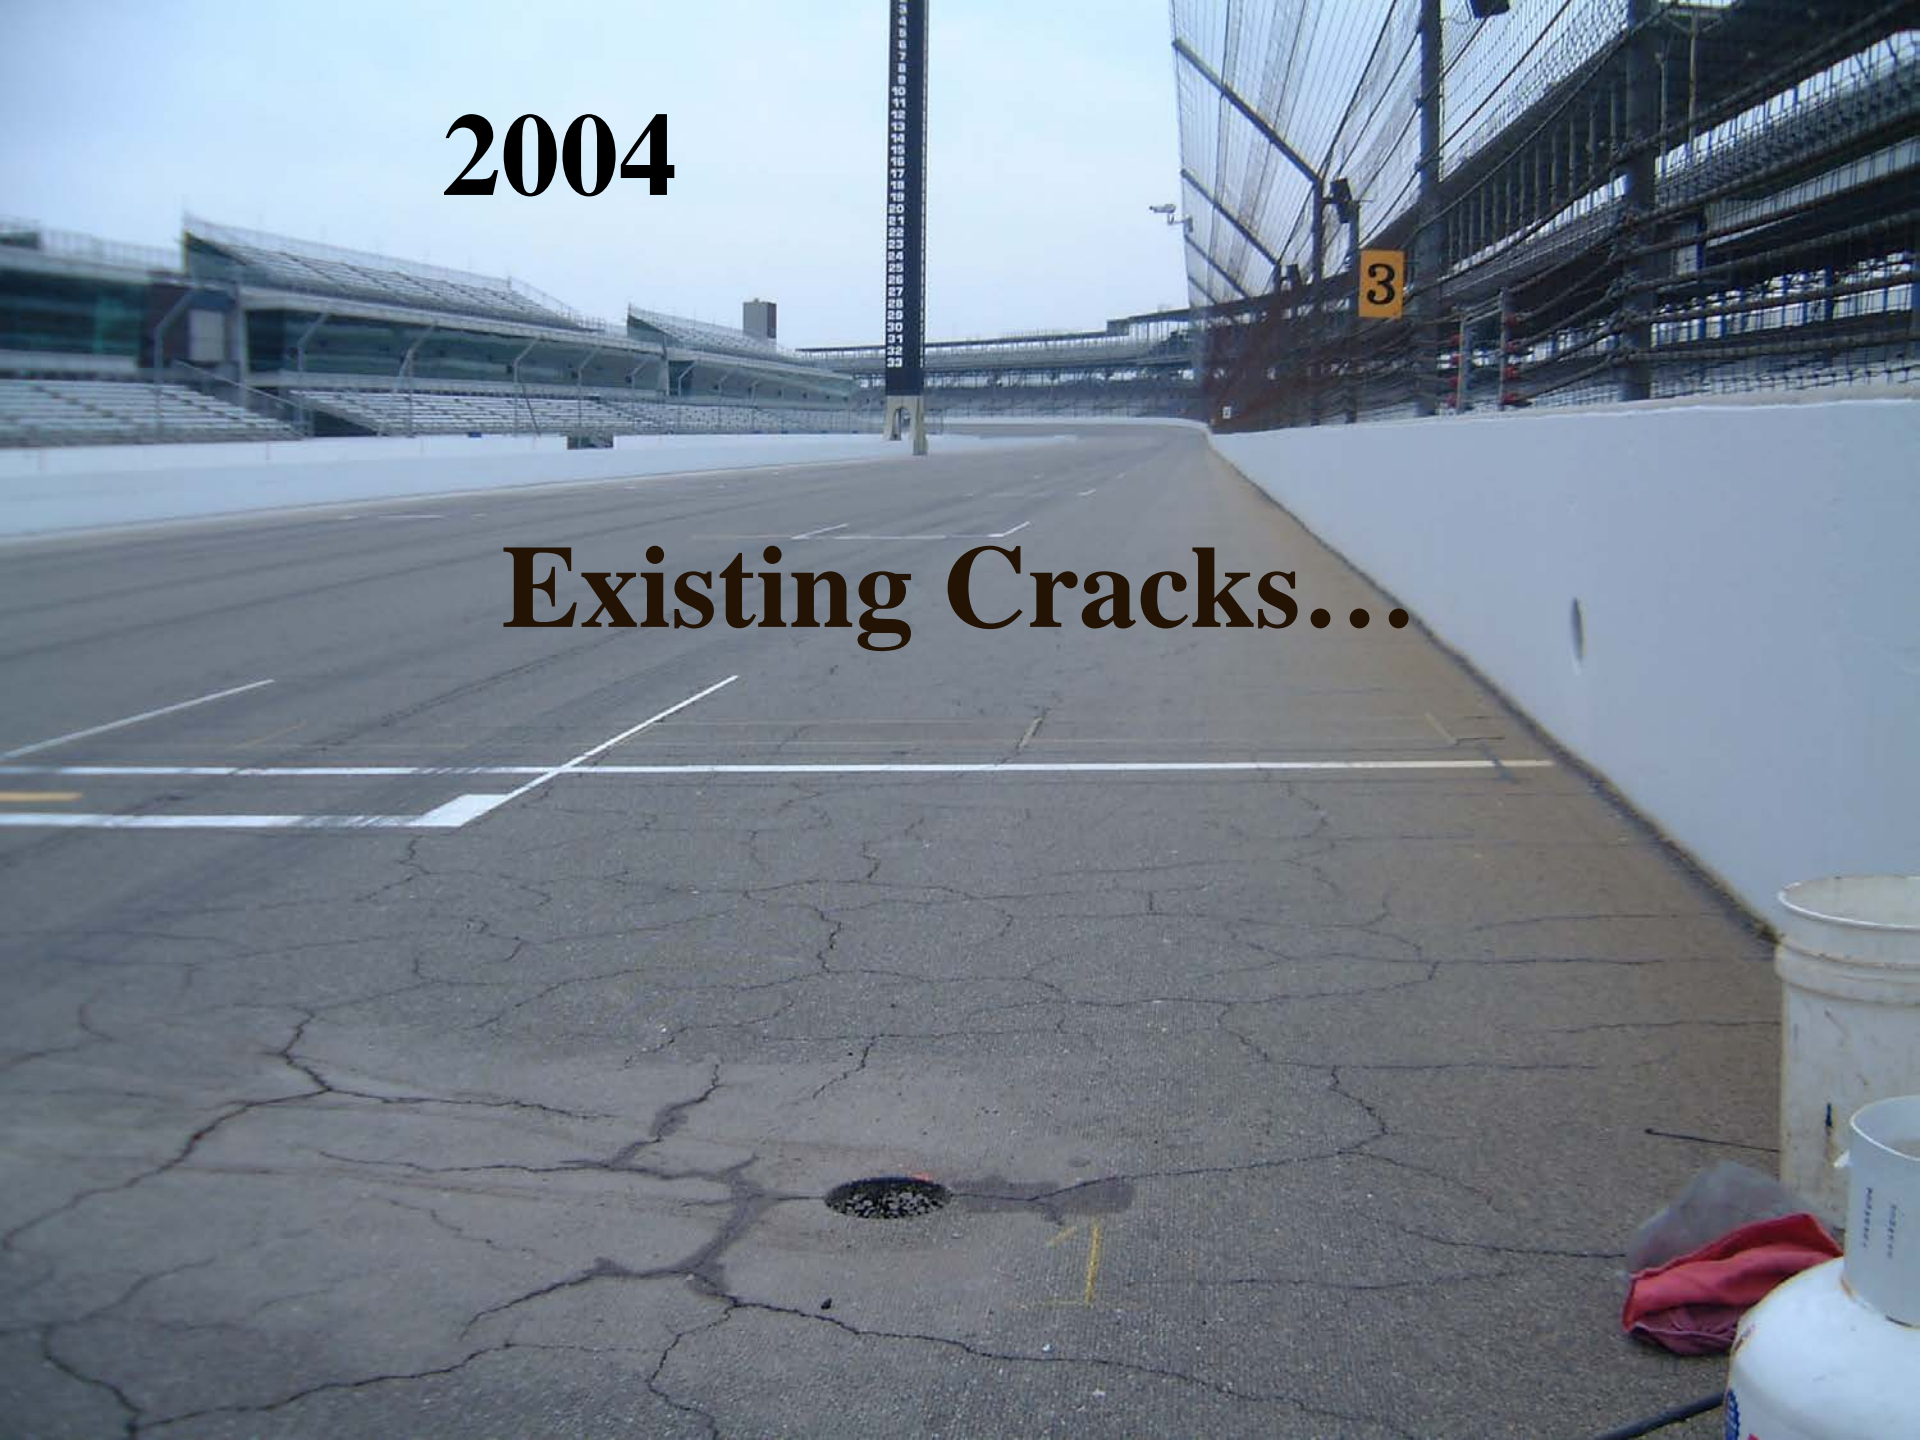
**Existing Cracks...**

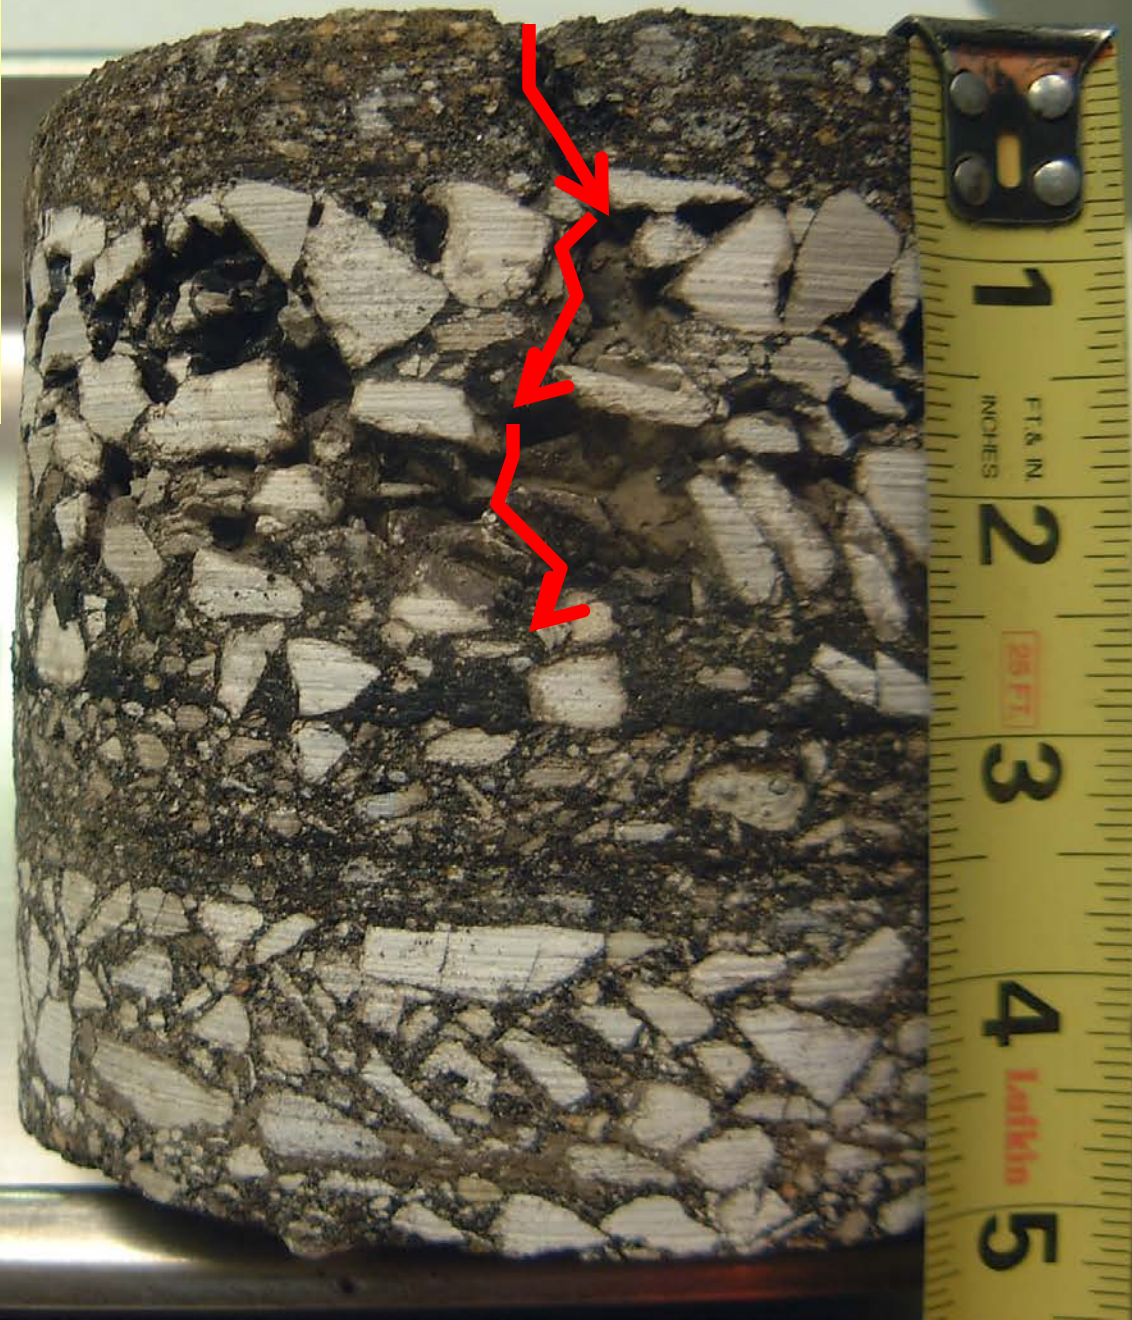
# Top-Down Cracking
