## Near Miss: Lathe Operations Result in Flying Projectile

**Lesson ID:** BNL-Lathe-2012-0001

**Originator:** Brookhaven National Laboratory

**Date:** December 19, 2012

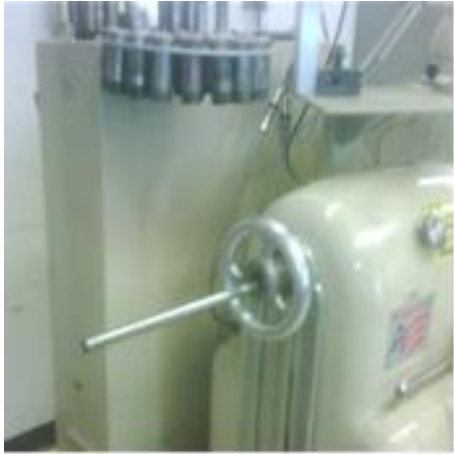
Contributing Cause: The Tool and Instrument Maker did not support the tube extending from the rear of the headstock.

Monarch EE Lathe with protruding pipe

- Conduct a stand down in Fabrication Services to review and enhance safety attitude.
- Solicit commitments from Fabrication Services personnel as to what they can do to improve safety.
- Develop a training course to read & acknowledge.
- Clearly label the Speed Control Dial and Lever on the Monarch EE Lathe.
- Remove the collets rack from above the Monarch EE lathe.
- Revise the Machine Shop Safety Procedure.
- Revise the R2A2 of the Supervisor and General Supervisor for Fabrication Services.
- Utilize support mechanisms for material extending out from the lathe.

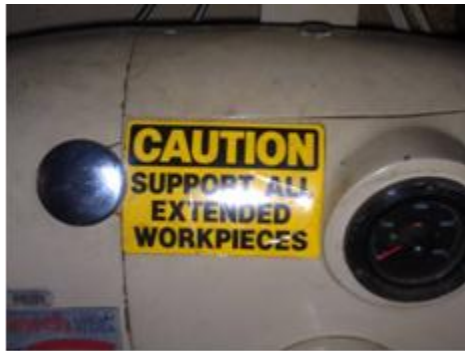
The Monarch EE series lathe was labeled with a prominently displayed yellow label stating "CAUTION SUPPORT ALL EXTENDED WORKPIECES"

Caution sticker on lathe

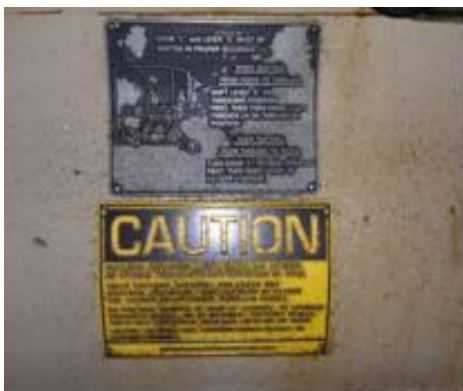
A manufacturer installed label was visible on the front of the Monarch EE lathe stating "CAUTION Material extending from either the spindle or spindle mounted device can bend or whip. Fully support, capture, and cover any material extending from the rear of either the spindle or a spindle mounted device. Do not use wedges at rear of spindle, at spindle mounted device, or at material support device. Their use can cause material to bend or whip. Failure to heed this caution could result in serious injury."

Caution sticker on lathe

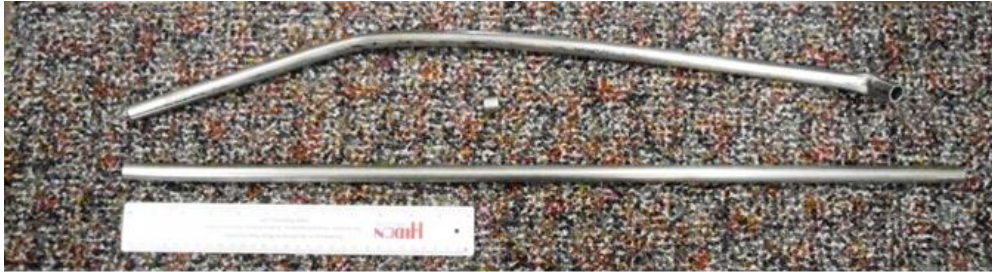
Recovered sections of 5/8" stainless steel tube

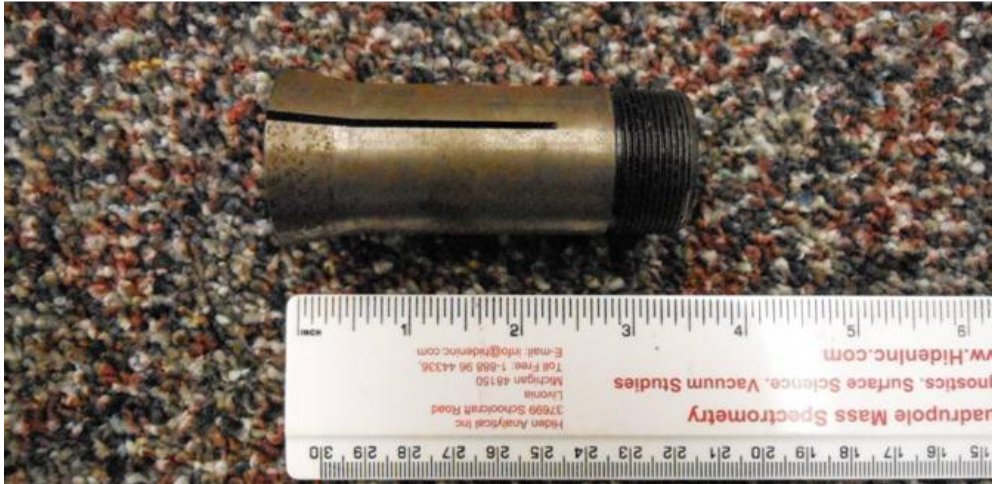
**Discussion:** On July 10, 2012, at 4:20 PM, a Tool and Instrument Maker in the BNL Central Fabrication Shop located in Building 479 was preparing to cut a 5/8 inch X 0.060 wall stainless steel tube in a Monarch EE series lathe. 27.5 inches of tubing was extended out of the rear of the headstock of the lathe when the machine was started. The material extending out of the back of the machine was unsupported. The lathe was set to operate at a speed of 2000 RPM when it was started with the material installed. The correct speed for this task was 300 RPM. Upon engaging the lathe drive mechanism, the tube extending from the rear of the headstock bent and contacted a collet chuck stored in a tool tray above the lathe. The collet was sent airborne, striking and breaking a window. There were no injuries.

Ejected Hardinge 7/8 5C collet

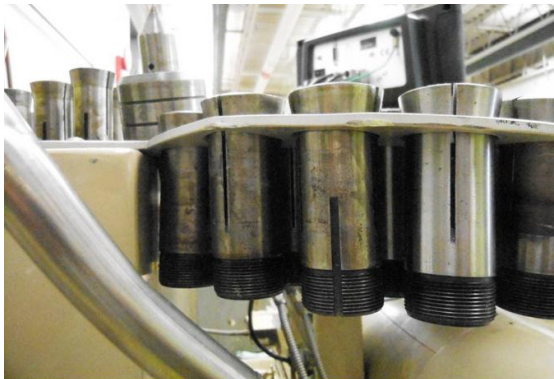
Monarch lathe collet storage rack damage
