Geotechnical Problems Caused by the 2023 Kahramanmaras - Turkiye Earthquakes

Professor Tugce Baser, Dr. Ozgun Alp Numanoglu, and Professor Okan Ilhan

March 31st, 2023

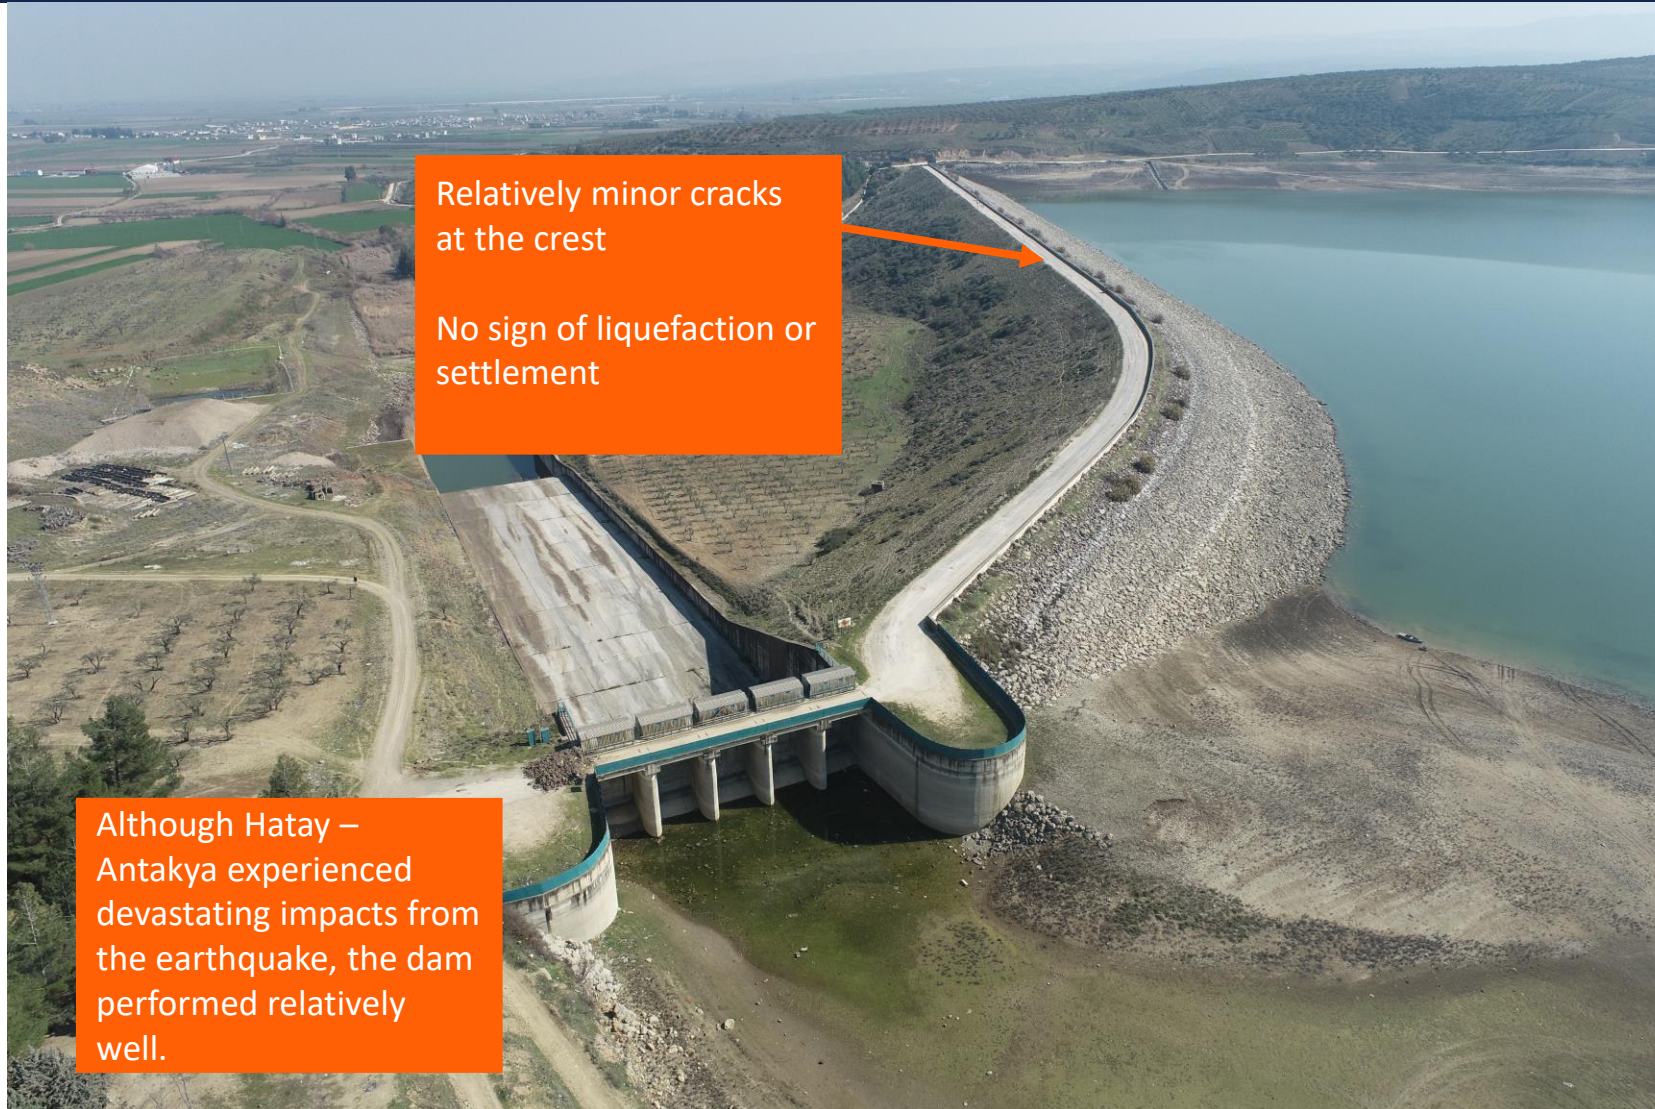
Yarseli Dam – Relatively Good Performance

Relatively minor cracks at the crest

No sign of liquefaction or settlement

Although Hatay – Antakya experienced devastating impacts from the earthquake, the dam performed relatively well.

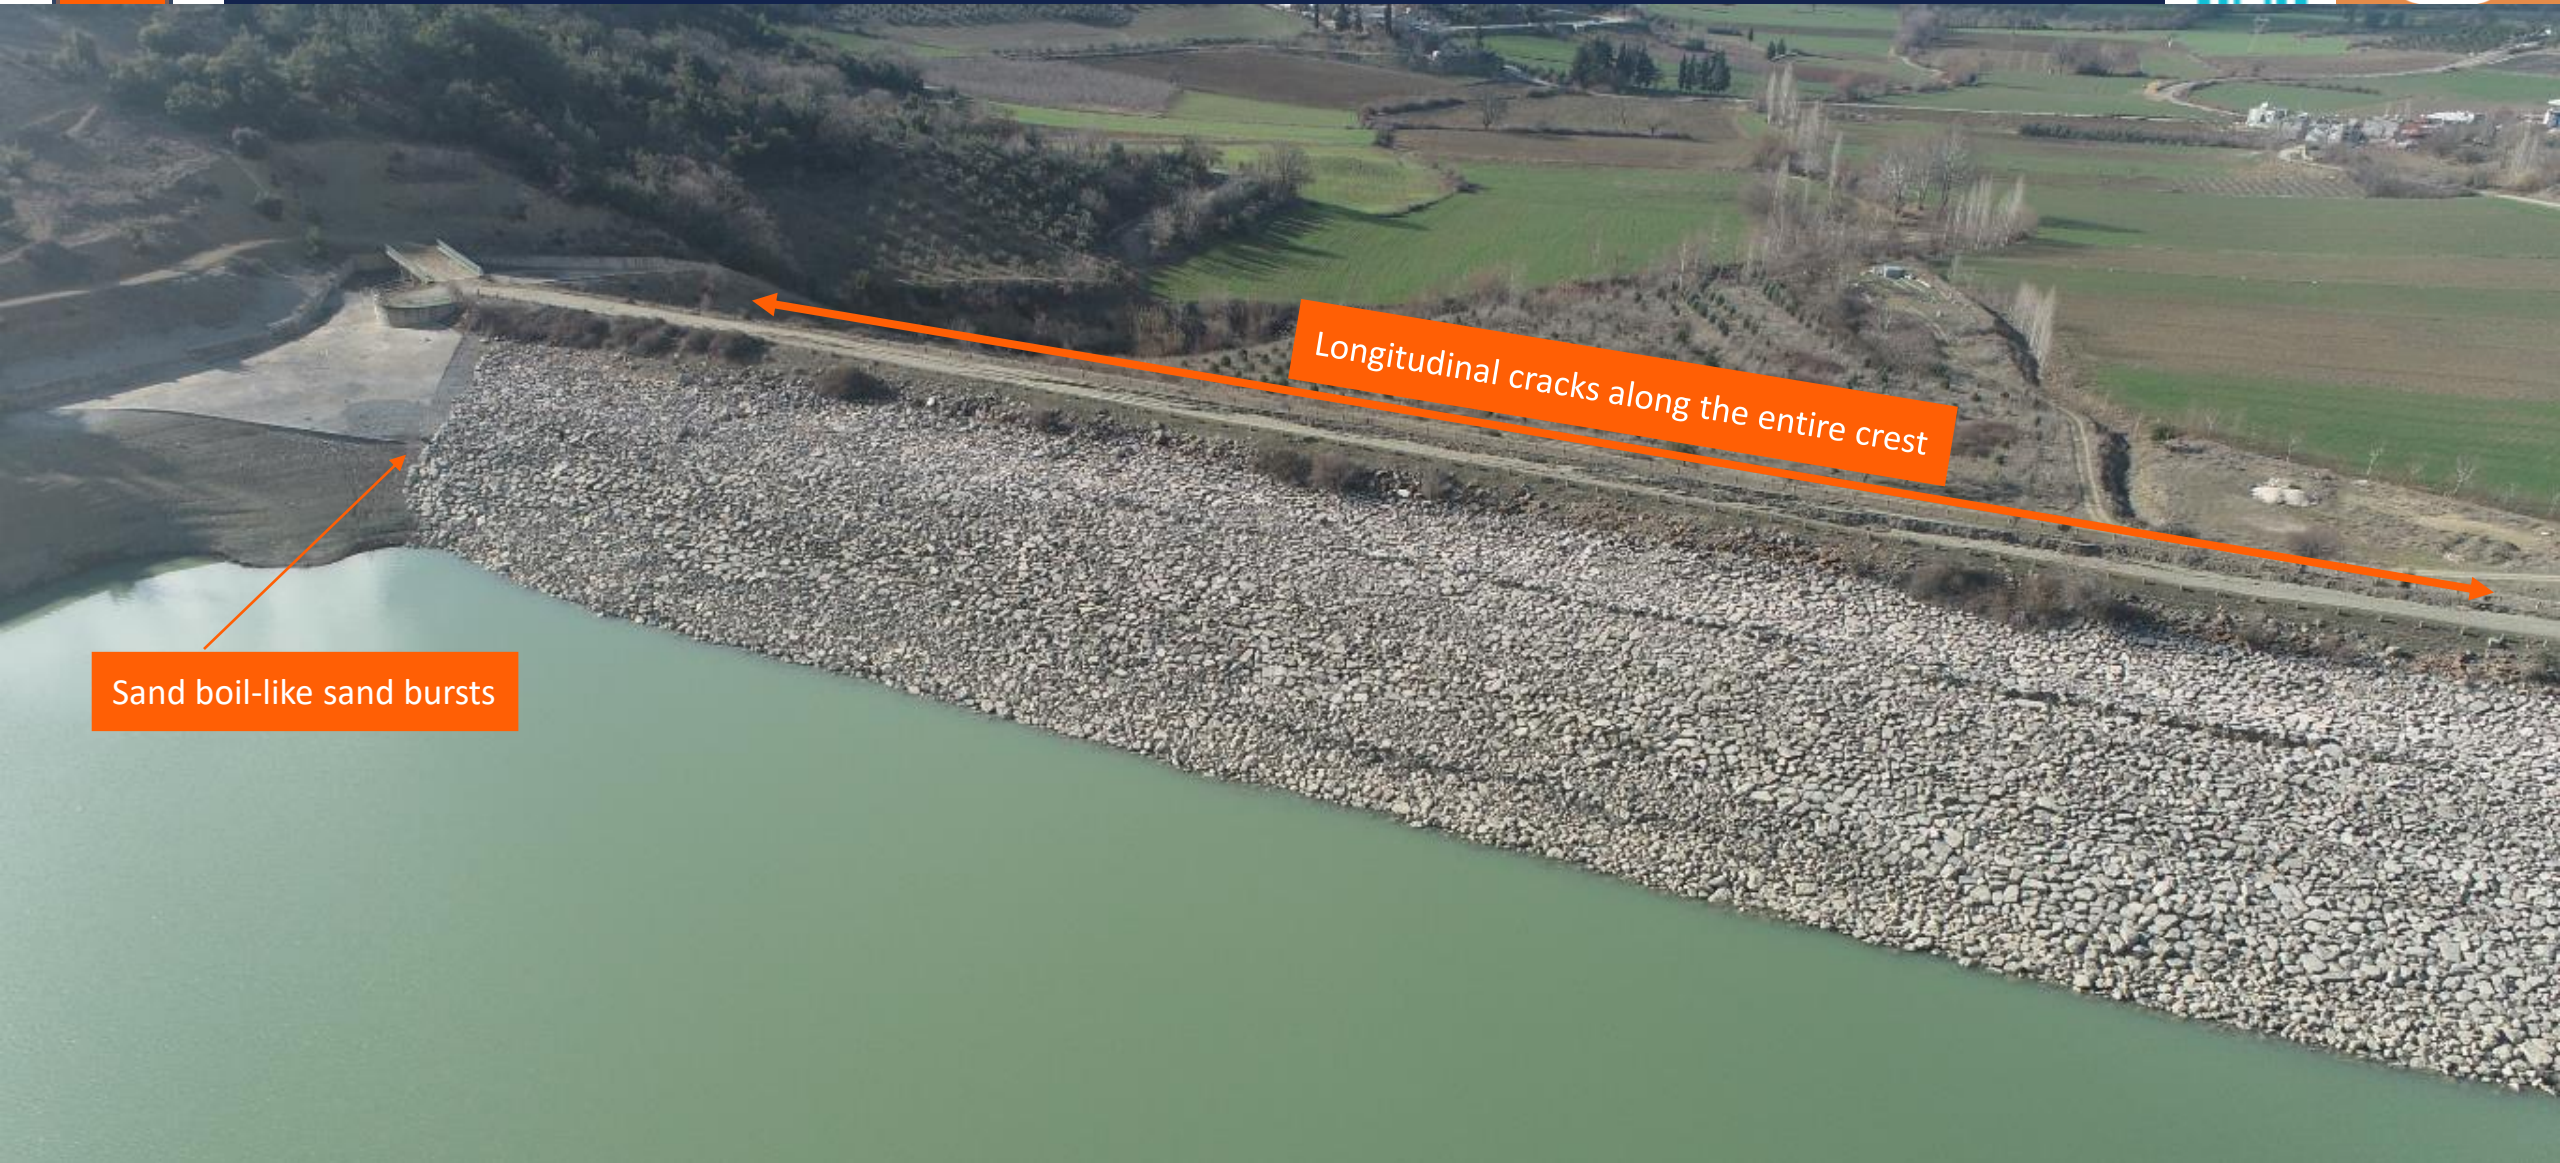
Ariklikas Dam - Osmaniye

Sand boil-like sand bursts

Longitudinal cracks along the entire crest

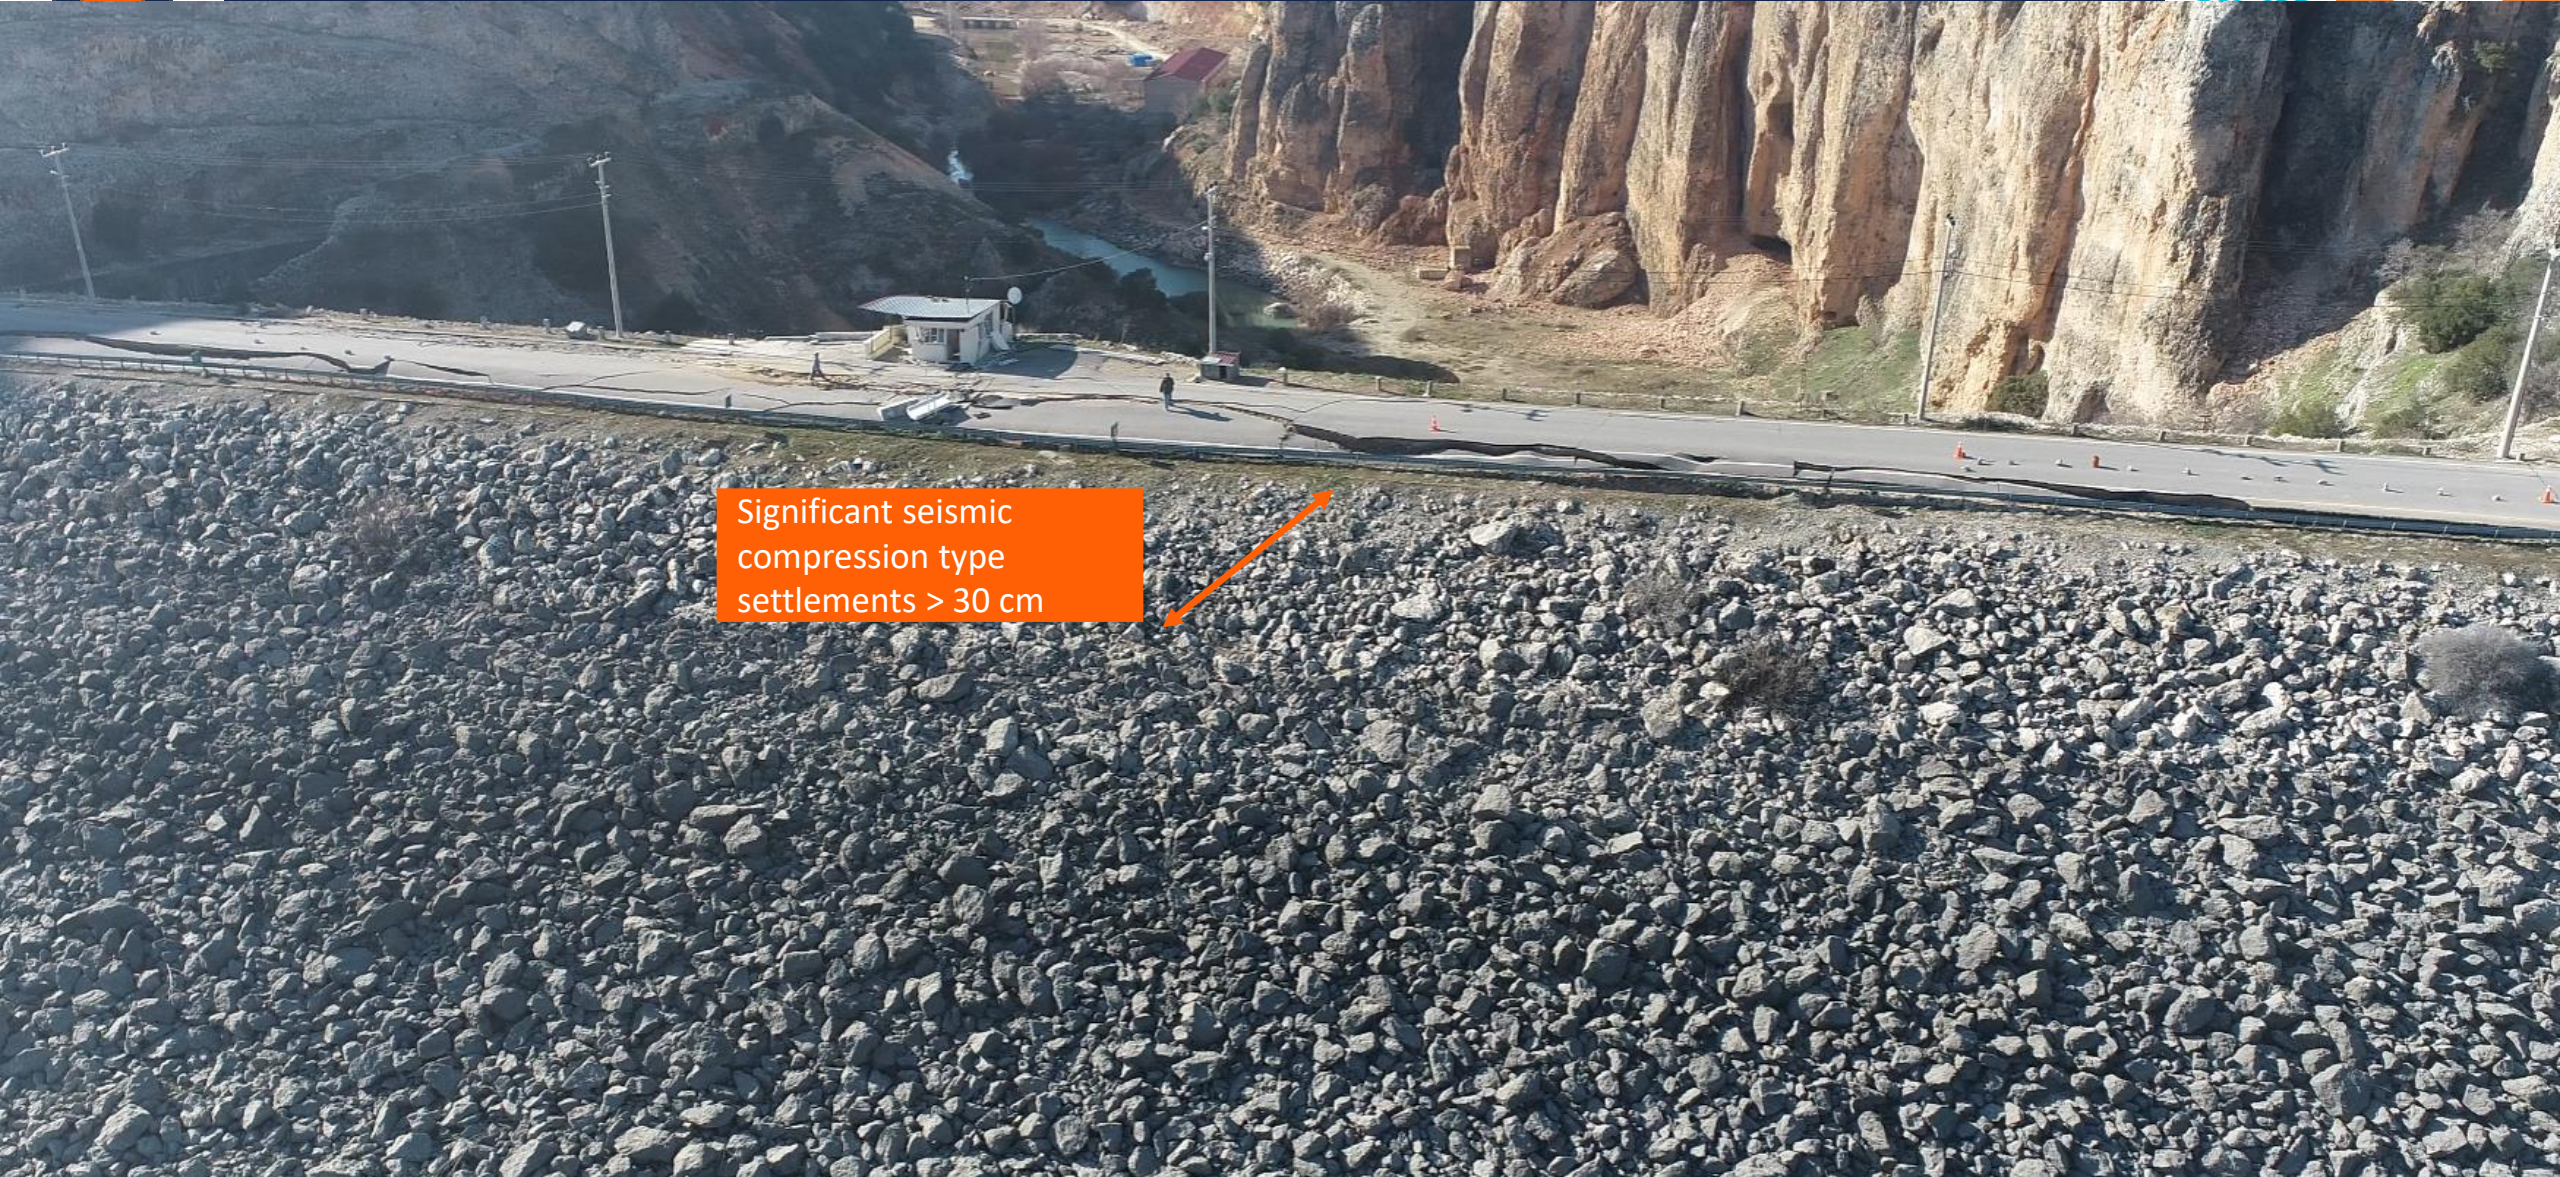
Kartalkaya Dam- Pazarcik, Kahramanmaras

Significant seismic
compression type
settlements > 30 cm

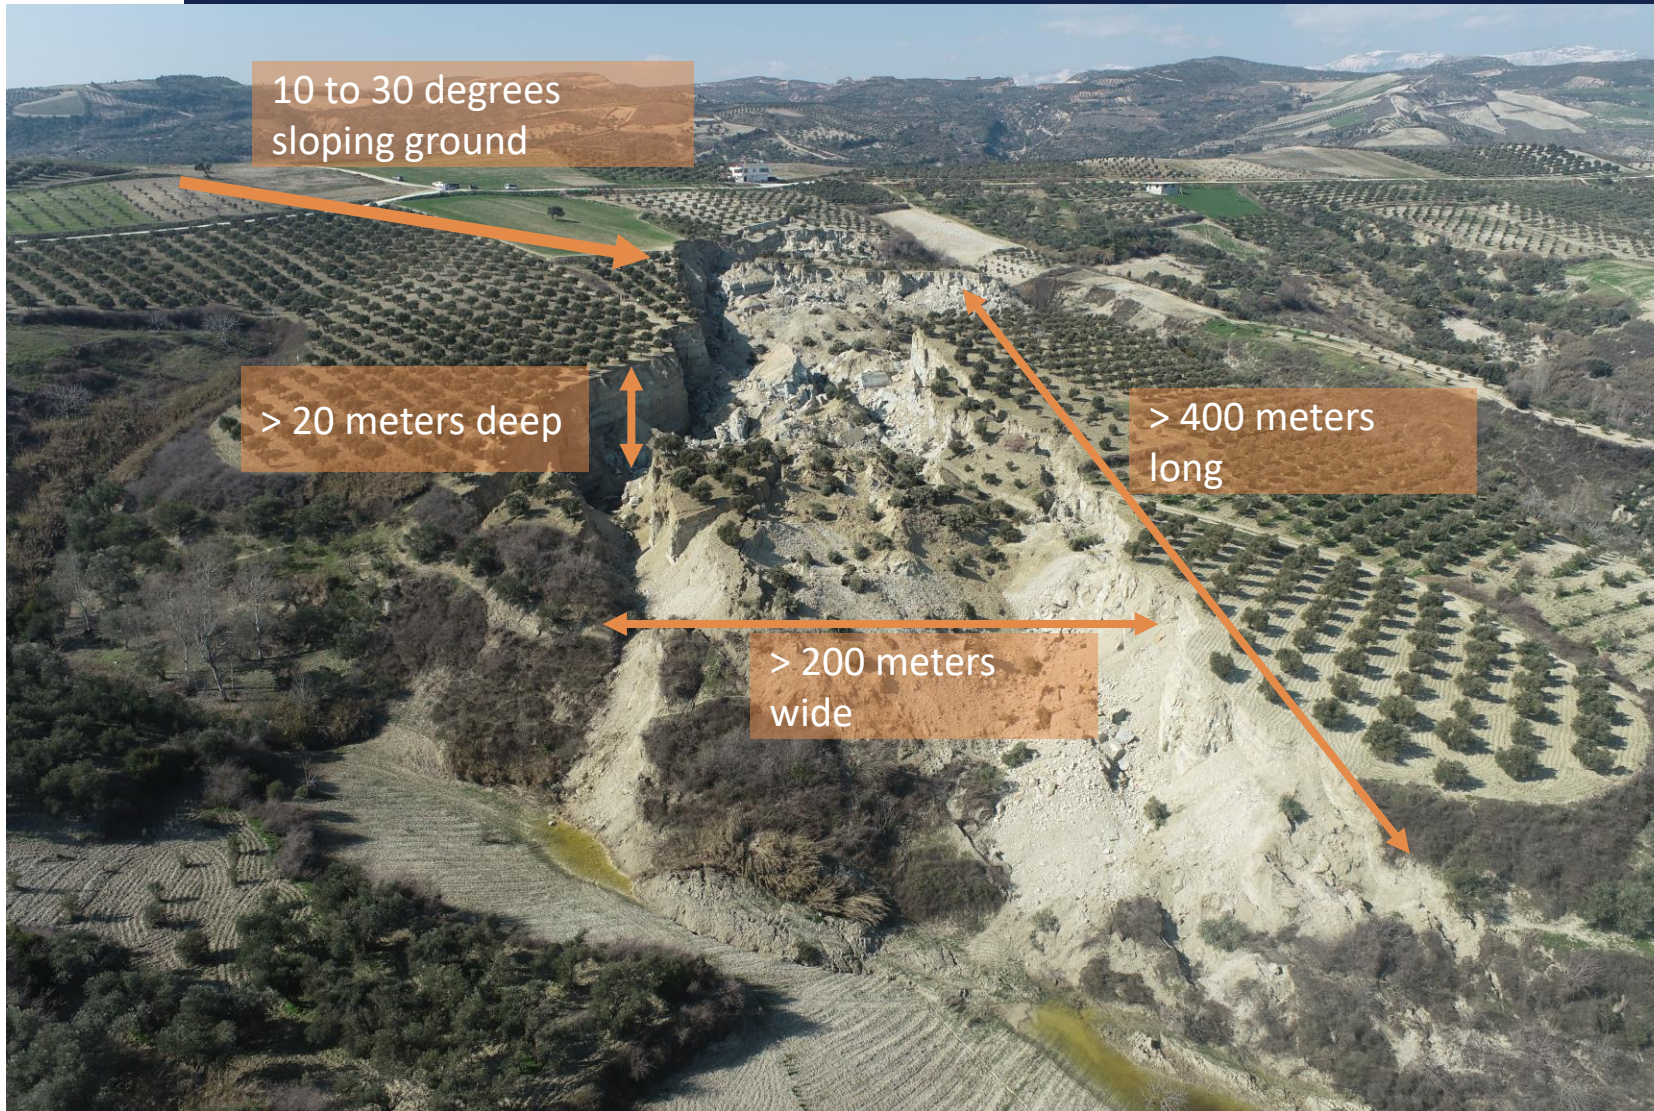
Altinozu Landslide

- Already mobilized slope?
- Heavy rainfalls right before the earthquake
- Mobilization after the earthquake (e.g., aftershocks, creep, new earthquakes?)

- Was the slope already moving before the earthquake?
- Heavy rainfall right before the earthquake. The sequence of events took place at the area indicates series of extreme events
- Mobilization after the main slip (e.g., aftershocks, new earthquakes, creep type continuation of the slope movement?)
- How will this landslide impact the locals living in the area?

- Altinozu landslide is required monitoring of the slope movement (if any) in case of a progressive failure
- Although not shown in this presentation explicitly, site amplification evidence is strong in this event and needs to be further studied.

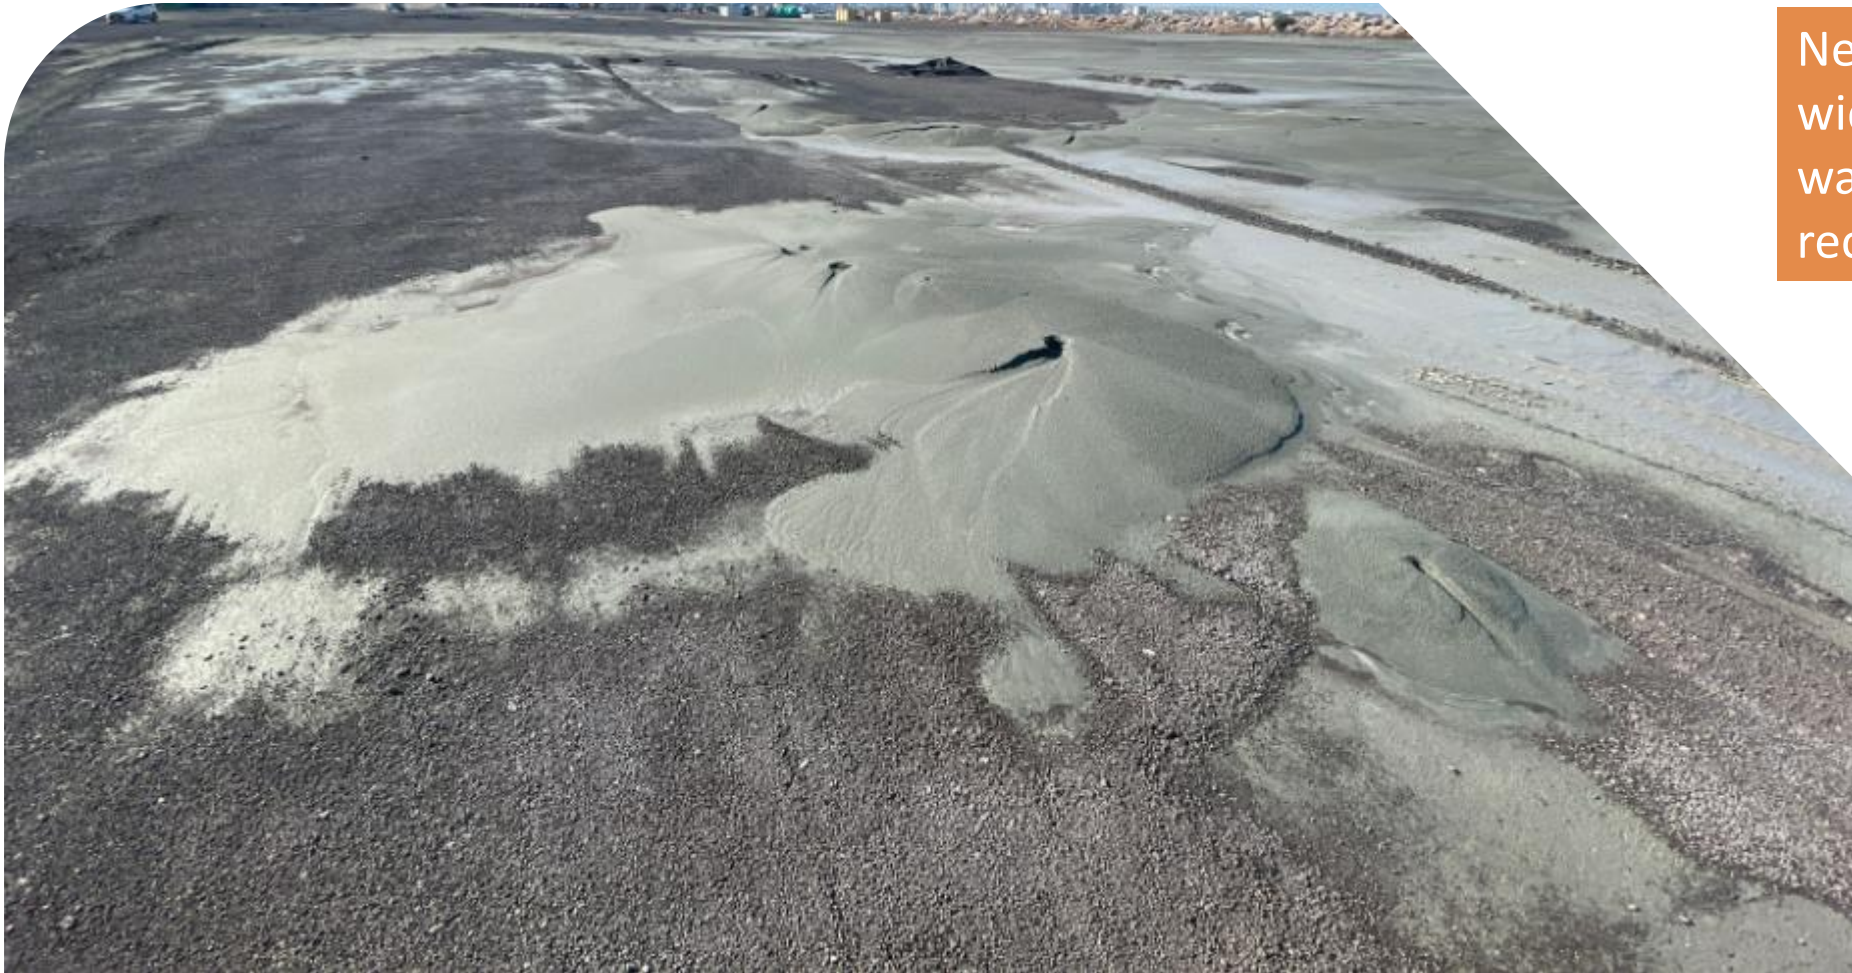
Iskenderun Coastal Line (Reclaimed Areas) – Sand Boils

Near-free field widespread liquefaction was observed at the reclaimed areas.

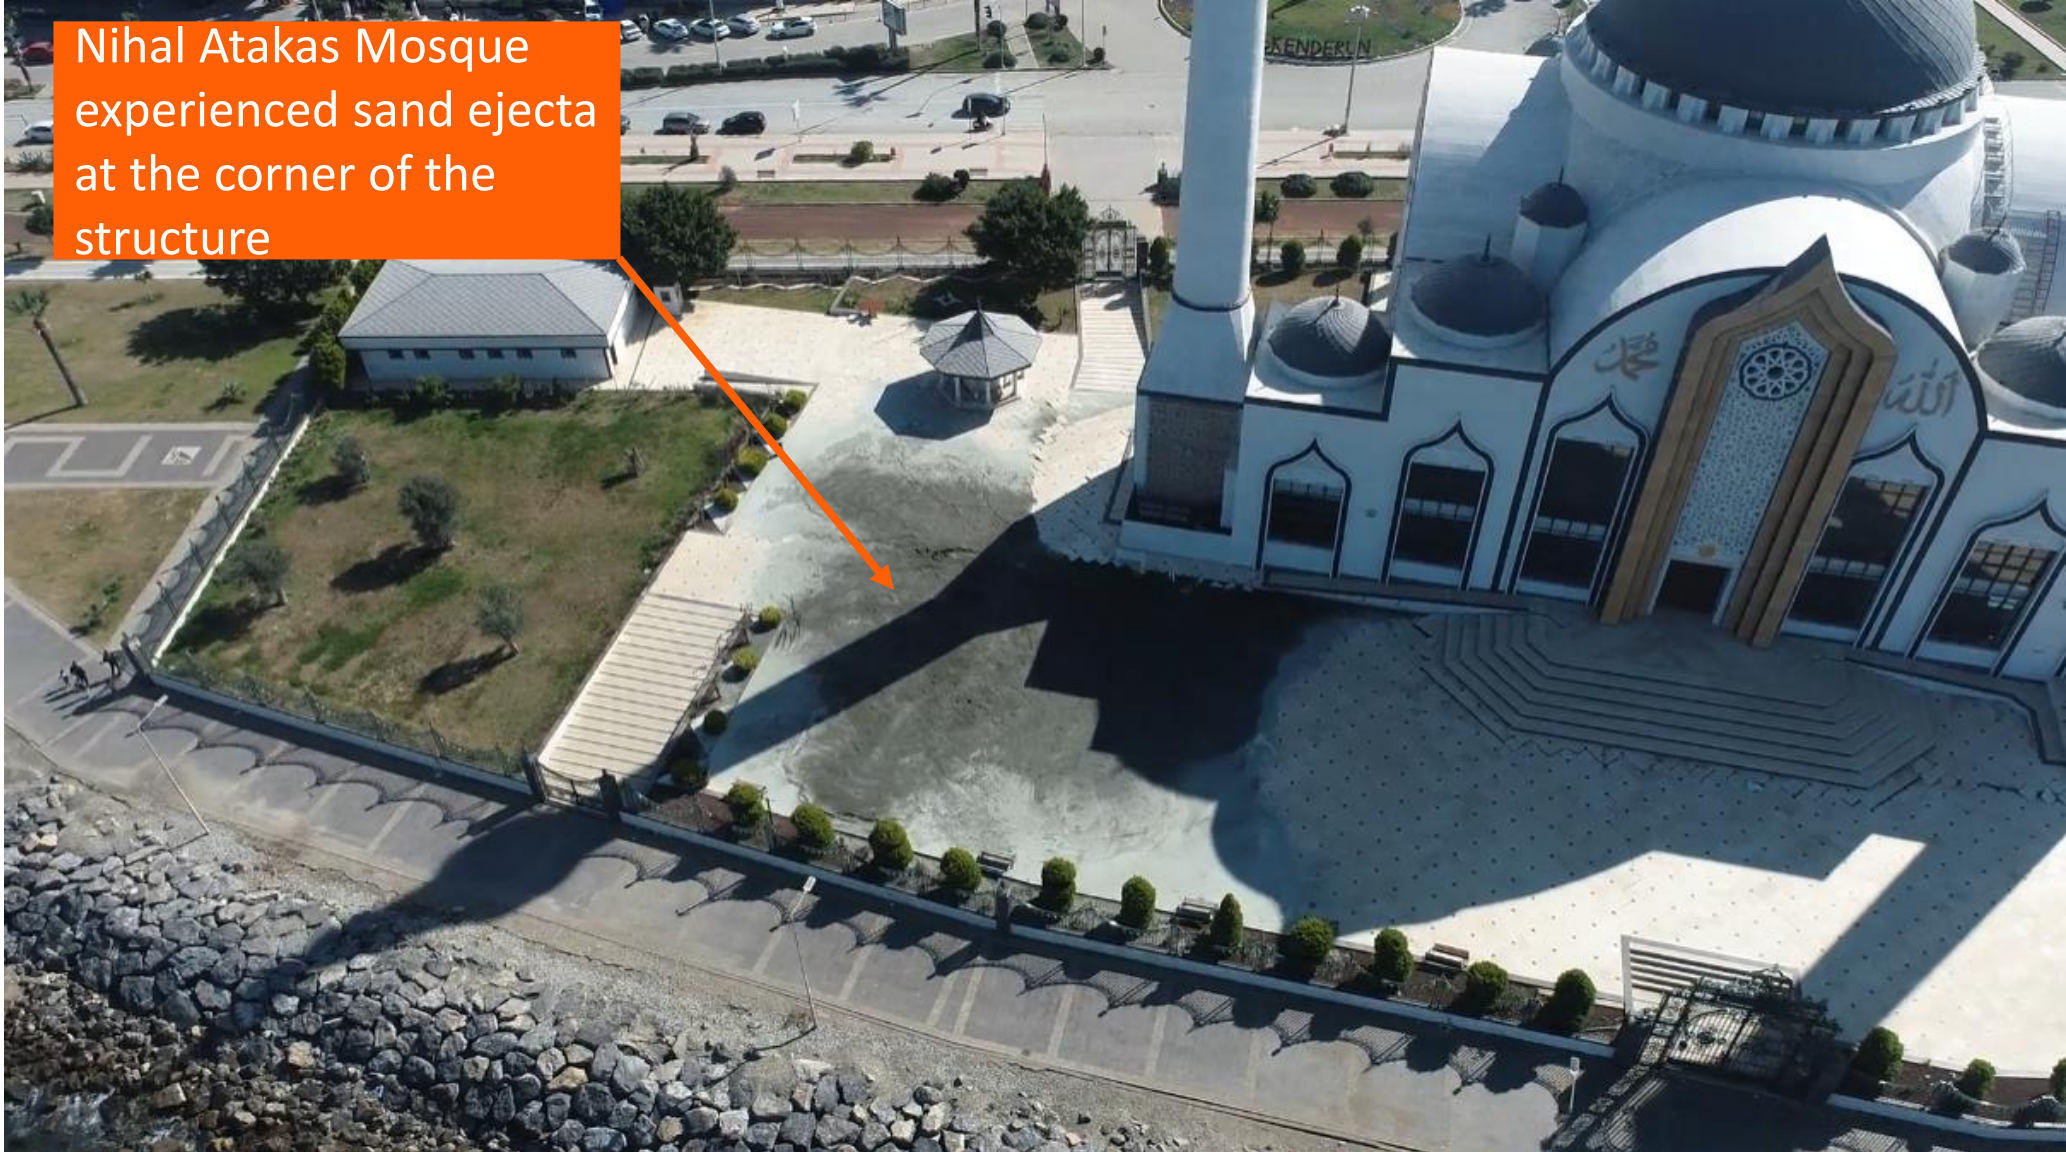
Iskenderun Coastal Line (Reclaimed Areas) – Sand Boils / Sand Ejecta

Nihal Atakas Mosque experienced sand ejecta at the corner of the structure

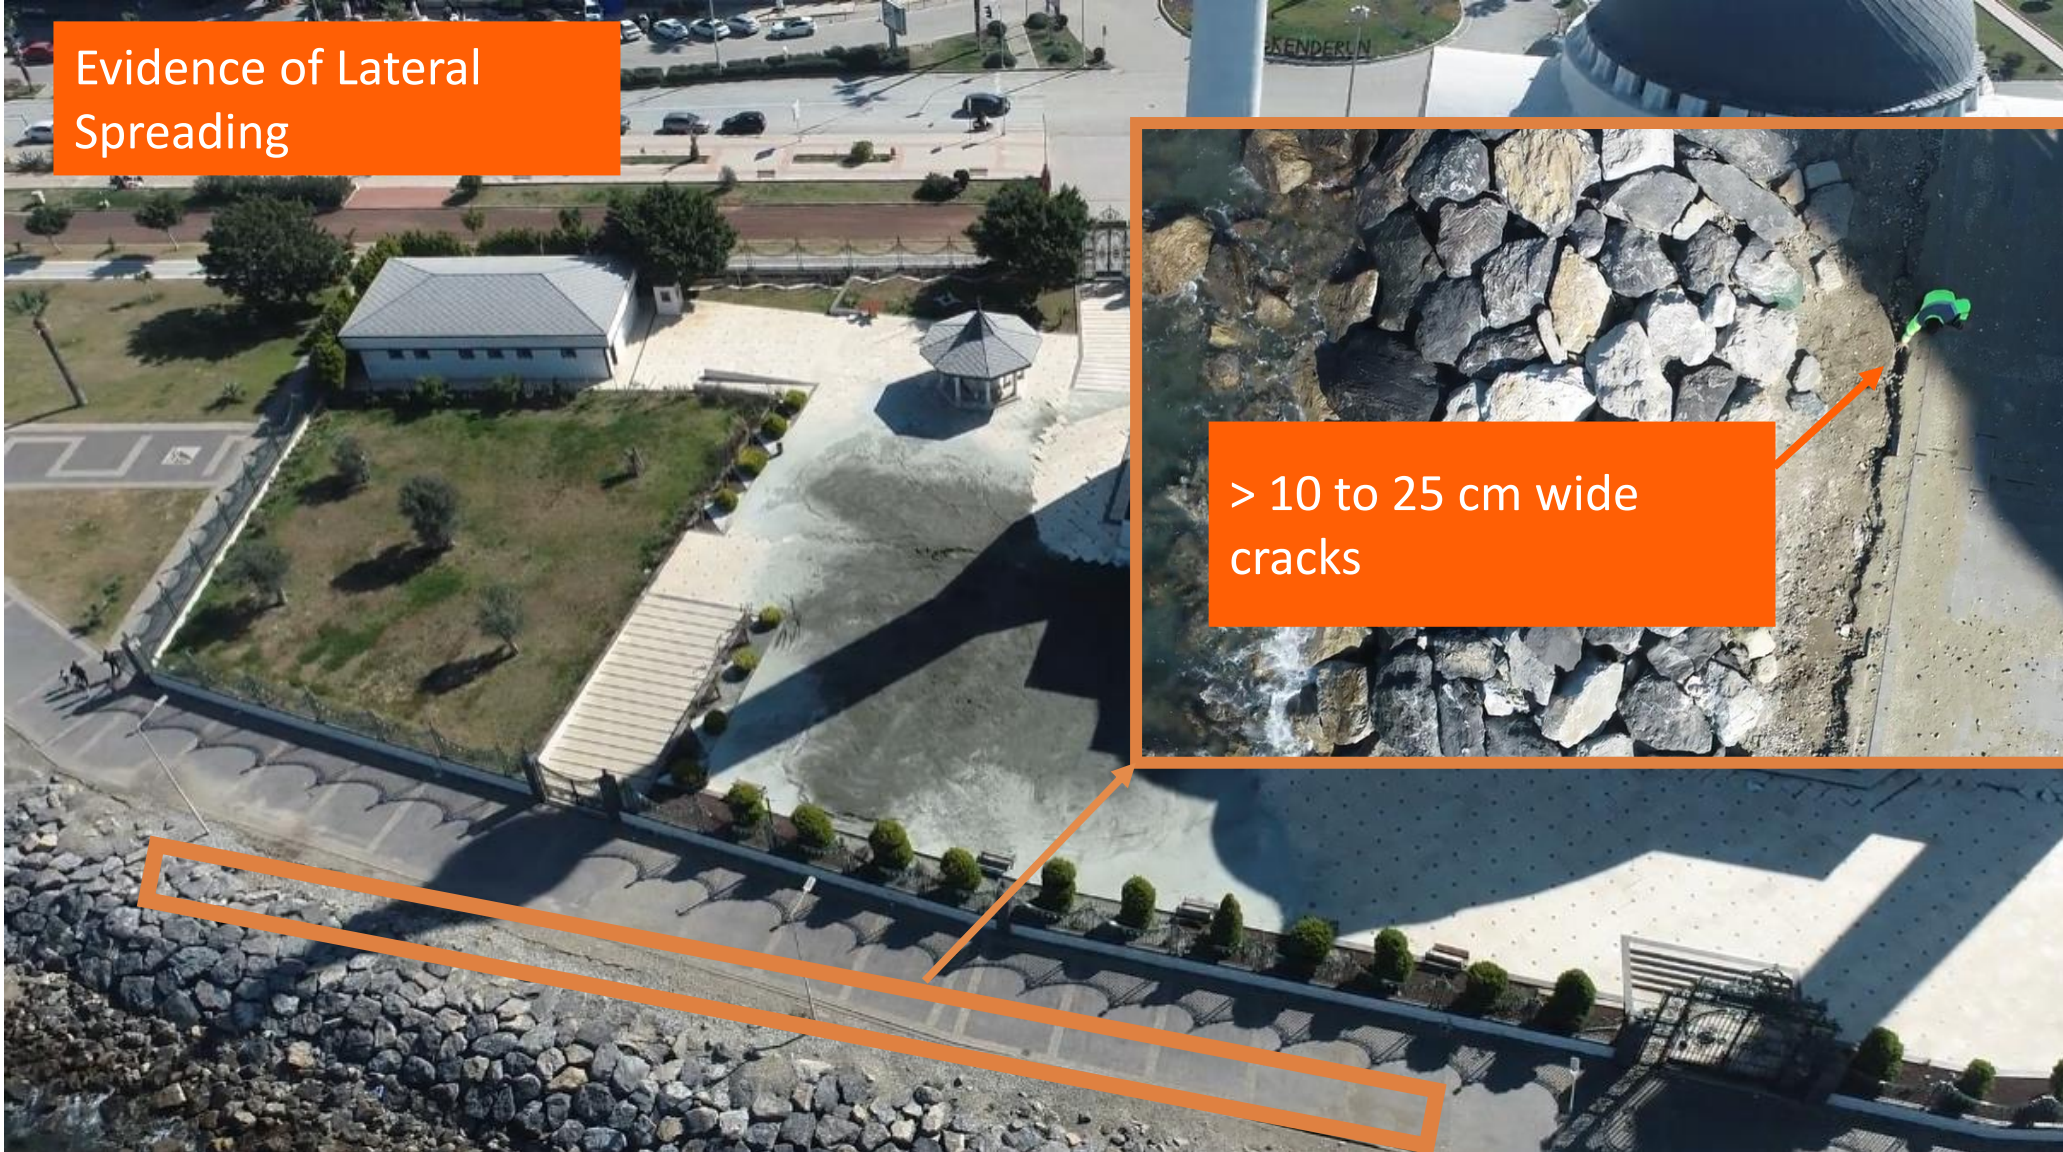
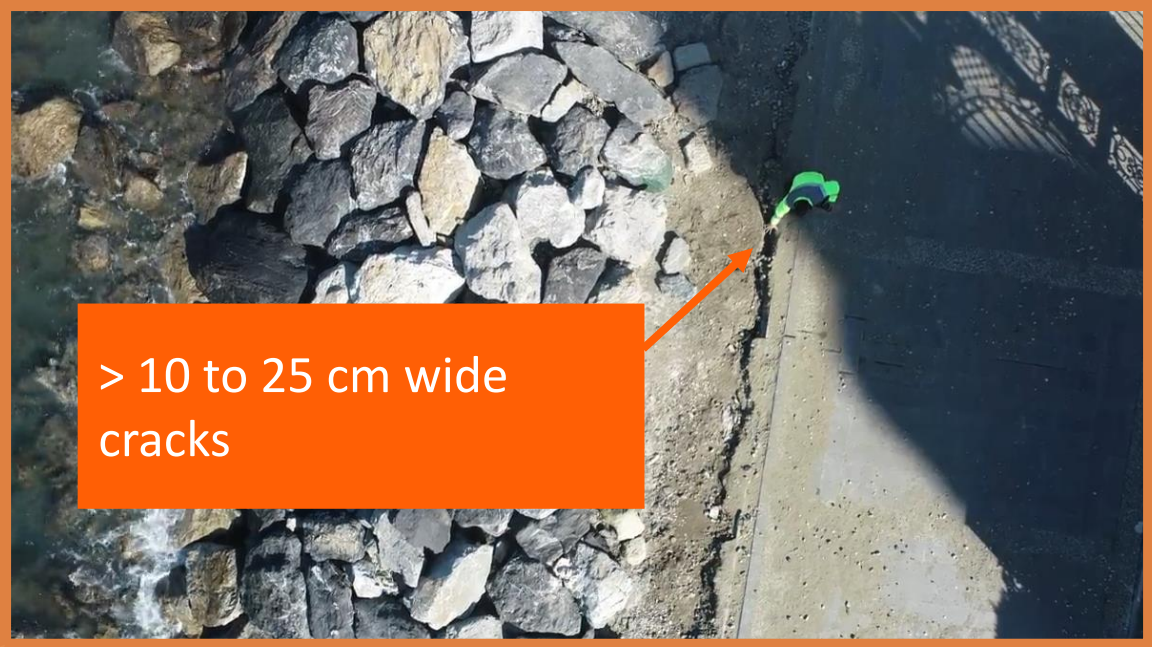
Evidence of Lateral Spreading

> 10 to 25 cm wide cracks

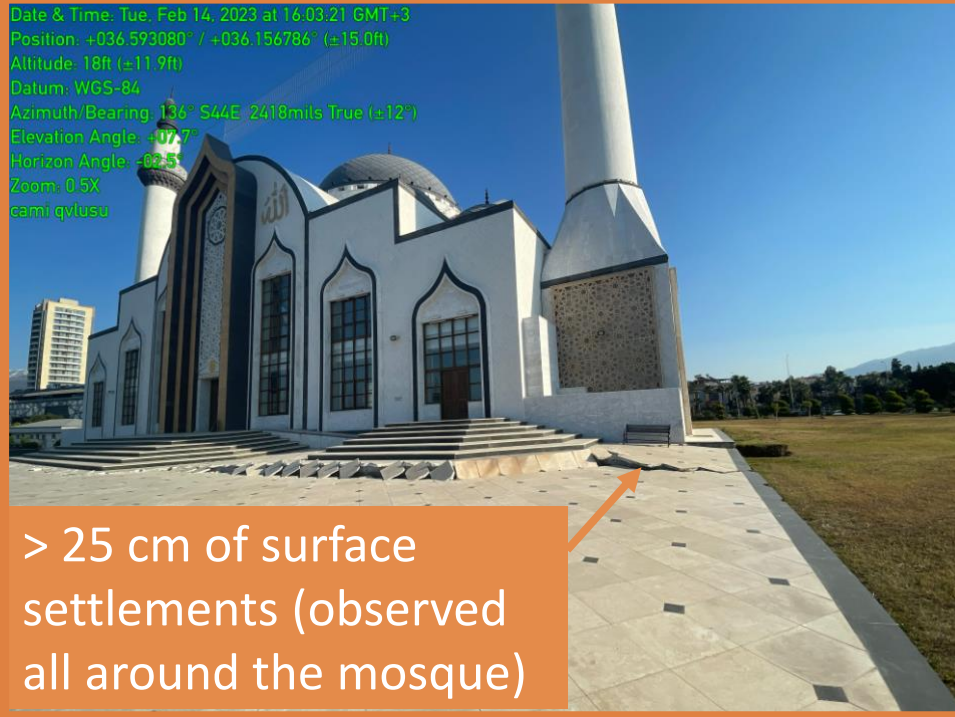
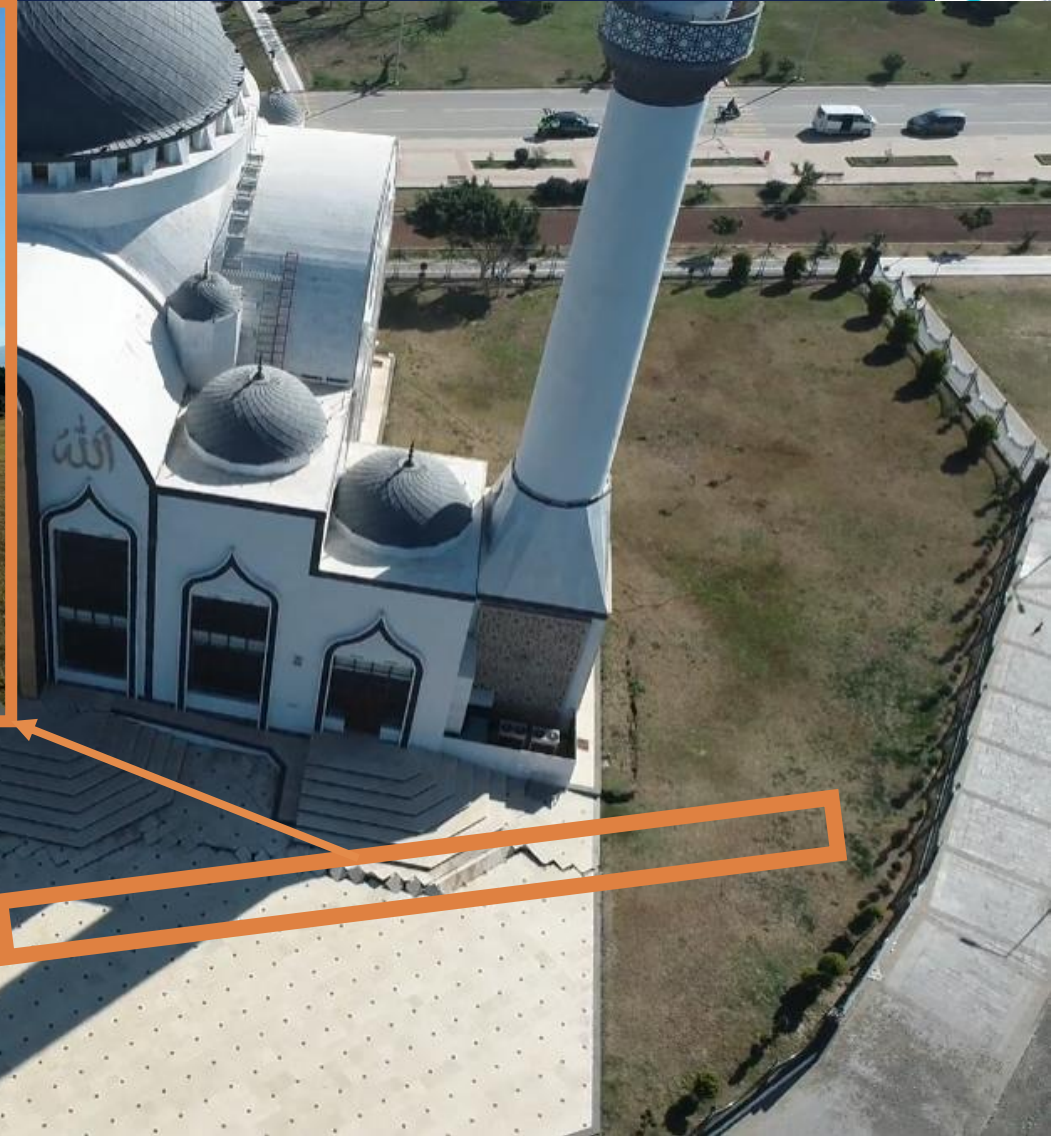
Iskenderun Coastal Line (Reclaimed Areas) – Differential Settlement

> 25 cm of surface settlements (observed all around the mosque)

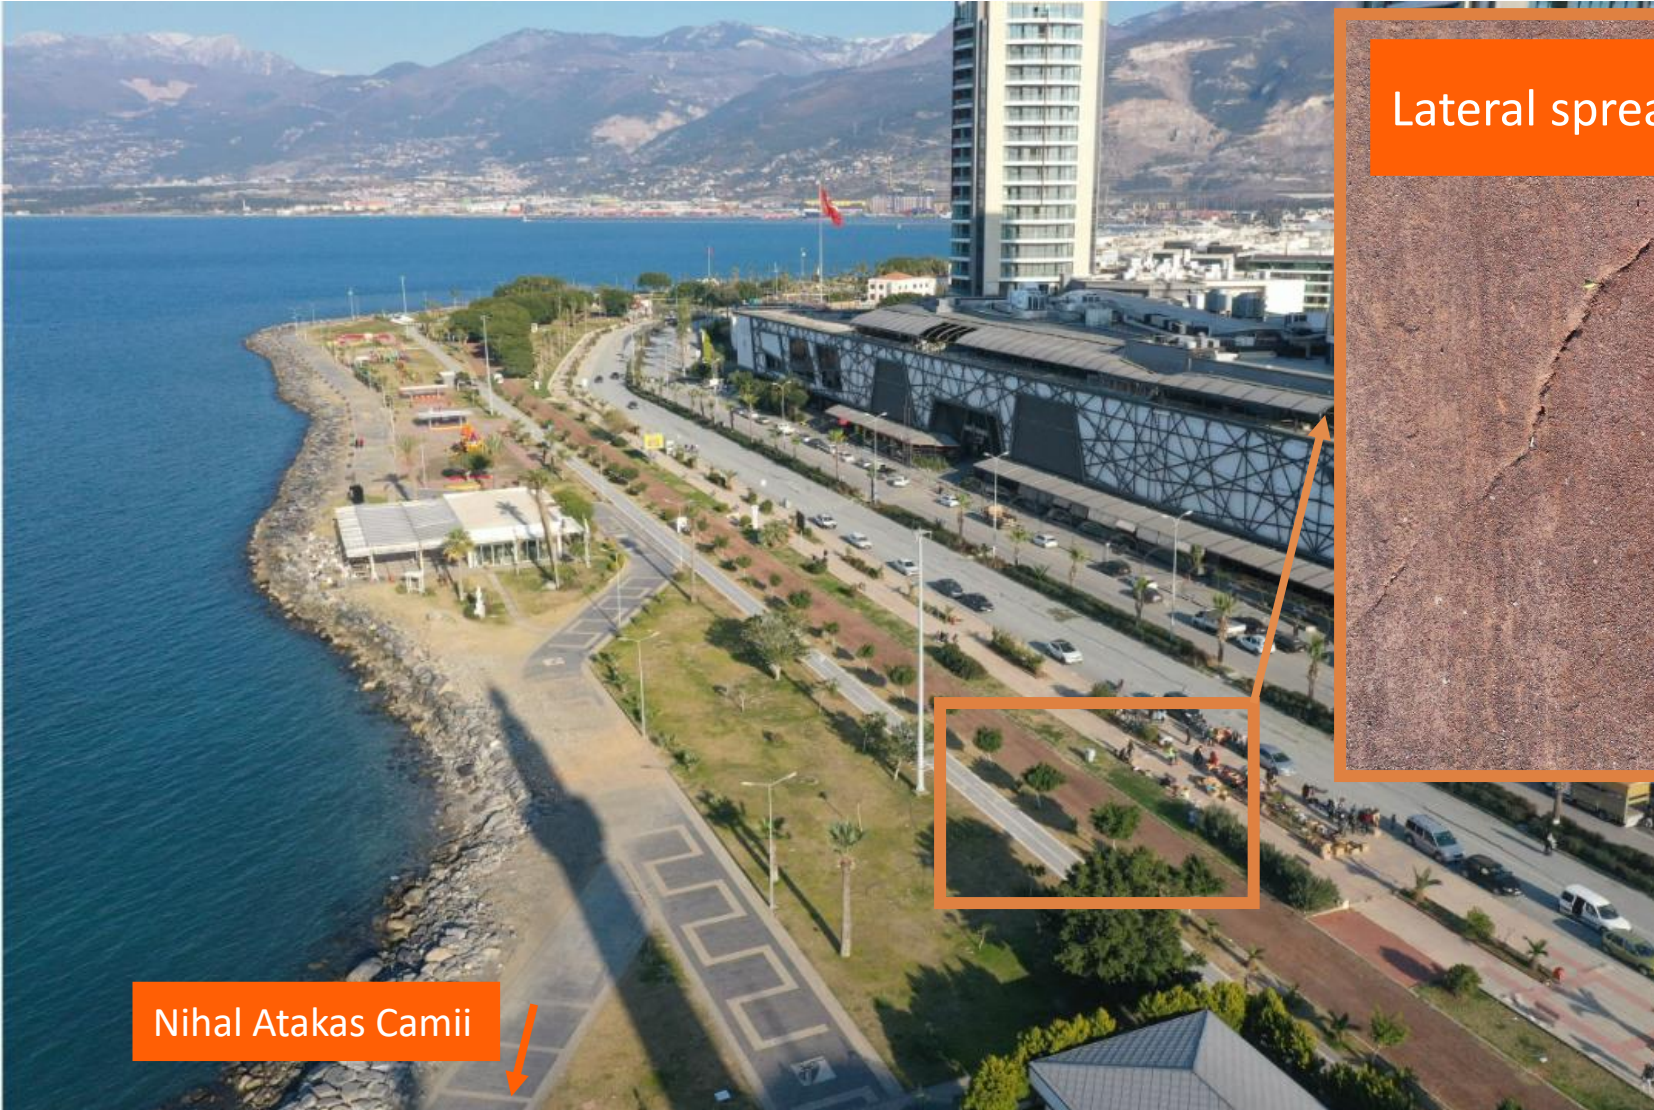
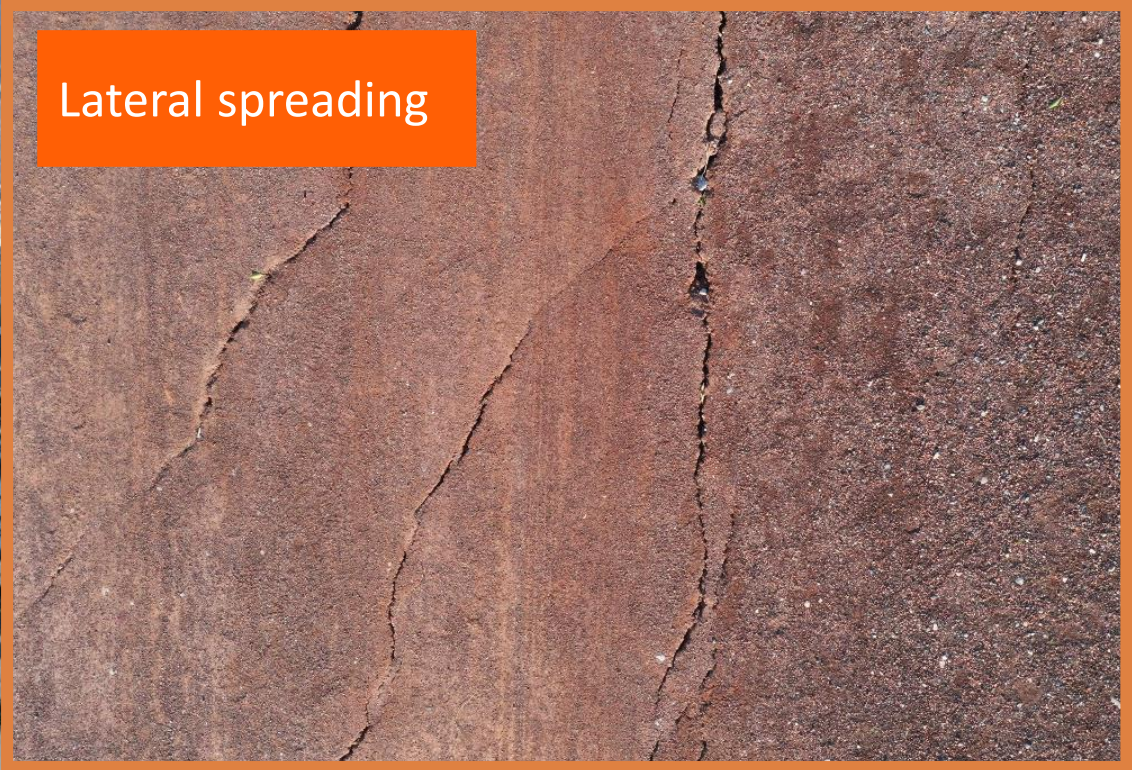
Iskenderun Coastal Line (Reclaimed Areas) – Lateral Spreading

Lateral spreading
