Geotechnical Problems Caused by the 2023 Kahramanmaras - Turkiye Earthquakes

Professor Tugce Baser, Dr. Ozgun Alp Numanoglu, and Professor Okan Ilhan

March 31st, 2023

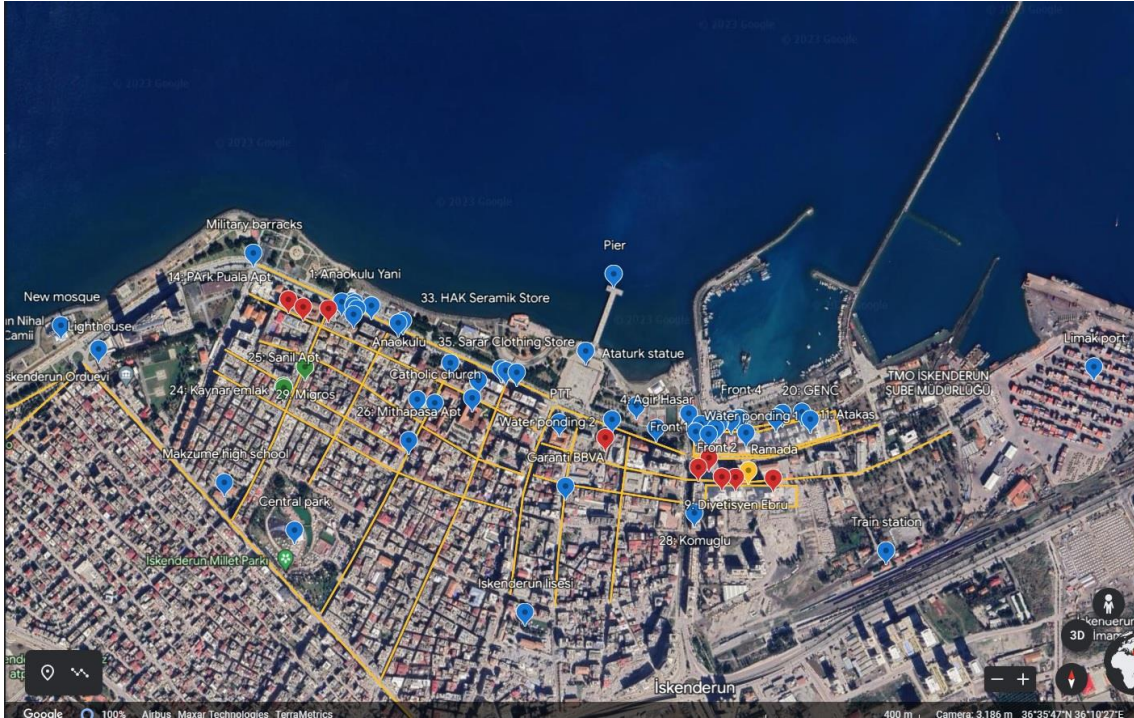
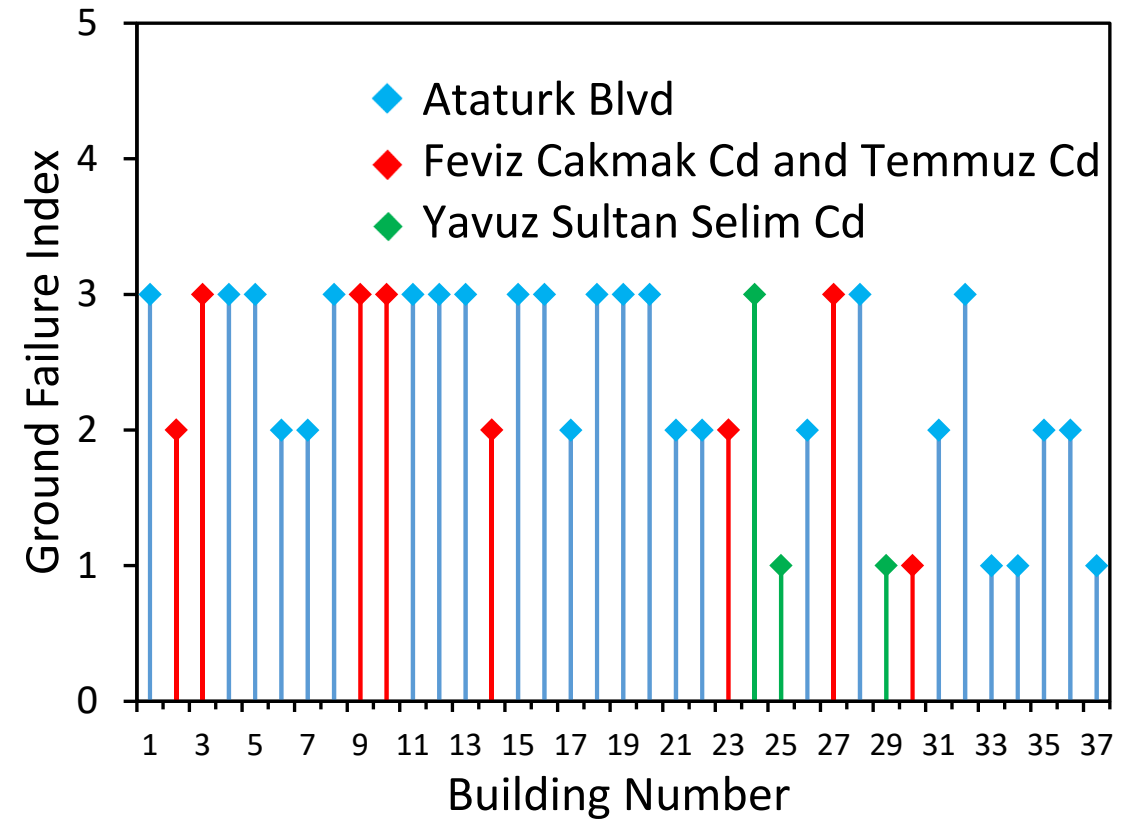
Iskenderun Building-Foundation Performance

- Widespread liquefaction
- Liquefaction occurred both at near-free field and at soil-structure interaction cases
- Settlements vary between 20 cm up to 150 cm and largest settlements occur at the edges of the Iskenderun dock (might be related to thickness of reclamation material)
- Lateral spreading with 5 cm to 25 cm displacements was measured around the coastal line

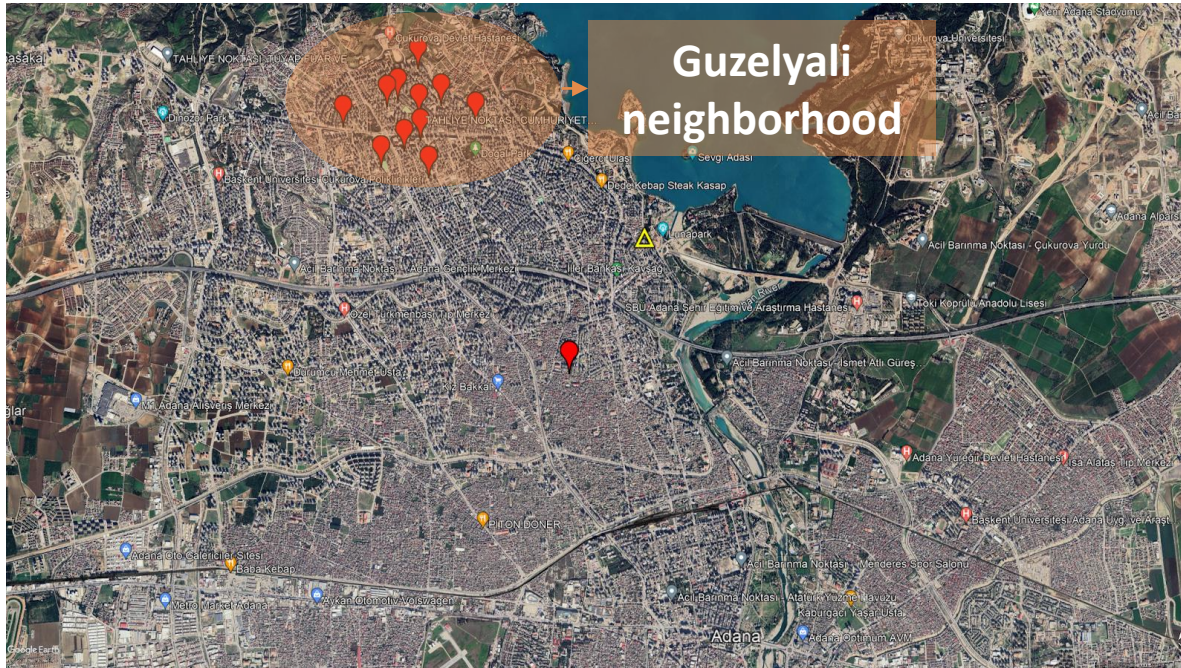
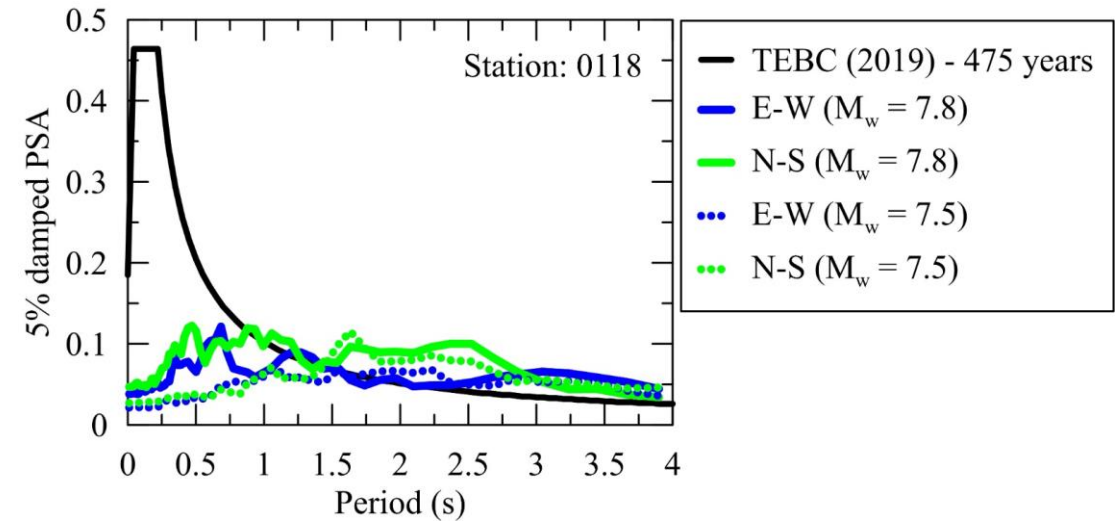
ADANA: A Puzzling Case History

- 12 residential buildings with more than 10 stories catastrophically collapsed resulting in 1,000 deaths
- 3800 buildings red tagged to be demolished
- Collapsed buildings in a specific neighborhood of Adana, 11 of these buildings laid within an area less than a kilometer radius
- Distant to the earthquakes and **weak ground motions ($\sim 0.05g$)** close to the area with the collapsed buildings

- Adana case is attributed to the lack of technical expertise on earthquake-resistant design, poor construction practices and **possibly an unforeseen seismic amplification in this area.**
