Severe Finger Laceration during Machine Shop Operations

Lesson ID: 2015-ANL-026 Originator: Argonne National Laboratory Date: 12/10/2015

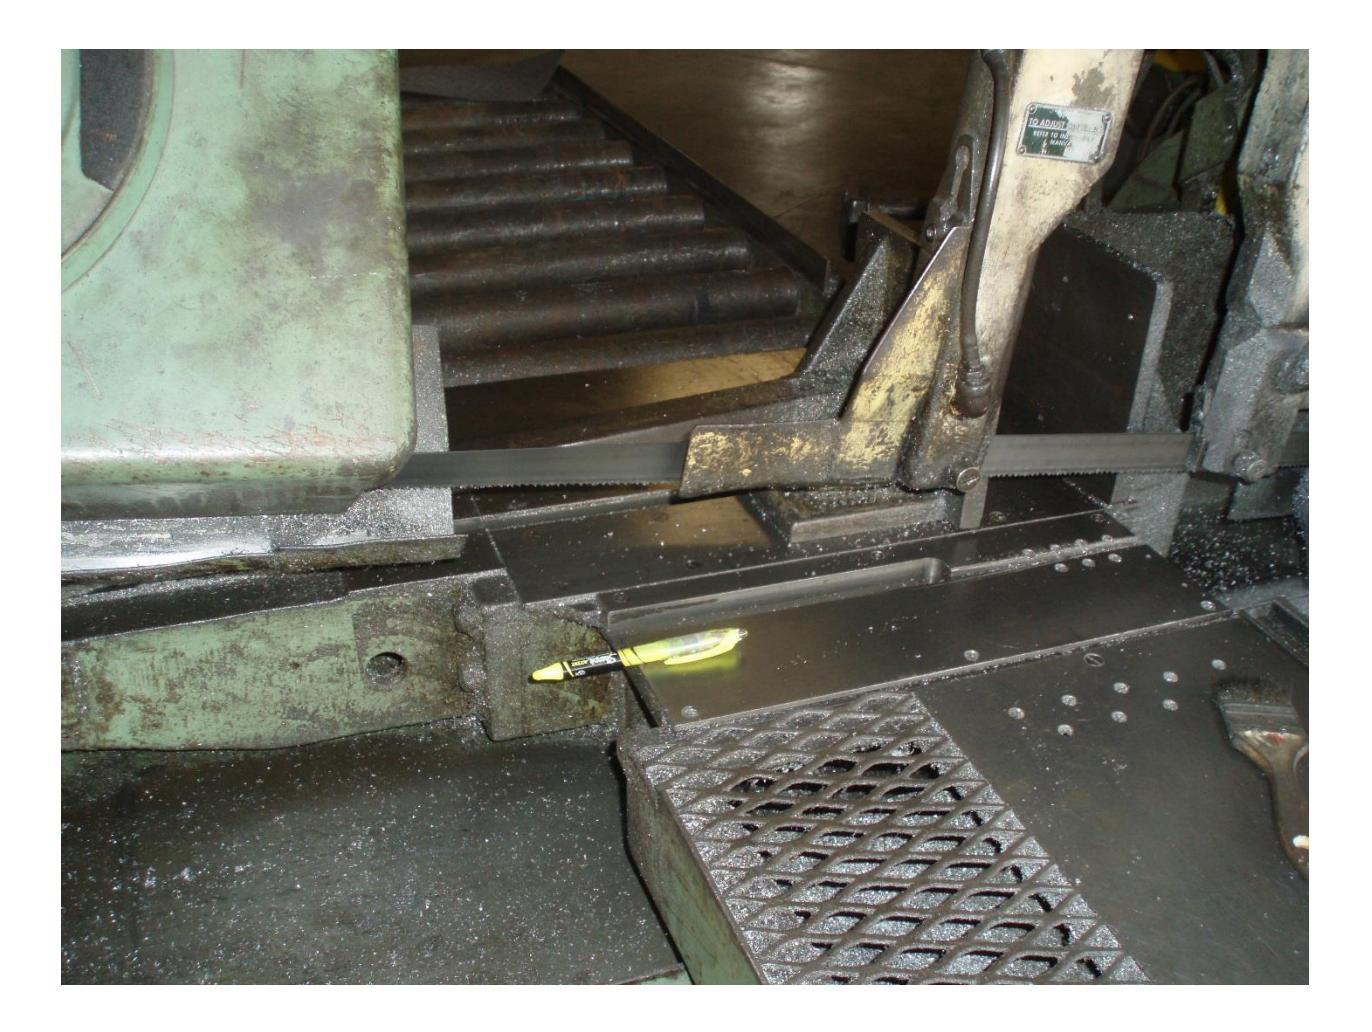
1) Inadequate guarding condition was not previously identified- An inspection conducted in 2013 noted guarding deficiencies on Saw 2 but recommendations only addressed the deficiency on the right side of the cutting point of operation.

3) The saw was operating with the blade rotating while the senior repair machinist leaned to check an unusual sound- When a sound was heard across the table and to the right of the cutting point of operation, the repair machinist leaned over to the right and the left hand moved forward and under the moving saw blade to the left of the guide arm, beyond the short length guard attached to the guide arm. The left index finger contacted the unguarded blade.

1) Conduct a material saw guarding evaluation of all saws within Central Shops before returning any saw to service following the stand down. Utilize machine guarding SMEs to conduct the evaluation.

2) Create a visual record of each Central Shops saw that documents the correct and complete installation of all required guards.
