HAMBURG
Testing laboratory Perspective

Chicago Testing
Laboratory, Inc.

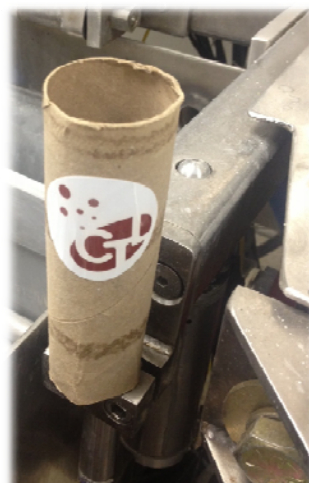
- Maintenance
 - Keep Clean
 - Linear Variable Differential Transducer (LVDT)

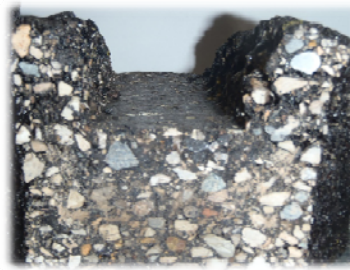
Range

- Low
 - Failure at 190 Passes
- High
 - 0.85 mm at 20,000 Passes

Most fell within:
2.64 to 10.60 mm

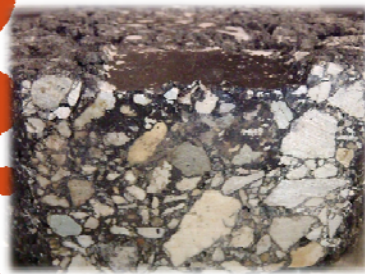
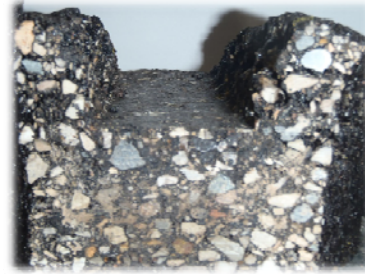
“Flyers” (5% of total)

- Where left and right wheel were significantly different
- Average Right – 6.46 mm
- Average Left – 6.62 mm
