HMA Field Cracking and Performance Test

David L. Lippert, PE
Sustainability Implementation Engineer

ICT-R27-161- CONSTRUCTION AND PERFORMANCE MONITORING OF VARIOUS ASPHALT MIXES

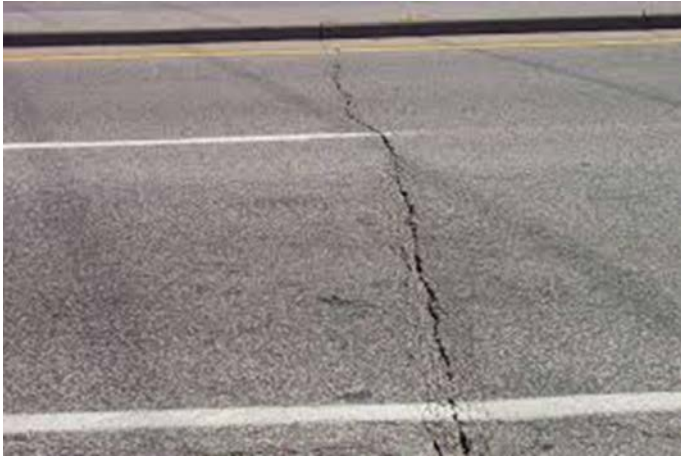
Thermal Cracking (Full Depth HMA)

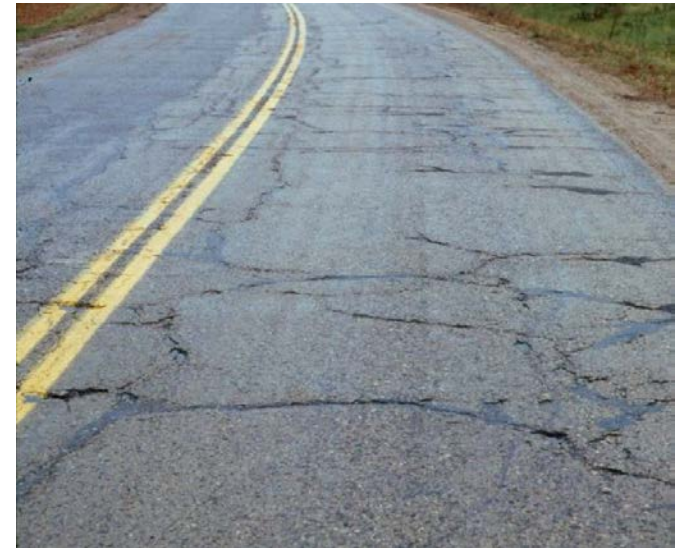
Block Cracking (All HMA)

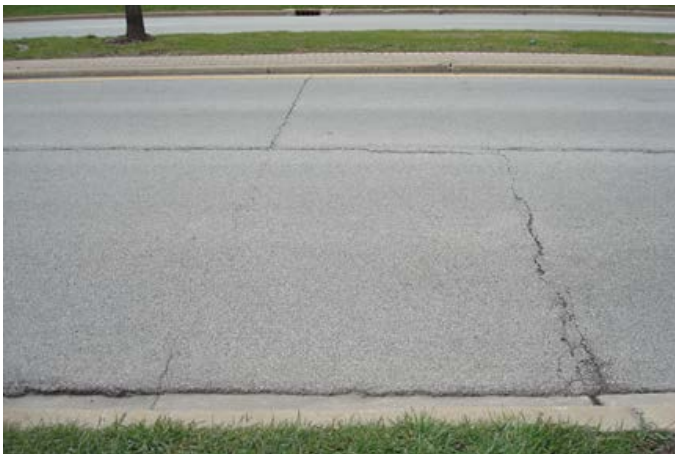
Reflective Cracking (Composite)

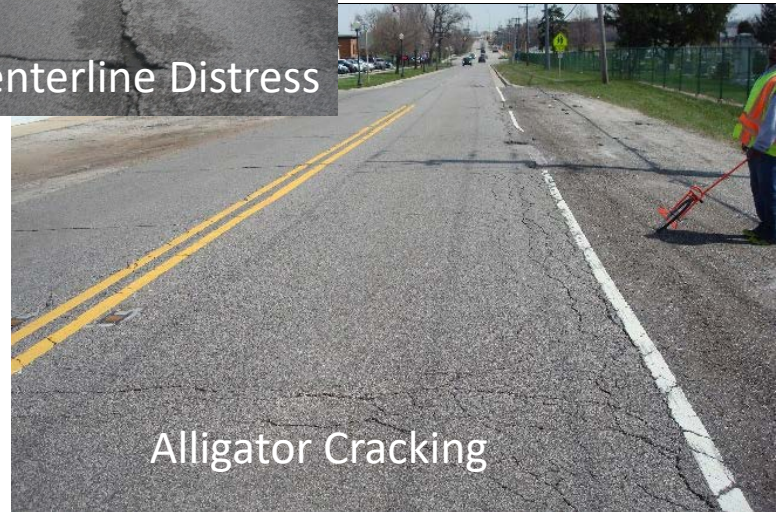
Alligator Cracking

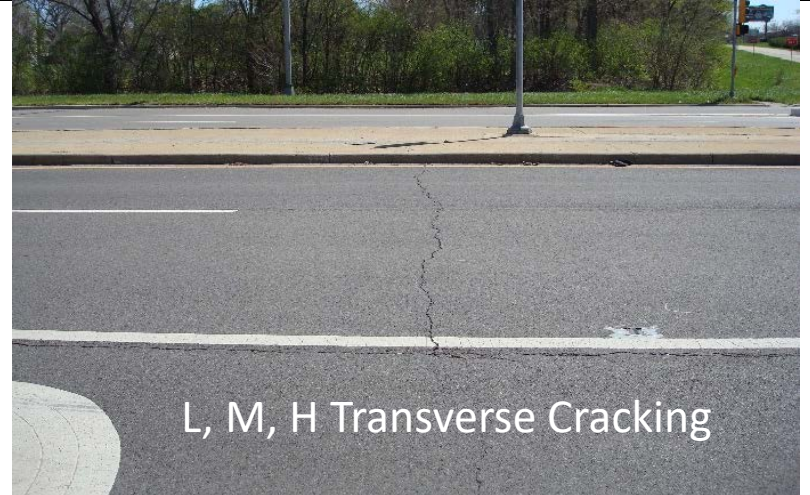
L, M, H Transverse Cracking

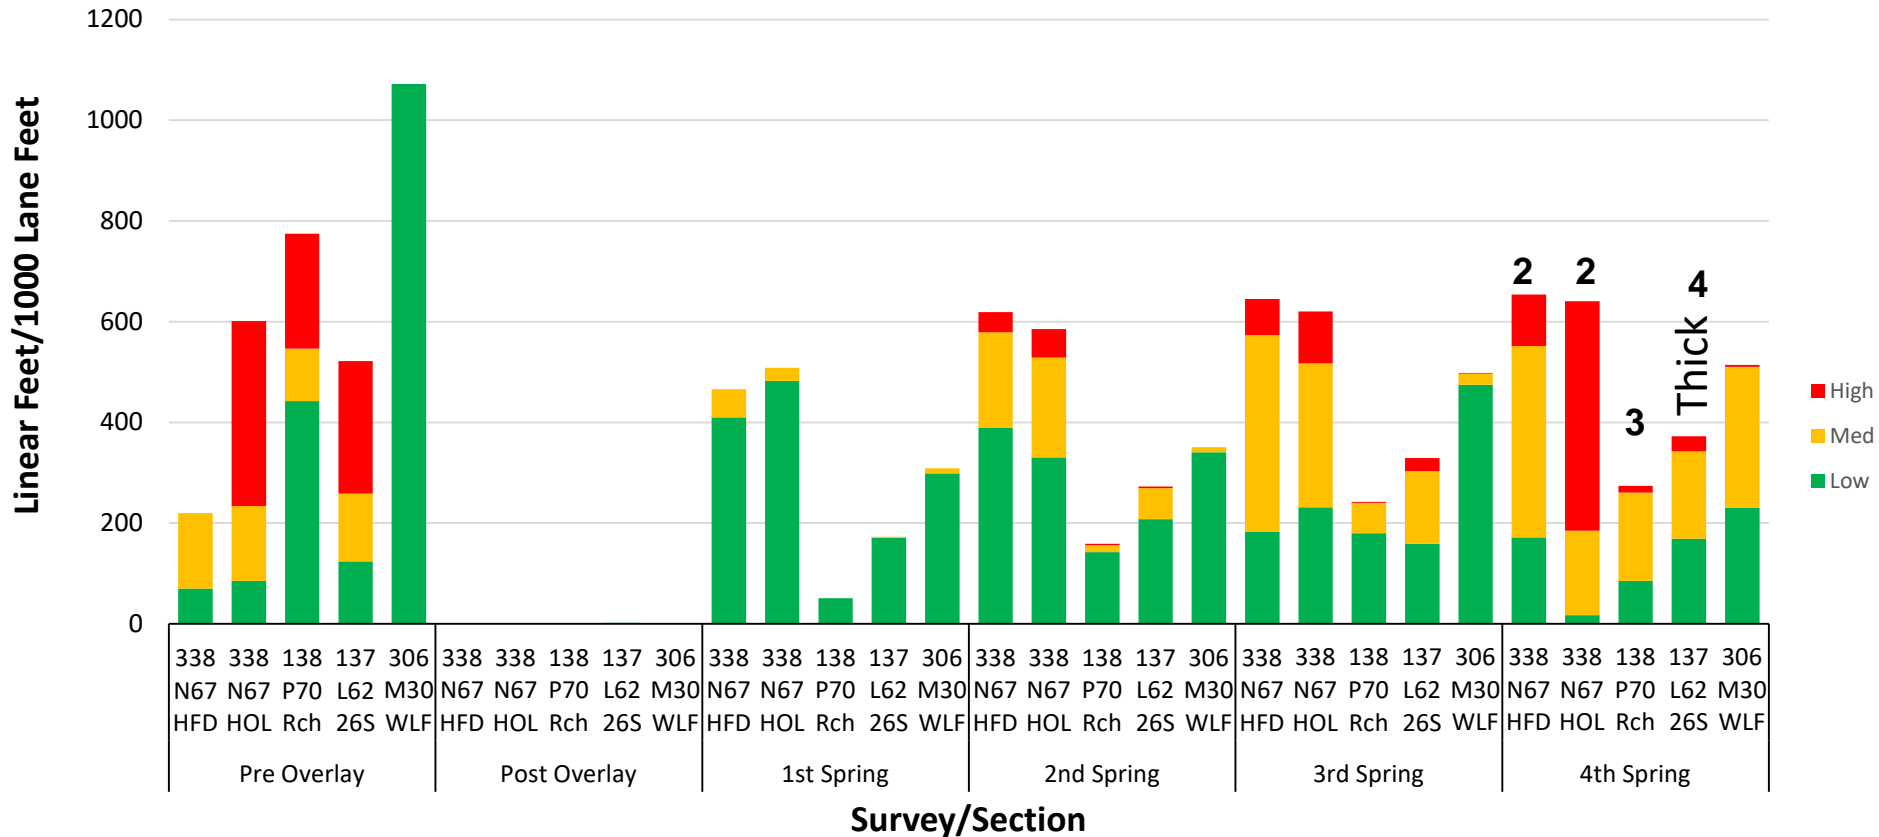
Harrison St, Richards St, 26th St & Wolf Rd Transverse Joints and Cracking Linear Feet/1000 Lane Feet

- **Richards (non-RAS) and Wolf Road**
 - Transverse cracking at lower severity
 - Wolf Road average slab length ~11'
 - Many slabs – little movement – less severity
- **26th Street severe centerline problems**
- **Harrison and Richards Alligator Cracking**
- **Harrison: extensive early transverse cracking and higher severity sooner than other projects**
(Mix 338 N67, FI = 1)

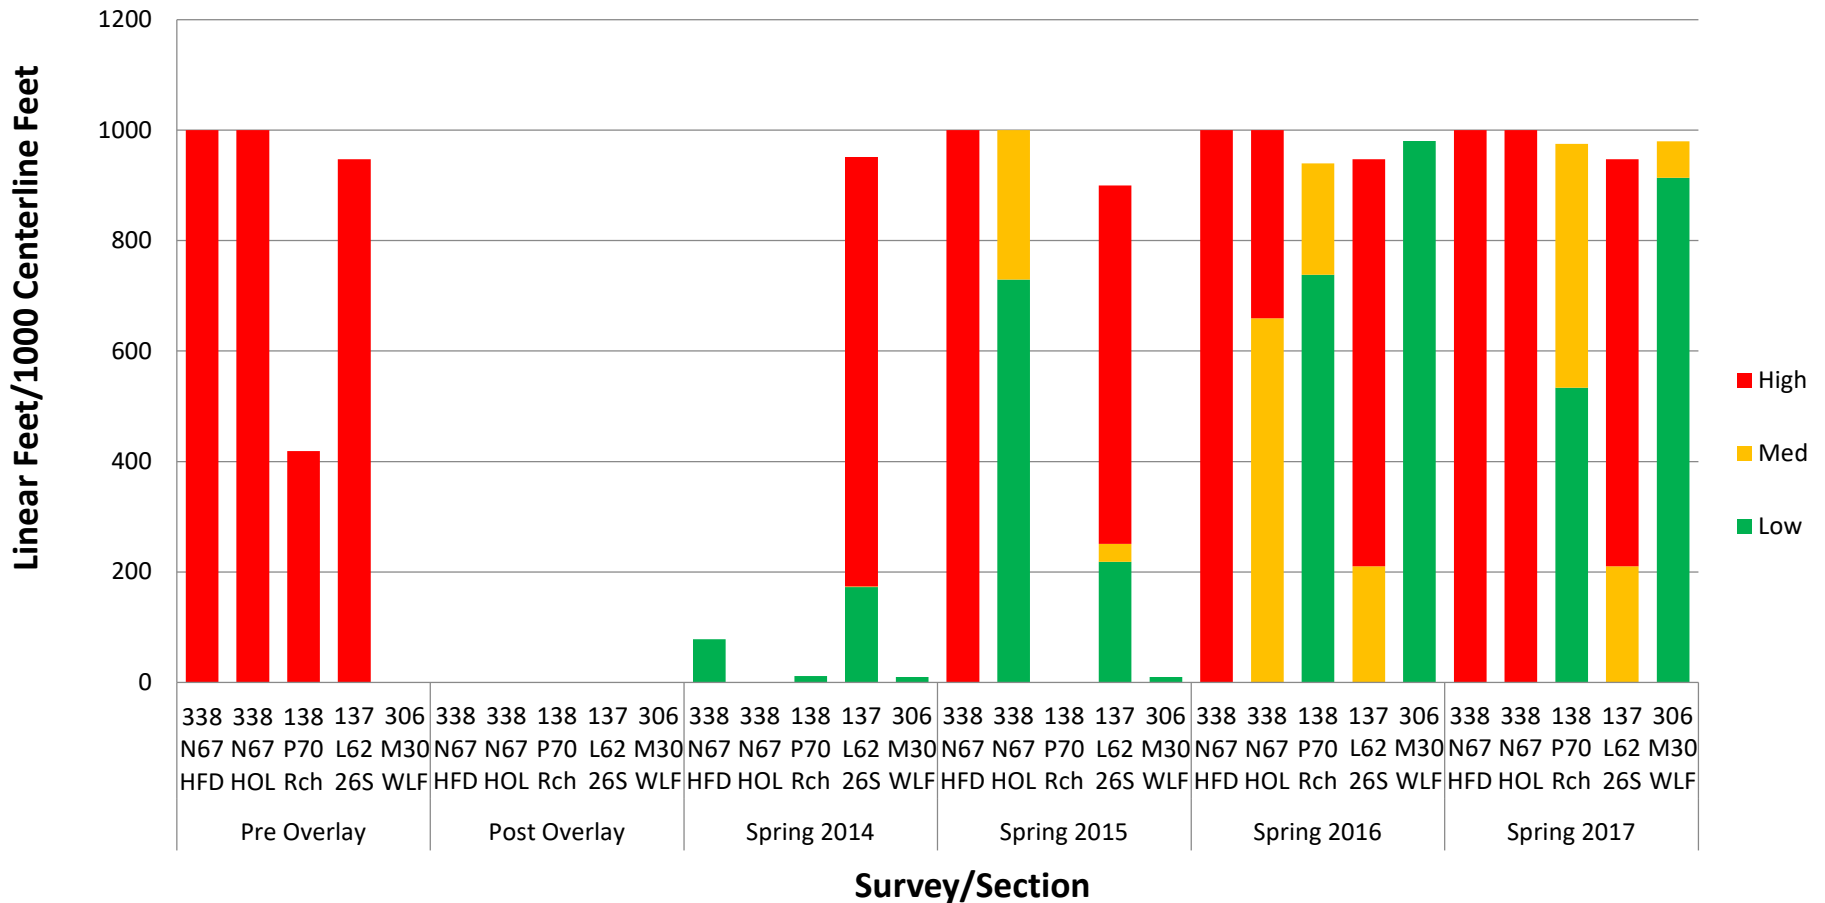
Harrison St, Richards St, 26th St & Wolf Rd

Centerline Cracking

Linear Feet/1000 Centerline Feet

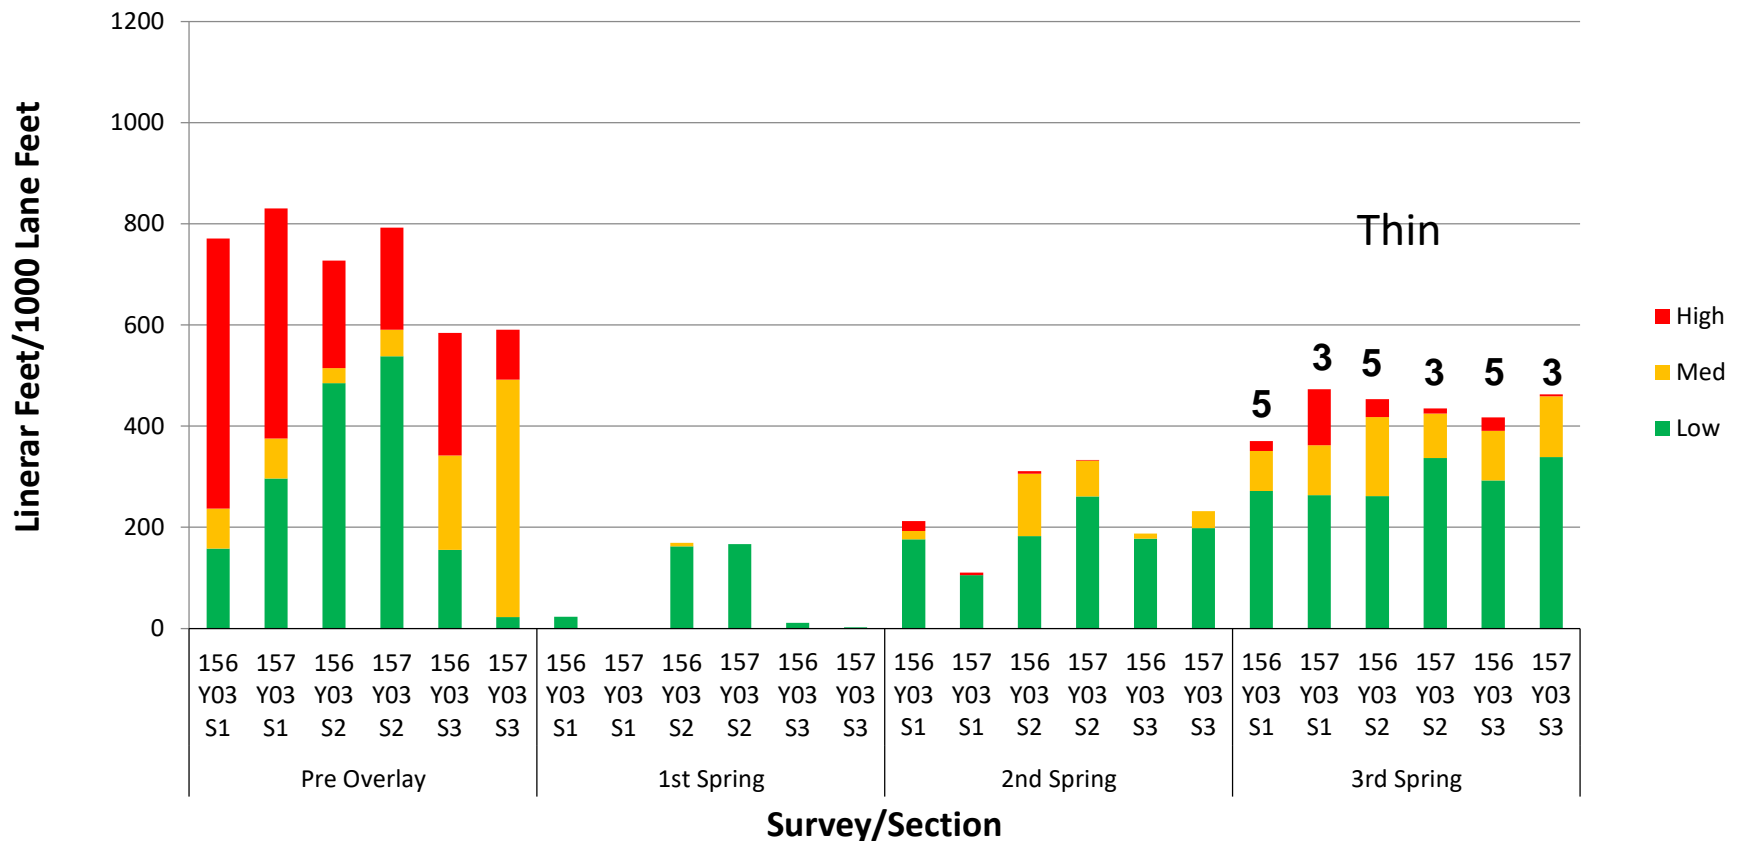
Crawford Ave./Pulaski Rd.
Transverse Joints and Cracking
Linear Feet/1000 Lane Feet

- **Transverse cracking** similar by **project** more than **segment** or different **mixes** on a project.
- **Higher amount of transverse cracking** on Crawford/Pulaski **“thin”** project.
 - 157 (SB) – ABR 30% w/PG58-28, RAS 5%
 - 156 (NB) – ABR 15% w/PG64-22, RAS 2.5%
- **Lower amount of transverse cracking** on US 52 (Y02) project **“thick”** and **“thin”** segments.
 - 140 (EB) – ABR 30% w/PG58-28, RAS 3.1%
 - 159 (WB) – ABR 29% w/PG58-28, No RAS
- **Raveling/Weathering/Segregation** on nearly all project measured in **1st spring** after construction on US 52.
- **Fewer** distresses at **lower** severity than 2013 projects.

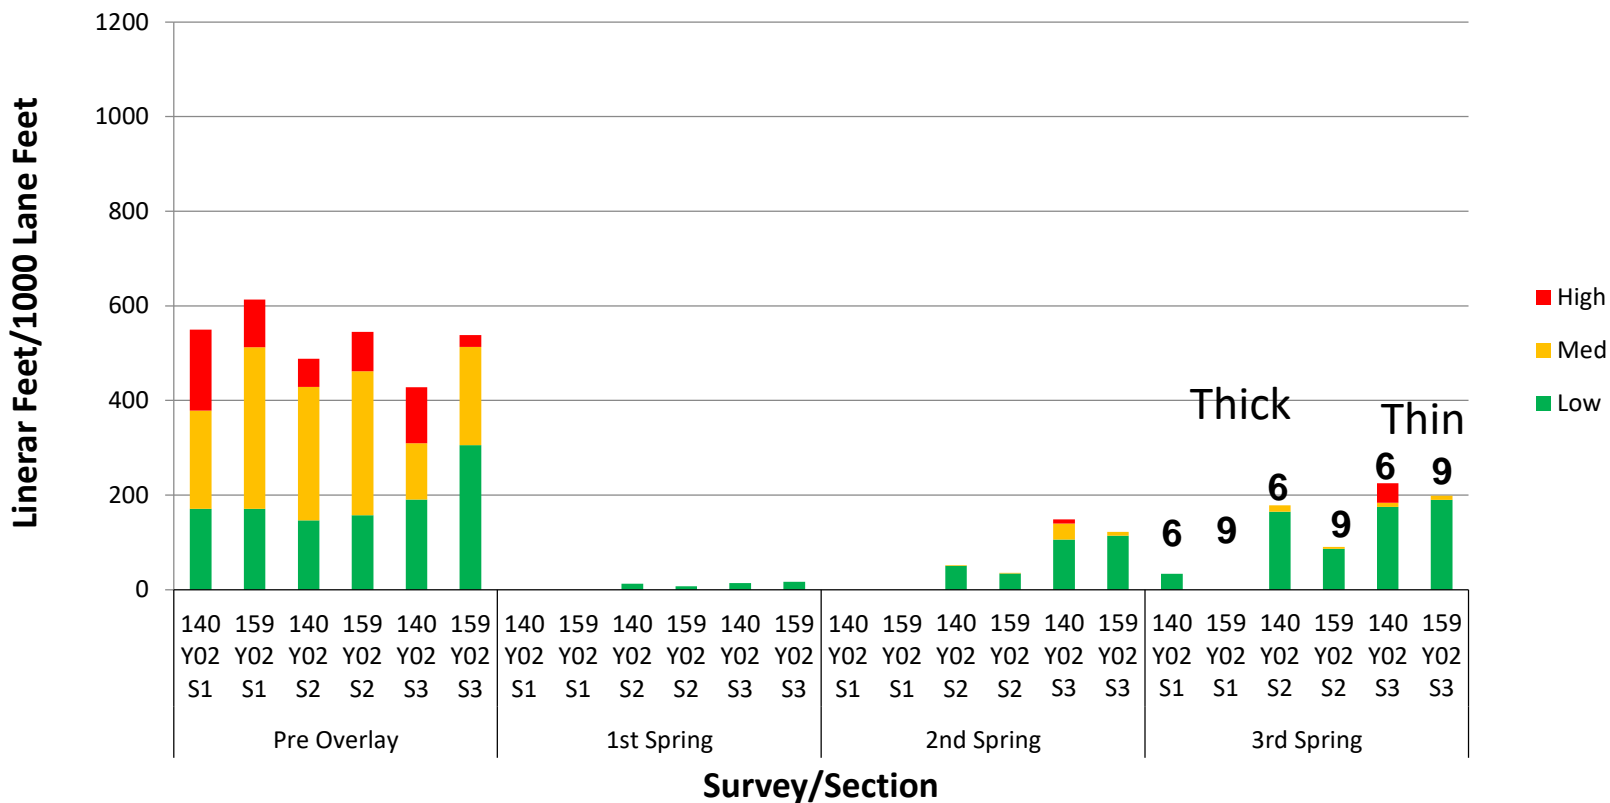
**US 52 (IL 53 to Laraway)
Transverse Joints and Cracking
Linear Feet/1000 Lane Feet**

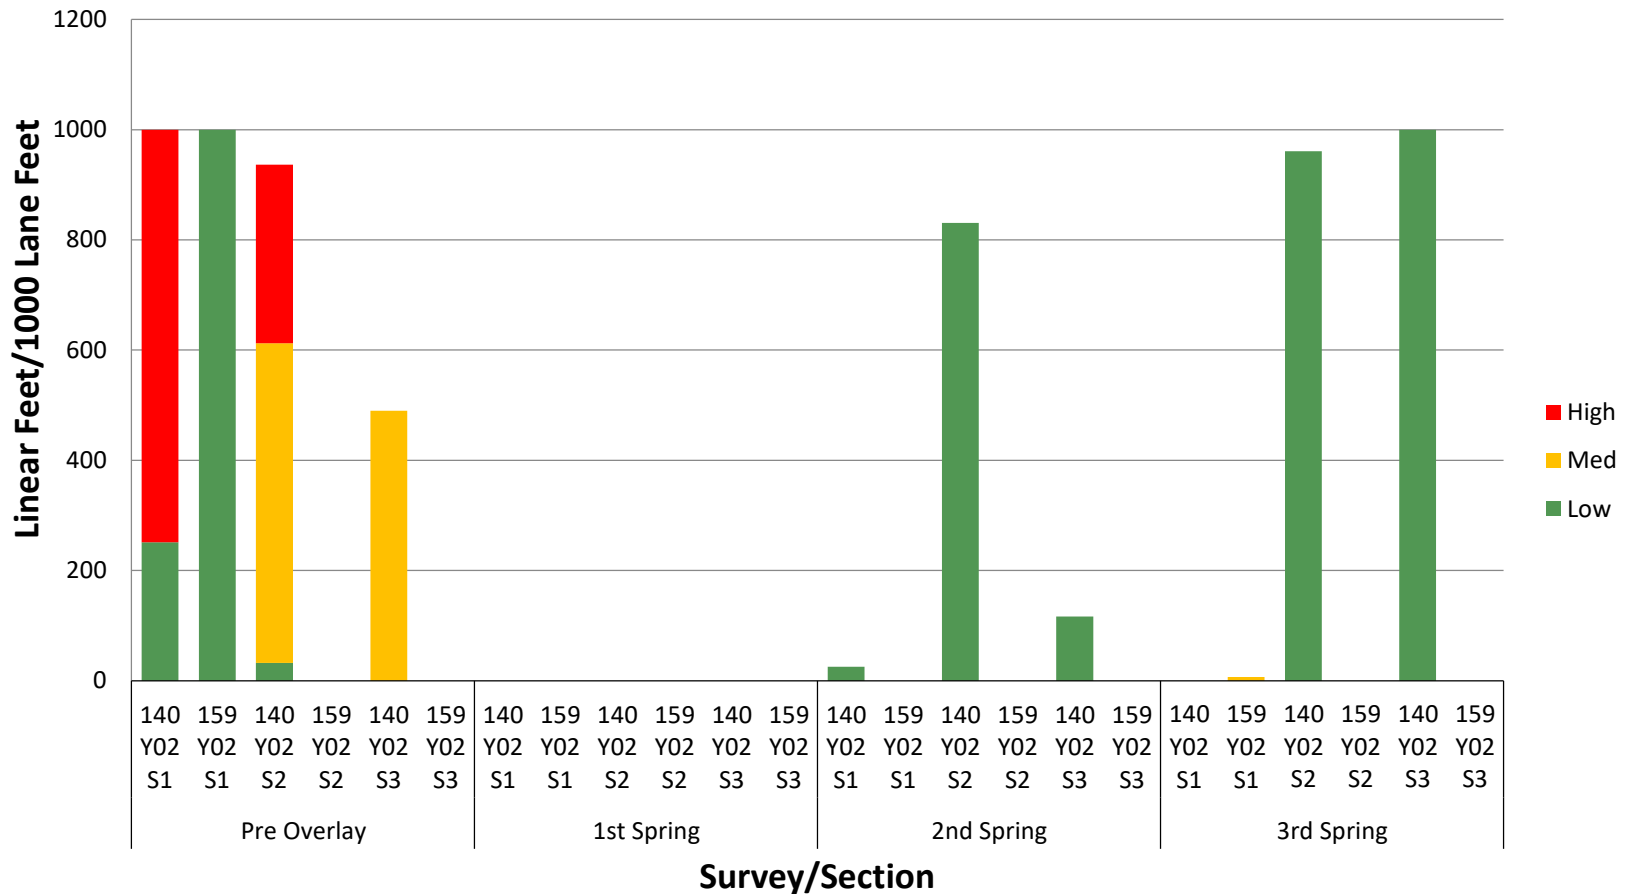
US 52 (IL 53 to Laraway) Centerline Cracking Linear Feet/1000 Lane Feet

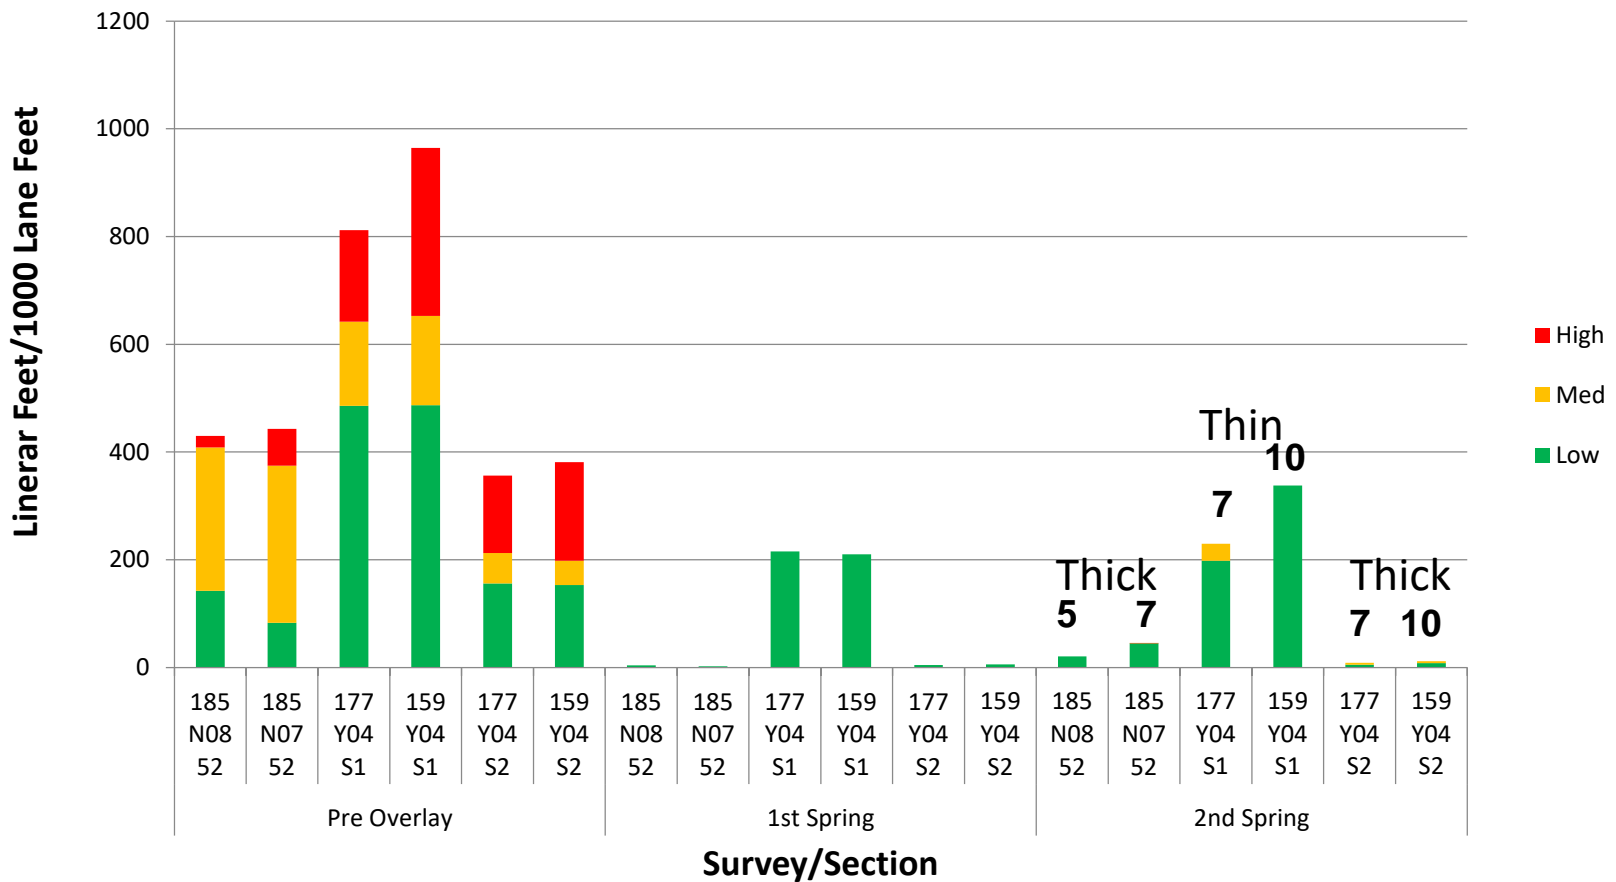
US 52 (Laraway to Gougar, Gougar to 2nd St) & Washington St Transverse Joints and Cracking Linear Feet/1000 Lane Feet

- **“Thin” overlays reflecting cracks/joints quickly**
 - West end Washington
 - Crawford/ Pulaski
- **“Thick” overlays (not removed by milling) reduces transverse cracking**
 - US 52 sections
 - Washington St. Segment 2
- **2015 TRA mixes performing much better than 2013 TRA mixes (thus far)**

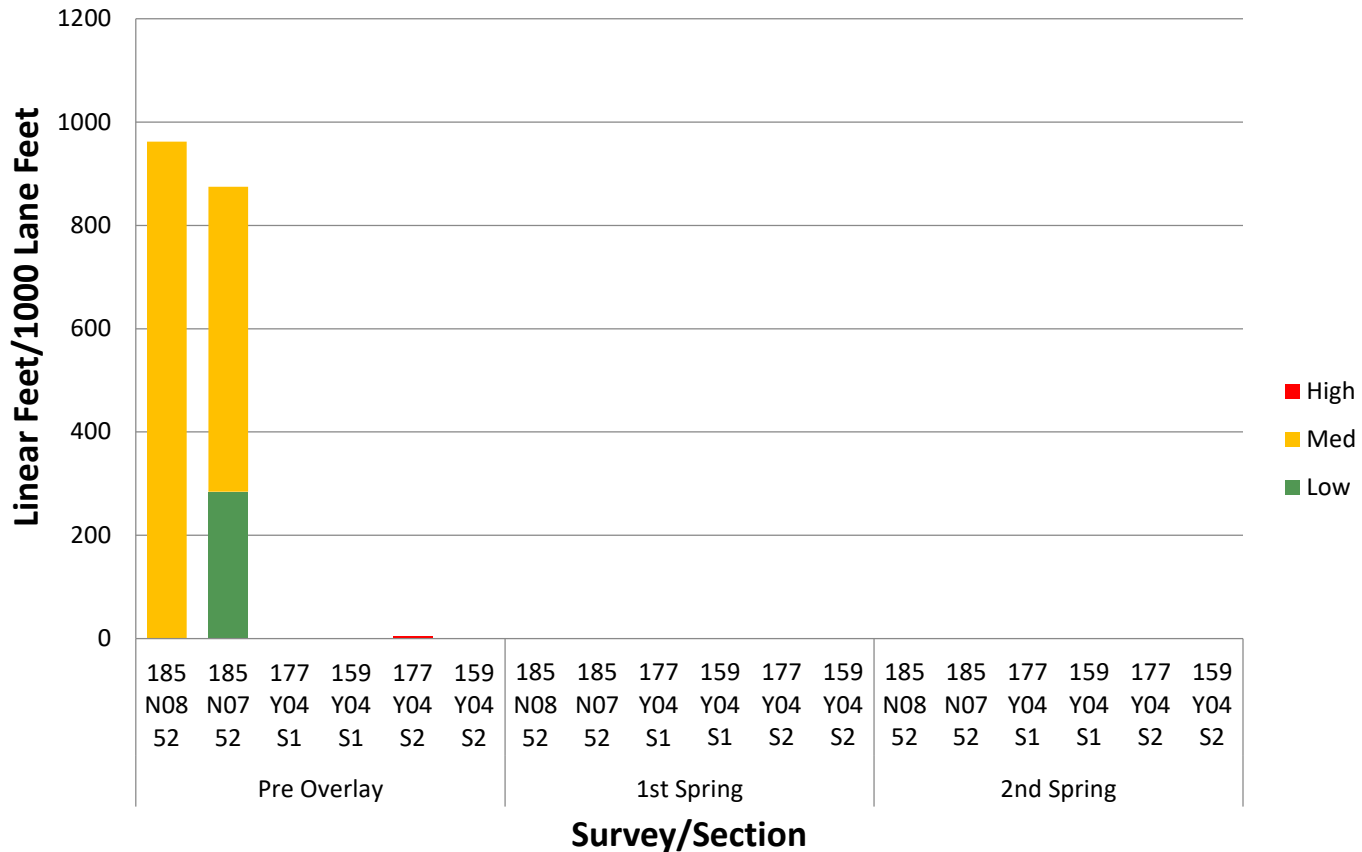
US 52 (Laraway to Gougar, Gougar to 2nd St) & Washington St Centerline Cracking Linear Feet/1000 Lane Feet

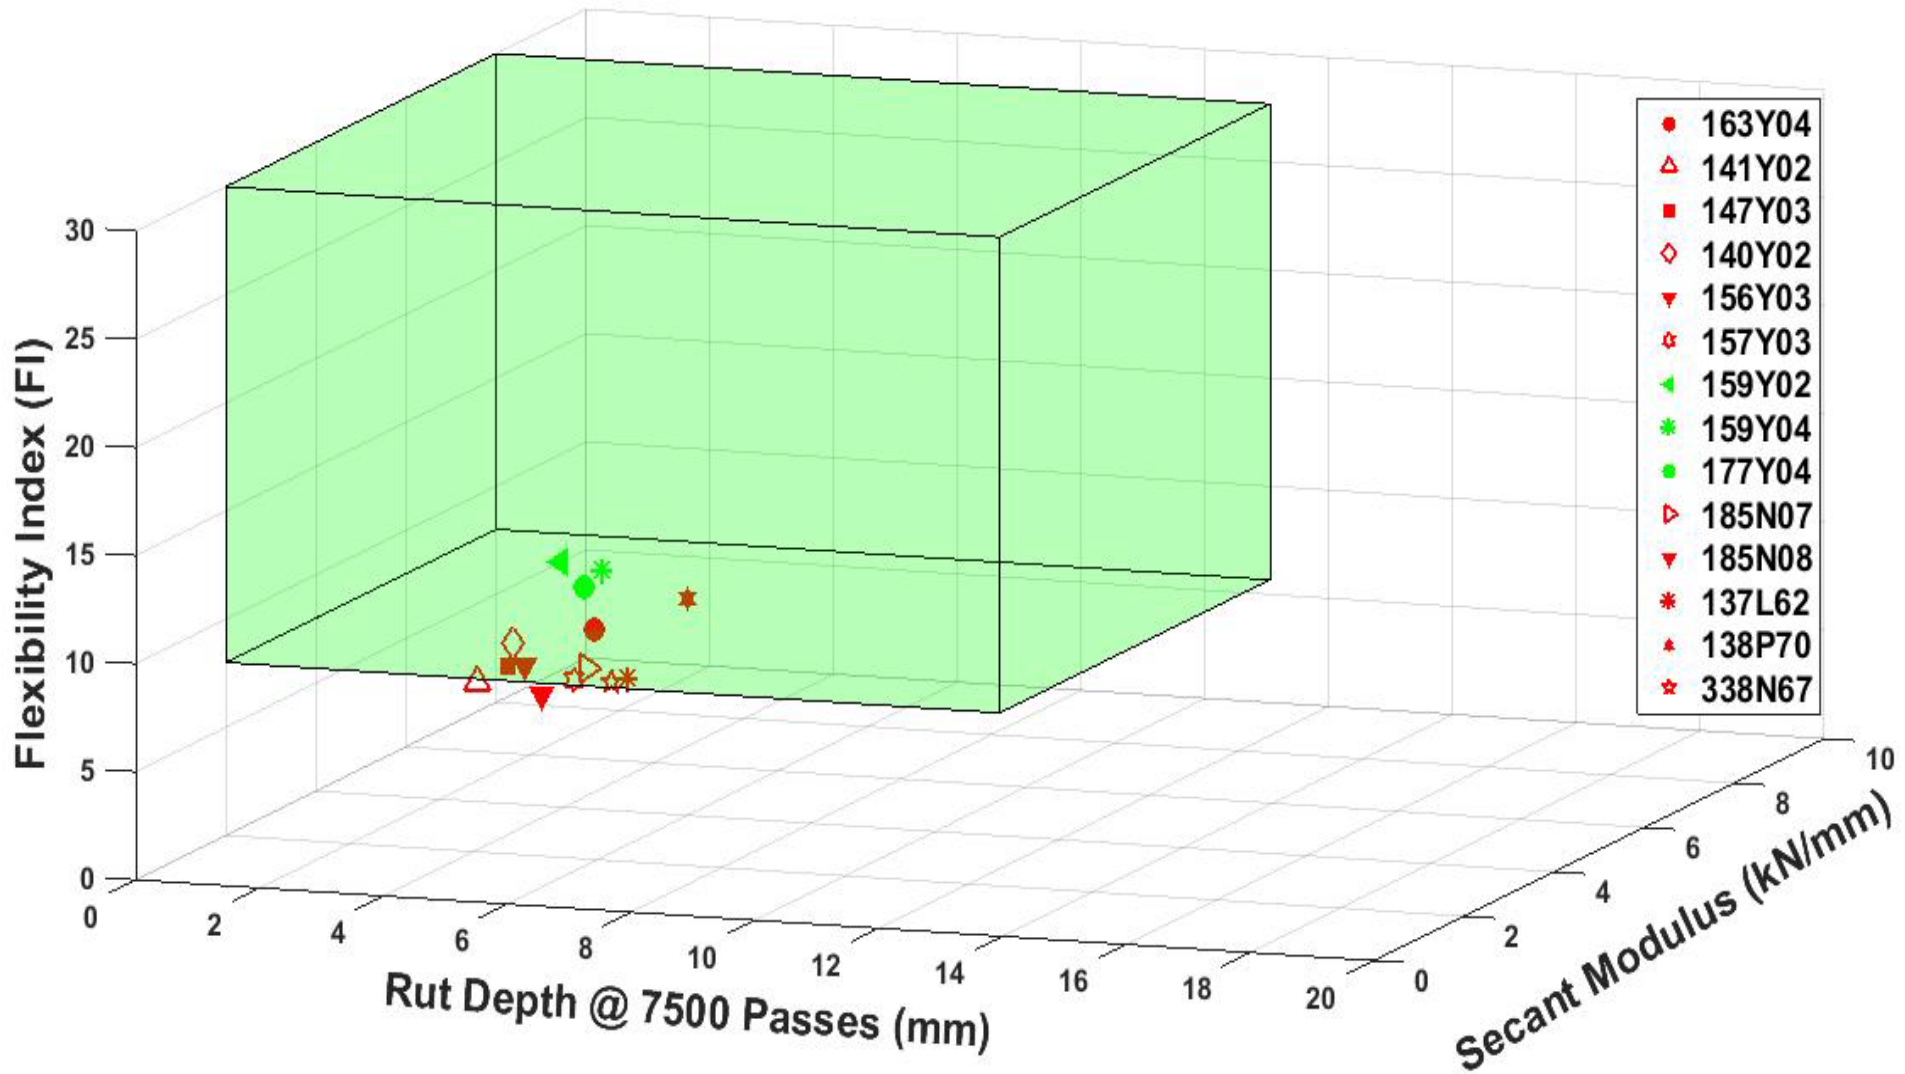
3D-BMD for PMLC

(Balanced Mix Design)

- **I-FIT should be adopted** for use as a specification requirement **in AC mixture design** and/or production.
- The proposed Flexibility Index (**FI**) value of **8.0** by IDOT **should be adopted**
- **Balance mix design** should be used and explore the **3D balance mix design**.
- Use of **virgin aggregates** rather than all recycled aggregates, would result in **better production control** of the AC mix and **less absorption** which would **reduce cost** of TRA mixes.

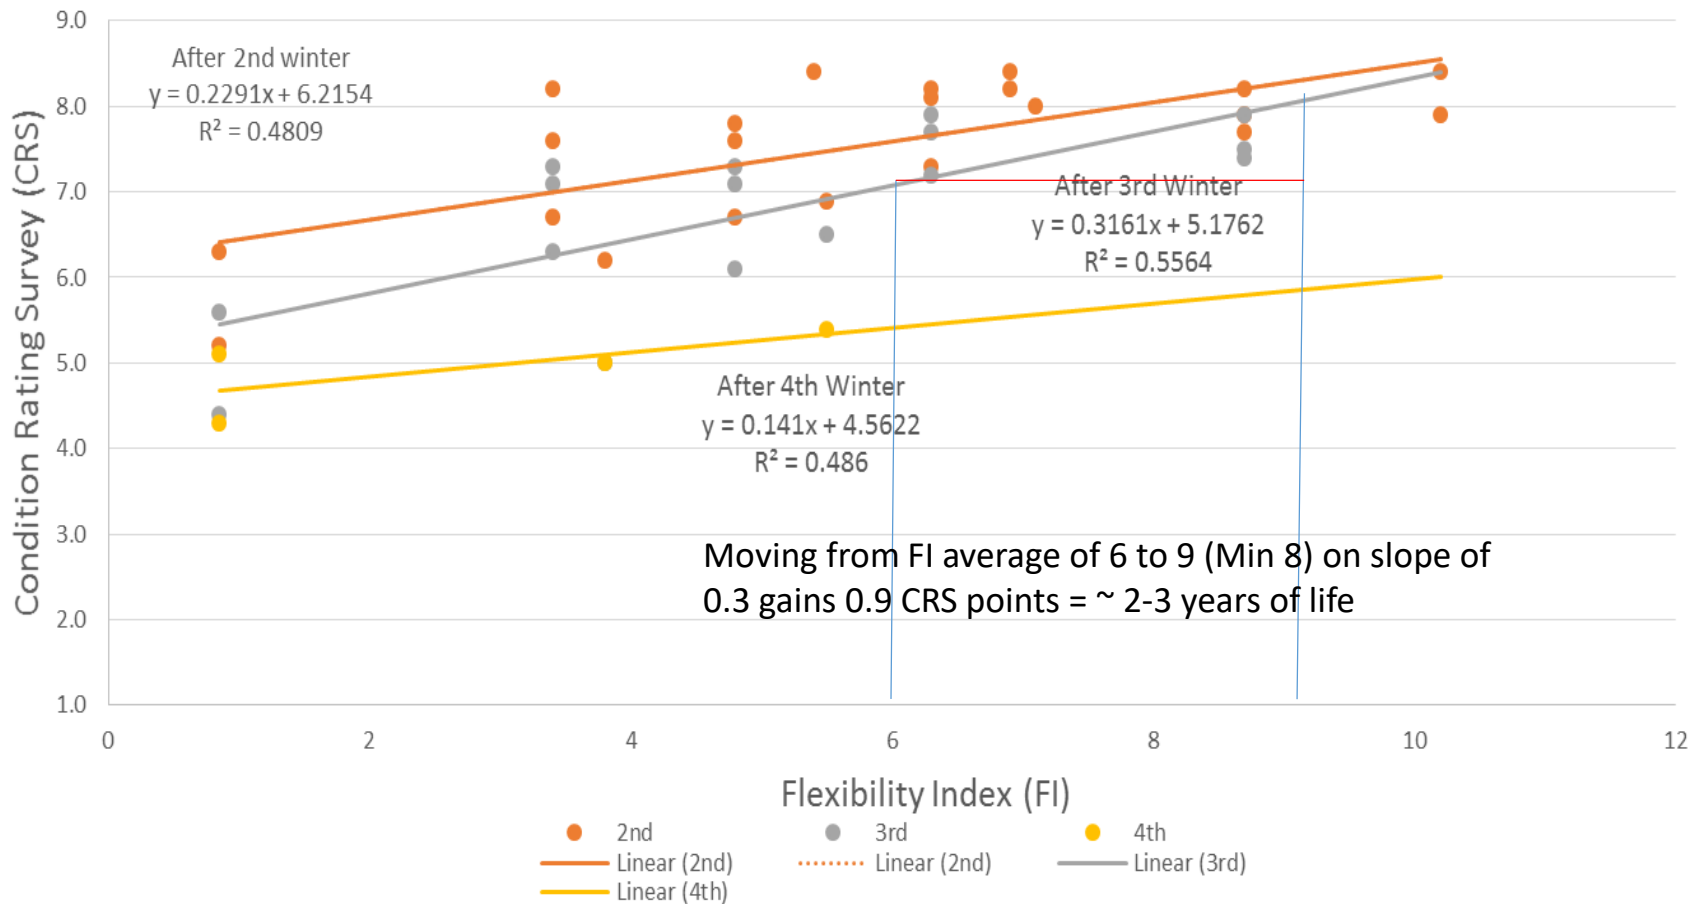
Flexibility Index vs CRS All Projects After Winter

- **2013 (N50) TRA projects performed worse at any given time.**
 - After 4 years nearly same CRS as pre-construction on Harrison – **Mix 338 N67 (FI = 1.6)**
- **Wolf Road (2013 let– No RAS and N70) performed similar to 2014 let projects**
- **“Thin”/”Thick” CRS trends are different, but not as strong as transverse cracking trends**
