# Attached Garages: IAQ Implications and Solutions

## ABSTRACT

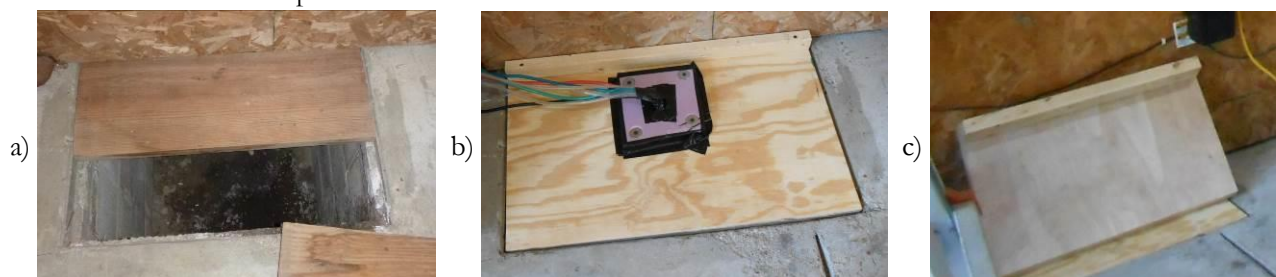
**Figure 2** Images of the various crawlspace access hatches at site 4: a) the original hatch with one plank set aside, b) a more air-tight temporary hatch with a pass-through for sample and pressure tubing, c) the permanent hatch

**Air & Duct Sealing.** Air sealing work was completed by a local contractor, and consisted of locating and sealing bypasses on the garage/house interface with combinations of caulk, 1 and 2-part expanding polyurethane foam, weather stripping, and rigid materials. Large intentional bypasses such as crawlspace and attic hatches were repaired or replaced when necessary with commercially available products, or with custom built units (see Figure 2 for an example of a replacement crawl space access hatch). When HVAC systems were present in garages, duct sealing was completed on the exposed ductwork using mastic and foil tape. A short baseline period occurred after each air/duct sealing intervention to evaluate the improvement.

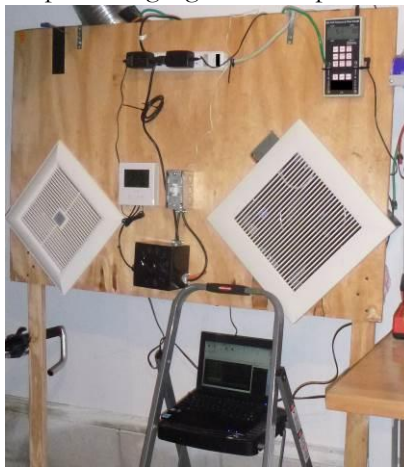
**Figure 3** The temporary fan apparatus installed in garages

**Mechanical Ventilation.** An apparatus (Figure 3) was designed and placed in each garage that allowed cycling between multiple fan speeds and control strategies. The apparatus includes a dial that the homeowner could toggle to switch between the fan settings at the researchers’ request. This facilitated the cycling between these settings without the need to coordinate and complete a site visit. The apparatus had two fans so that it could exhaust a wide range of air flows, including a low speed of 50 cubic feet per minute (CFM) and a high speed of 290 CFM. The medium speed was 100 CFM everywhere except site 1 where the medium speed was 130 CFM. The apparatus also included controllers that operated the fan continuously, based on the CO2 levels in the garage, or based on the state of the garage door. The fan speeds and control parameters for each site are detailed in Table 2. Due to time constraints or equipment issues, not all mechanical ventilation phases were completed at each site.

At sites 1, 2, and 3 the fan state was monitored using a logging power meter. As a result of the efficient operation of the fans and the resolution of the meter, it was difficult to differentiate the on vs. off periods for the low speed settings, calling into question the functionality of the advanced control devices. At sites 4 and 5 monitoring of the fan state was completed using a logging differential pressure gauge with a tap in the fan exhaust.
