REPORT#: 21KY002

REPORT DATE: 7/14/2021

Machinist Dies after Being Pulled into Manual Lathe

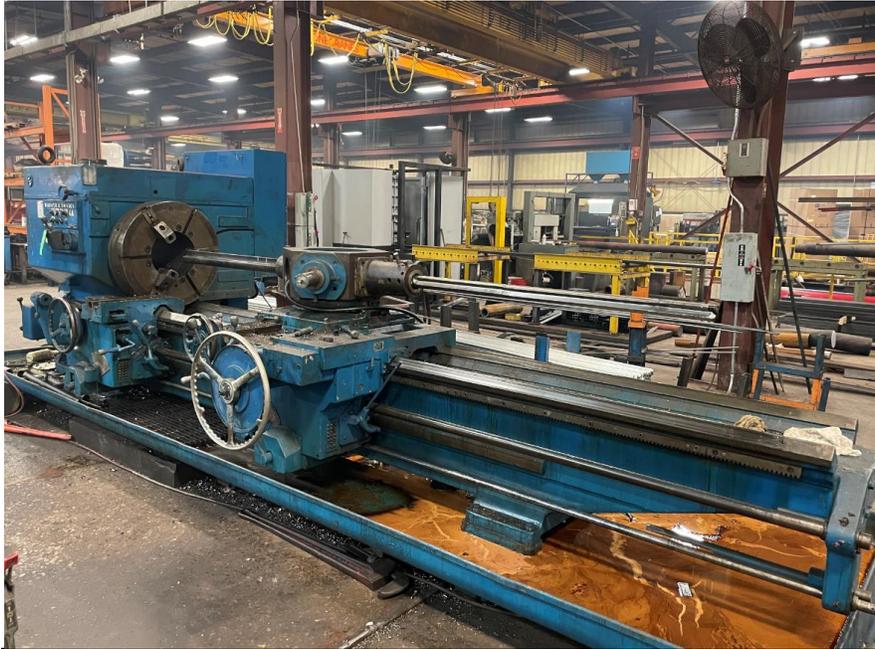
Photo 1. Photo showing involved manual lathe and facility floor/layout in the background. Photo is property of KY FACE.

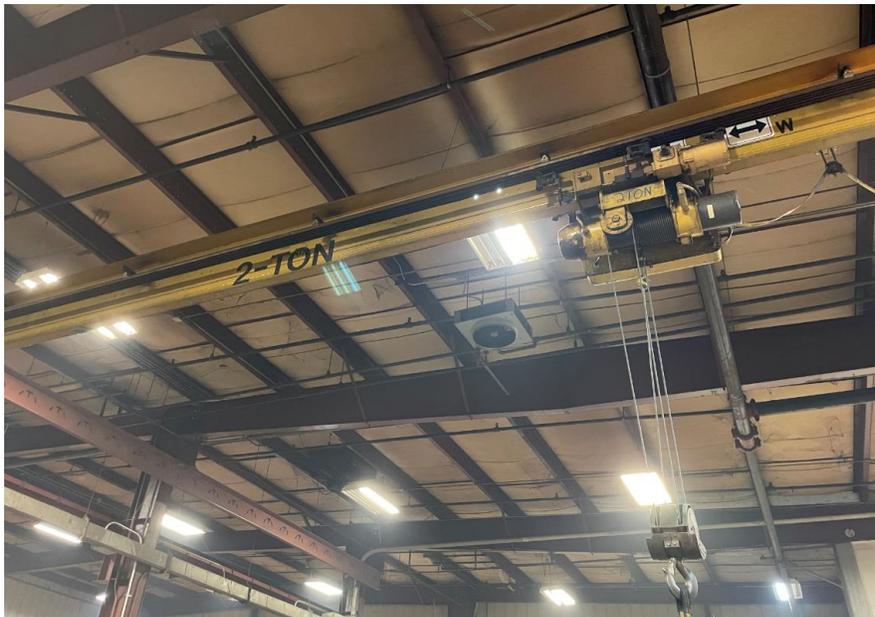
Photo 2. Photo showing overhead crane/hoist system located in the building. Photo is property of KY FACE.

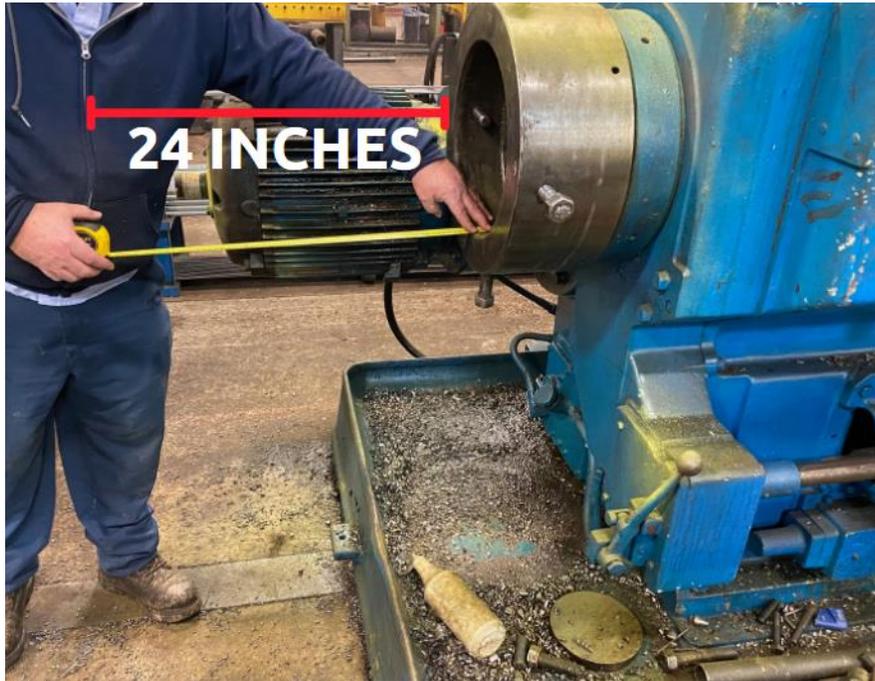
On Wednesday, February 17, 2021, a 52-year-old machinist (victim) was preparing to spot drill the center diameter a 103-inch-long piece of round steel material. Due to the length of the material, 24 inches were sticking out the back of the lathe, unguarded, and held in place with a clamping device that rotates as the lathe rotates. While the lathe was in operation and the steel rod was spinning, the operator attempted to reach to the top of the rear of the machine, allowing his clothing to contact the rotating clamping device of the lathe. The victim was pulled between the lathe motor and the rotating steel that was being machined, which resulted in the injuries that led to his death.

Photo 3. Photo showing the involved manual lathe. The steel rod protruded from the rear of the machine approximately 24 inches. The red line depicts how far the steel was protruding from the end of the lathe. Photo is property of KY FACE.

Recommendation #1: Employers should fabricate or purchase guarding and affix to machines to protect operators.

Although retrofitting aftermarket guarding can be difficult, OSHA stated in a letter of interpretation that the agency encourages the development of safety devices that will eliminate hazard exposure to employees. The company should purchase aftermarket guards for all unprotected machinery or fabricate their own guards for both the front and rear of each machine and have them tested by a nationally recognized testing laboratory.

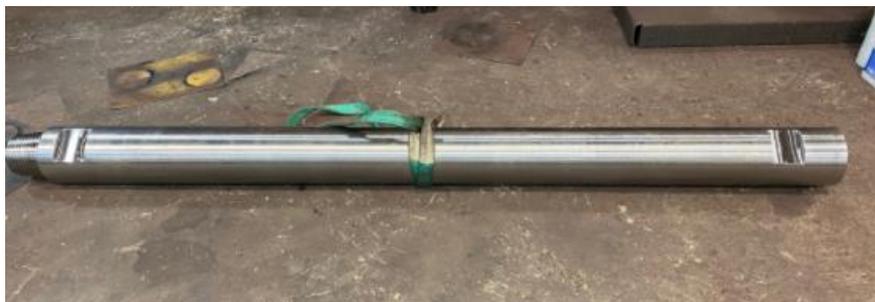
Photo 4. Photo showing similar piece of steel that was being machined when the incident occurred. Photo is property of KY FACE.

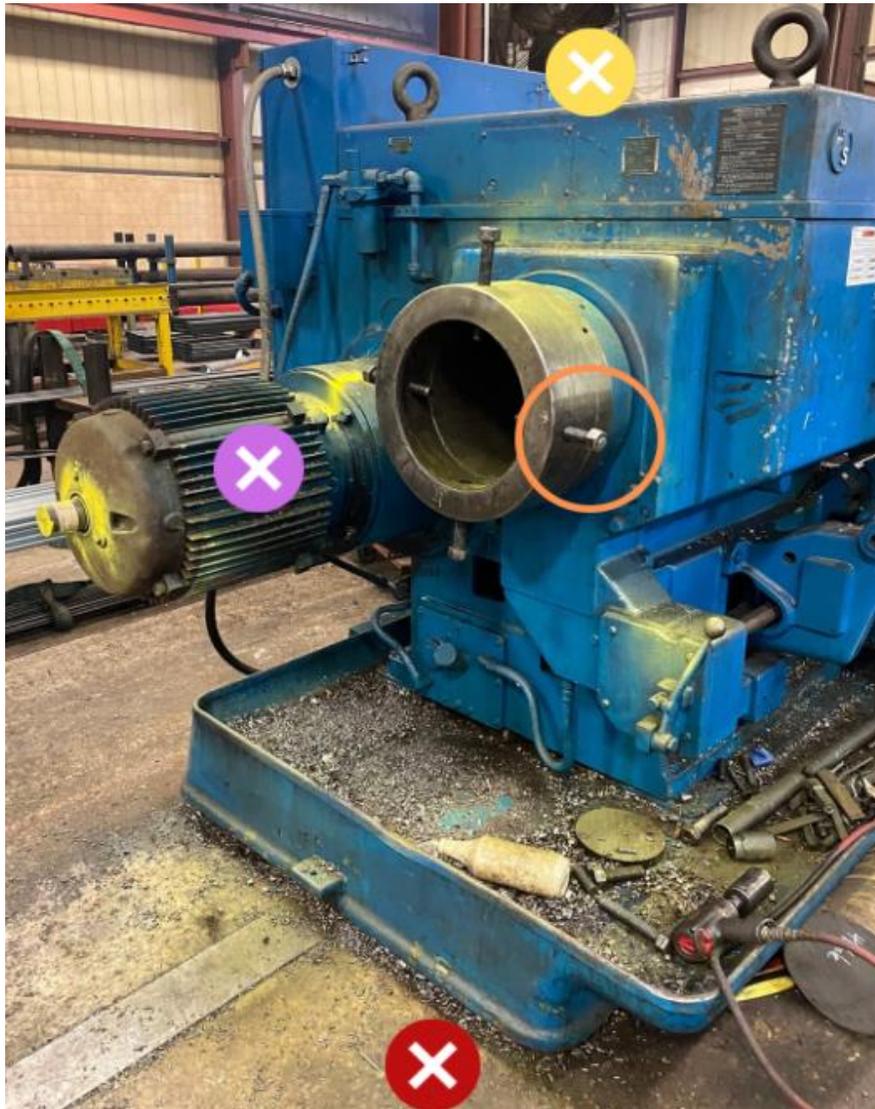
Based on the footage, a company representative speculates the victim was attempting to retrieve a glove that had previously been placed on top of the machine. As the victim extended his arm, his shirt sleeve contacted the clamping mechanism which pulled the victim into the lathe motor and rotating piece of steel. As the lathe continued to turn, the victim's body followed suit and rotated around the piece of steel forcing him to strike the motor of the lathe multiple times (Photo 5). An employee who was in the changing room heard the event unfold and ran out to investigate. After discovering the situation, the employee shut the machine down and called emergency services. Two employees worked to free the victim's tangled clothing from the lathe. Emergency medical services arrived at 7:01 am, 11 minutes after the incident occurred. The victim was reportedly partially conscious as he left the facility via ambulance. The victim was pronounced dead on arrival at a local emergency department. The site contact stated the video showed the victim rotating around the steel approximately twelve times.

Photo 5. The **red X** indicates the position of the victim when he attempted to reach on top of the machine. The **yellow X** indicates the location believed to be where the glove was located. The **purple X** represents the lathe motor which the victim struck multiple times after becoming entangled. The **orange circle** is highlighting the chuck which caught the victim's clothing. Photo is property of KY FACE.

Discussion: According to a company representative, the victim was wearing a long sleeve, loose fit shirt while operating the lathe. The shirt's sleeve became entangled in the clamping mechanism at the rear of the lathe when the victim was reaching on top of the machine. Wearing loose fit clothing can present a grave risk when operating machines with moving parts, such as a lathe. These risks may increase based on the season, weather, and temperature, as employees are more likely to utilize long sleeve jackets and shirts to stay warm. Other items such as long hair, beards, necklaces,

To reduce the likelihood of future occurrences, employers should mark applicable areas according to the OSHA standard and train employees appropriately on their application.

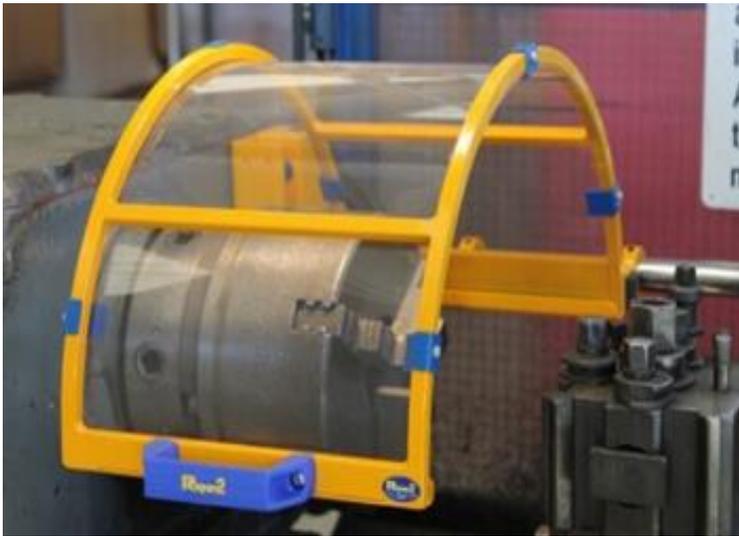
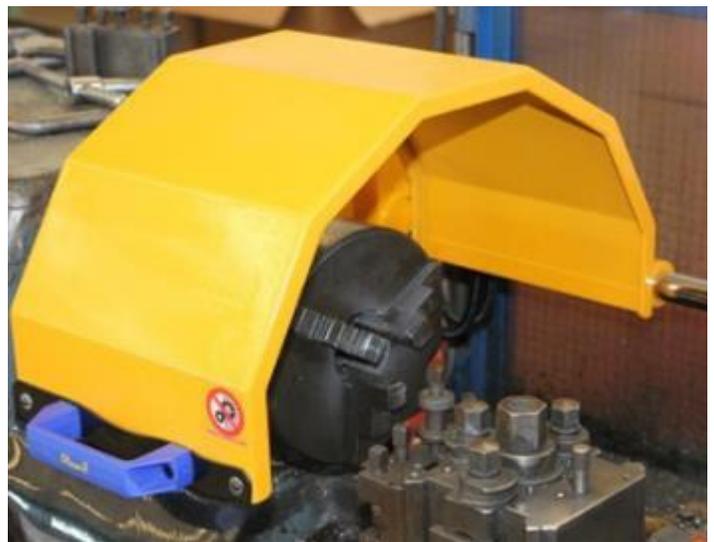
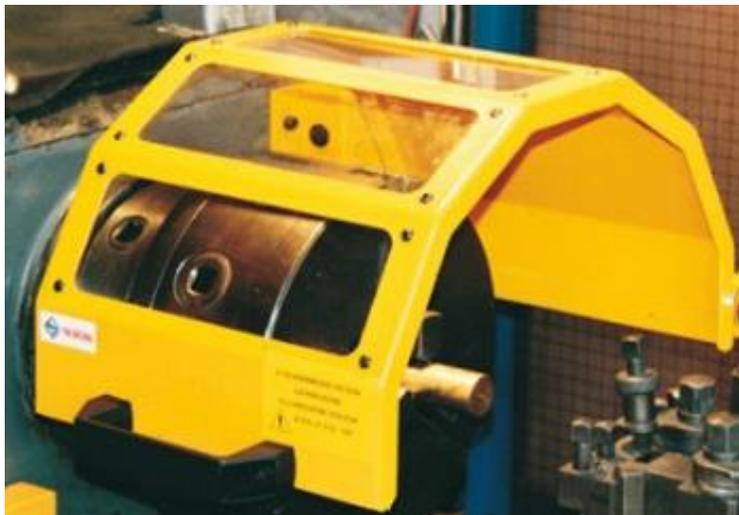
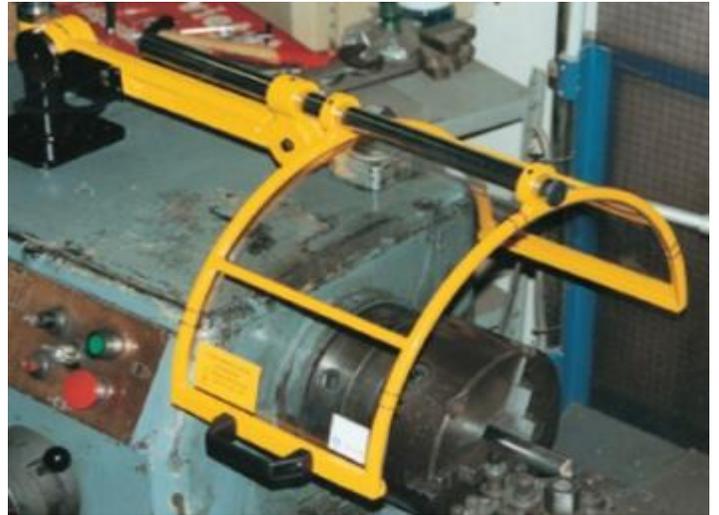
Photo 6, 7, 8 & 9. Examples of aftermarket guarding systems on similar machines.⁴ Photos obtained from <https://www.eputec.de/en/safety-guards/safety-guards-for-lathes/>
