IDOT's Pavement Evaluation Process

Representing
IDOT's Pavement
Technical Working
Group

Upcoming Pavement Management and Evaluation Manual

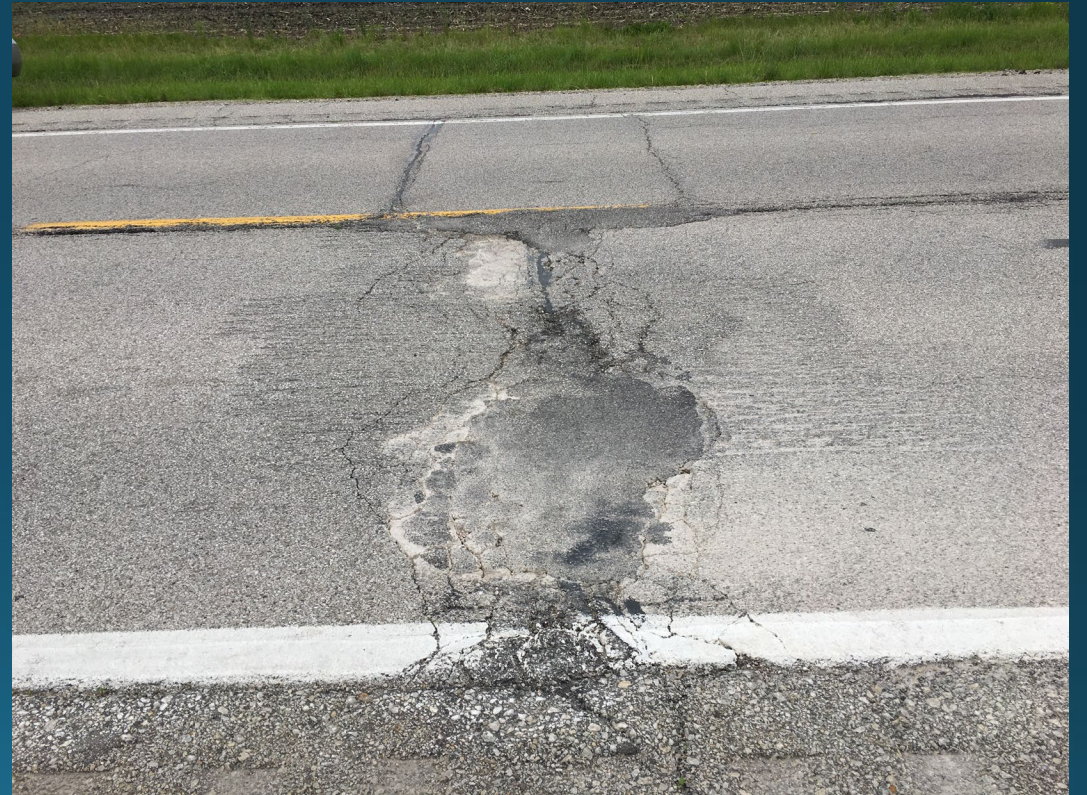
Does the High Severity
Structural Distress Really
Indicate Probable
Pavement Structure
Failure?

This one does!

- Staining from pumping fines is present in a wheel path
- Heaving at transverse cracks exposing broken underlying concrete.
- Cracking area in a wheel path is over about 1 ft wide and has a depression over about 0.5 inches

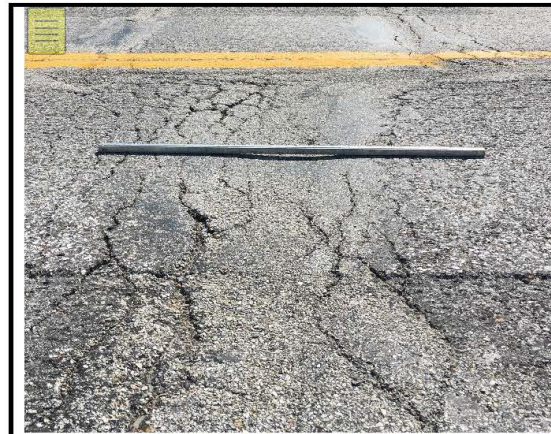
Transverse crack indicating a high probability of structural failure due to a width wider than 1 ft and a depression depth of 0.5"± in the left wheel path. Notice the existing overlaid patch in the adjacent lane at the top of the photo.

FIGURE 4-3.B Examples of HMA Surfaced Cracking Distresses Both Indicative and Not Indicative of Potential Structural Failure

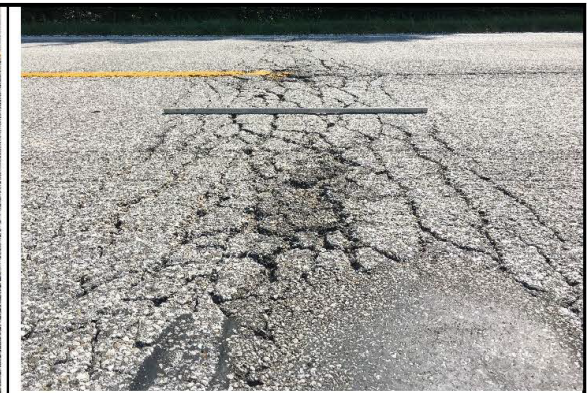
Transverse cracking indicating a low probability of structural failure because there is no staining or heaving, and there is no depression in the wheel path. Maintenance activities in the lower right side likely correct a loss of surface material.

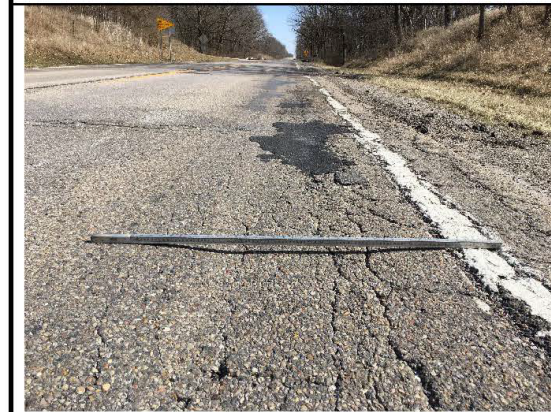
Alligator crack indicating a high probability of structural failure due to a width wider than 1 ft and a depression depth of greater than 0.5 inches in the right wheel path. The cracking offset corresponds to widening and indicates a high probability of widening failure.

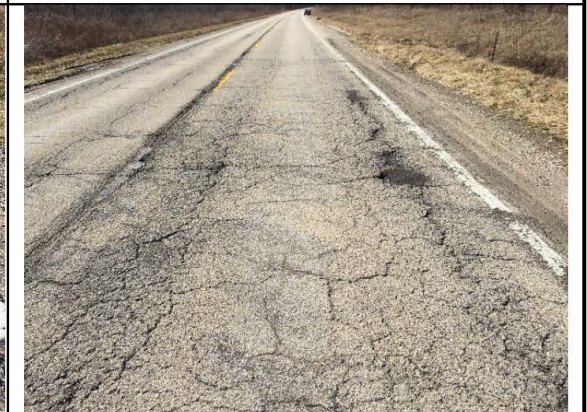
Alligator cracking indicating a low probability of structural failure because there is no staining and there is no depression in the wheel path. Maintenance activities likely correct a loss of surface material. The cracking is likely related to HMA surface lift deterioration.

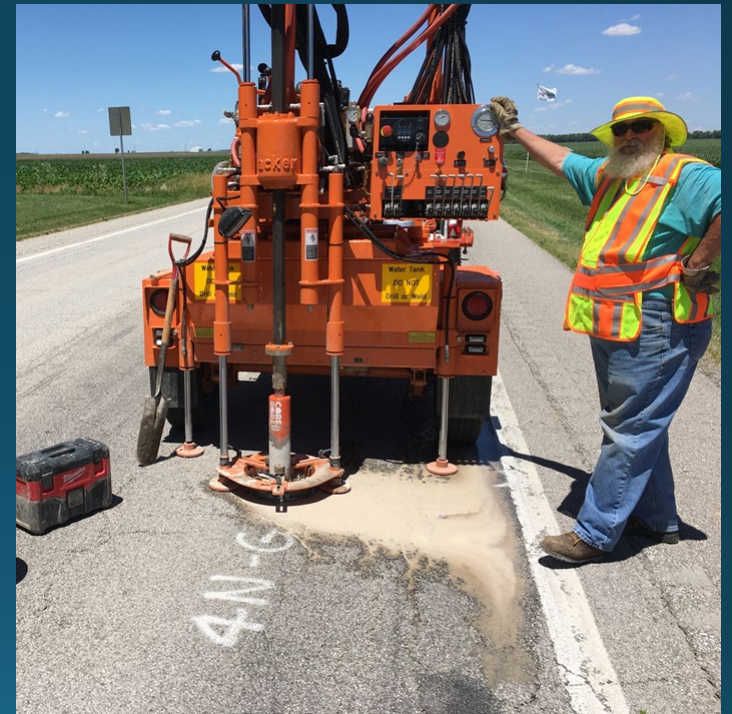
The Field Visual Assessment indicates a probably pavement structure failure area exceeding 1.0% and the ADT > 2,000.

Sampling HMA for lab testing is required when it will remain in place according to the earlier criteria.

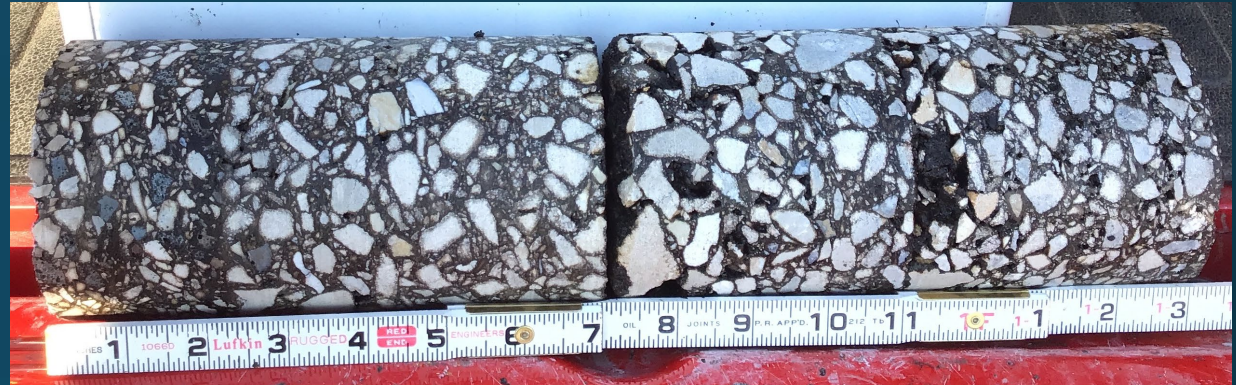
100% Intact – No Deterioration
