# Paver Segregation

**TIM ASCHENBRENER, P.E.**  
SENIOR ASPHALT PAVEMENT ENGINEER  
PAVEMENT MATERIALS TEAM  
OFFICE OF PRECONSTRUCTION, CONSTRUCTION AND PAVEMENTS  
FHWA

ILLINOIS ASPHALT CONFERENCE  
CHAMPAIGN, ILLINOIS  
DECEMBER 12, 2018

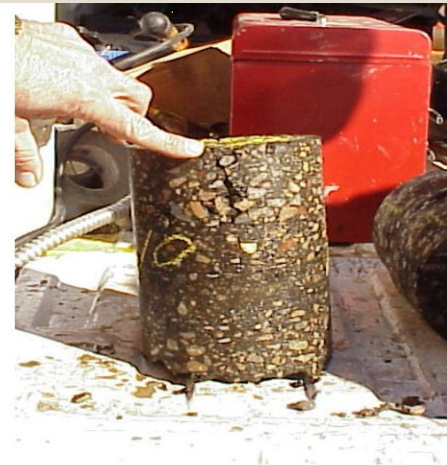
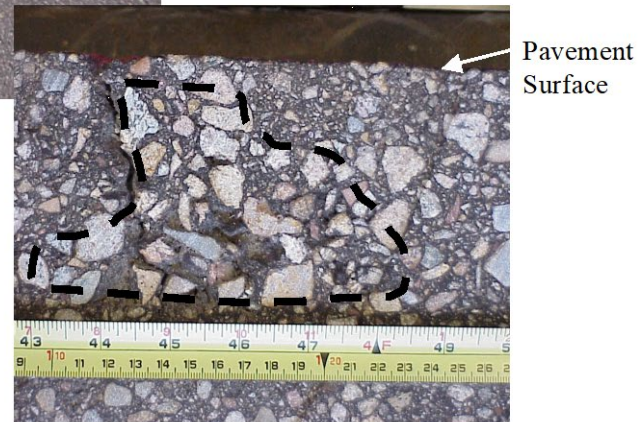
# I-25 Distress

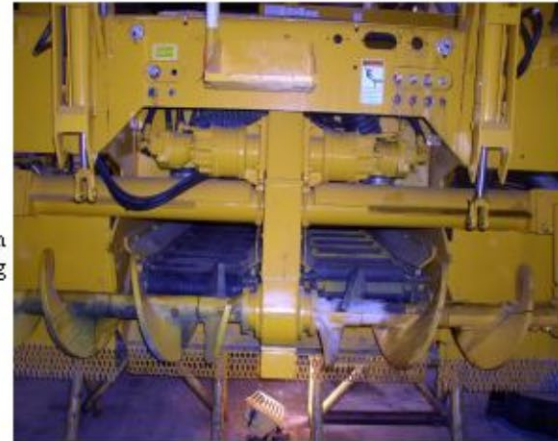
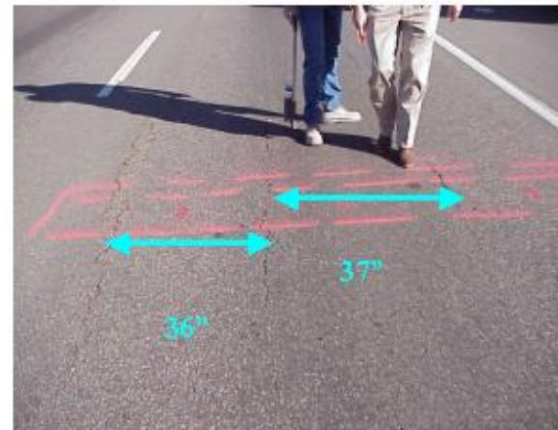
# Asphalt Paver

- Predominantly top-down
- Segregation related
- Induced by paver

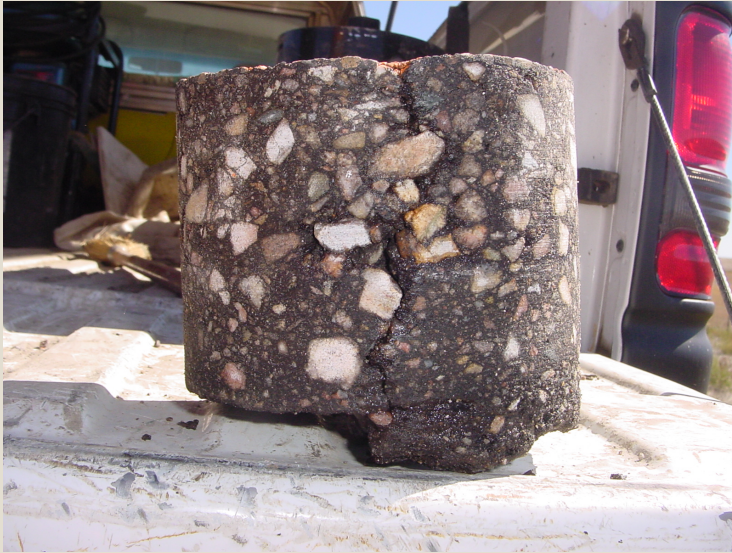
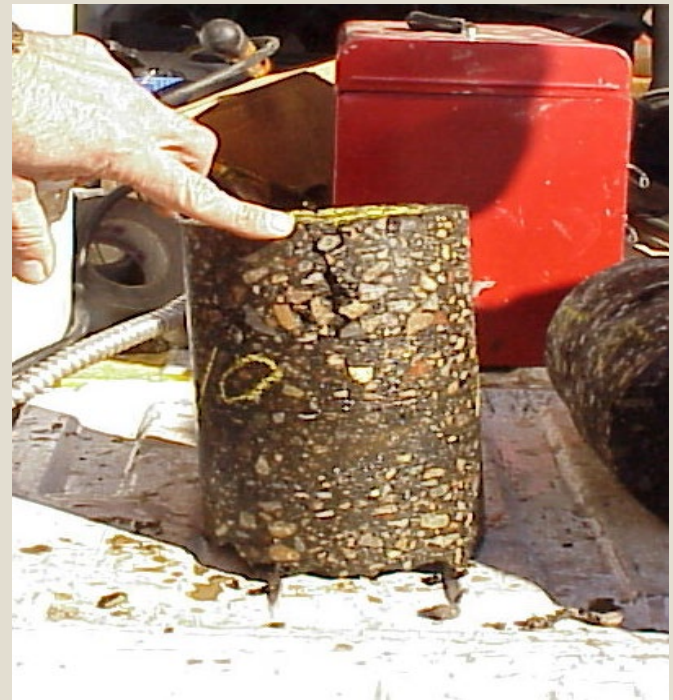
Reflective Crack or

Top-Down Crack?

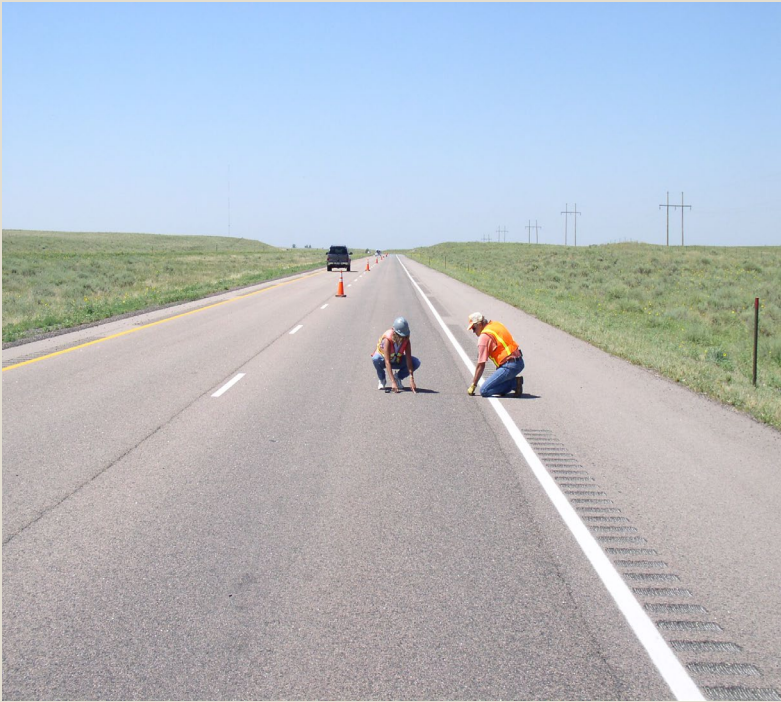
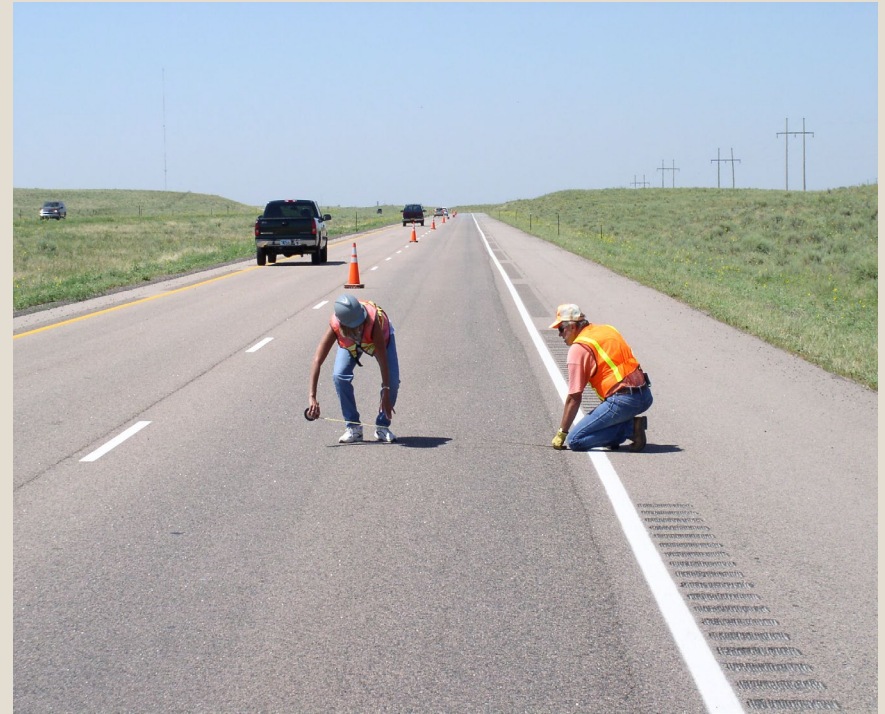
# For Sites with Paver Segregation

- Measuring distance from the joint to the crack

Site No.	Paver Manufacturer/ Model	First Crack*	Second Crack*	Third Crack*
3	1 / A	38"	73"	No Crack
6	1 / B	18"	No Crack	102"
13	2 / E	37"	No Crack	97"
17	1 / C	46"	No Crack	109"
19	1 / D	69"	No Crack	128"
20	3 / ?	58"	87"	No Crack
23	2 / ?	41"	70"	99"

\*Distance from longitudinal construction joint

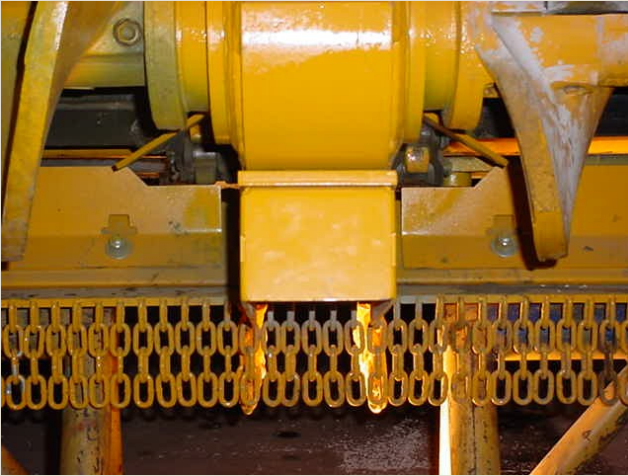
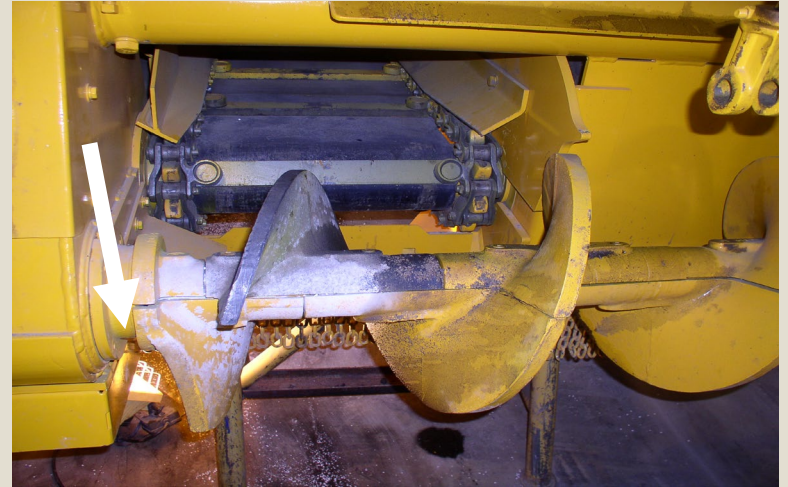
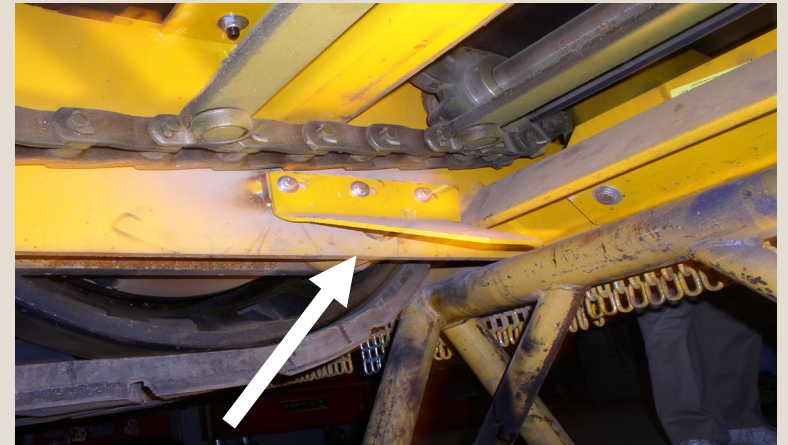
# Paver Modifications – Man. 1

- Asphalt Mixture Design
- Asphalt Paver Operation
- Asphalt Paver
  - Chain curtain
  - Deflector plates
  - Scraper plates
  - Reverse auger
  - Smaller diameter auger (first flight)

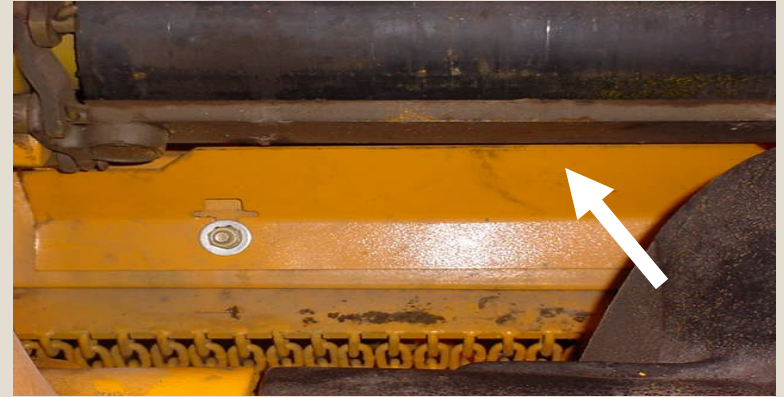
# Paver Modifications – Man. 1

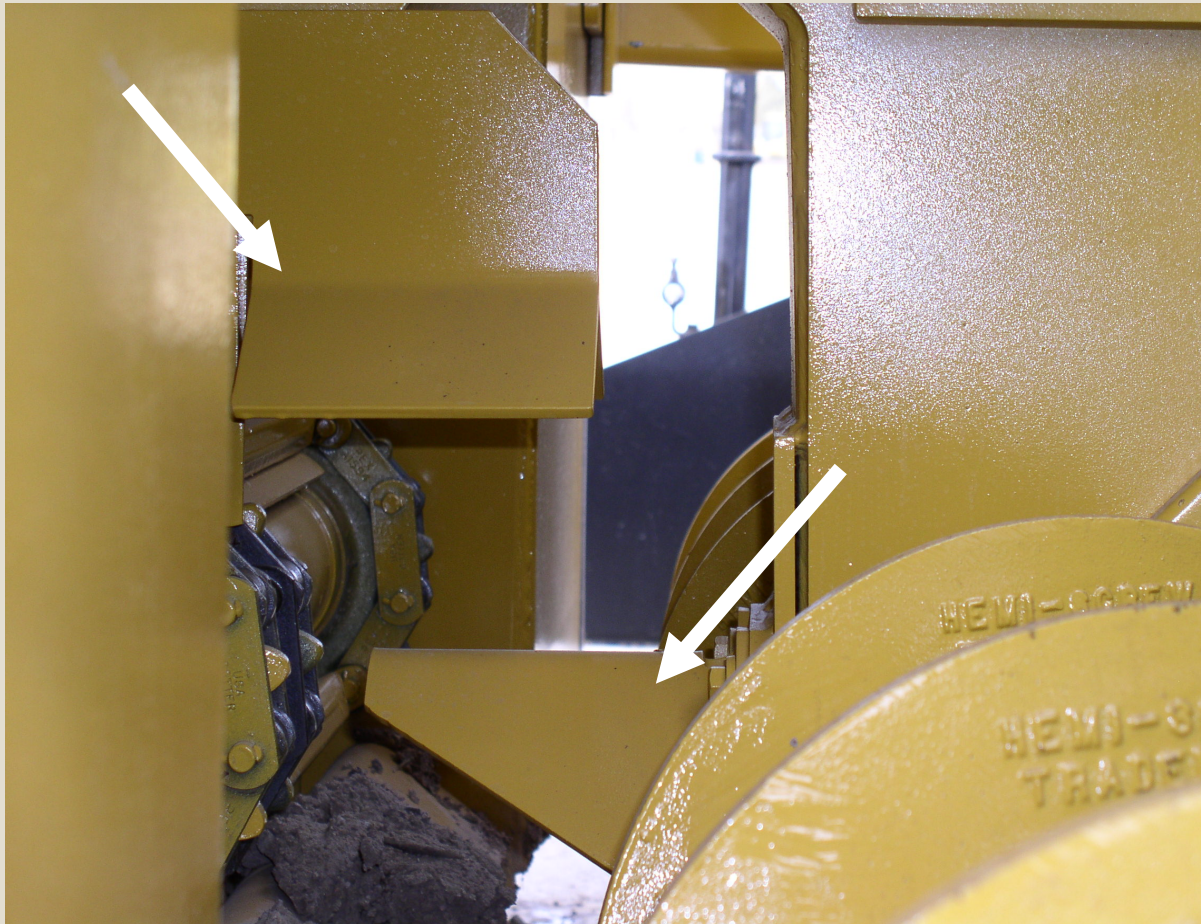
# Paver Modifications – Man. 2
