SHOULDER PAVEMENT PRESERVATION Spray-on Asphalt Rejuvenation

Illinois Tollway Deputy Chief of Program Implementation Cindy Williams Illinois Tollway Materials Engineering Consultant, S.T.A.T.E. Testing, Max Barry December 11, 2024

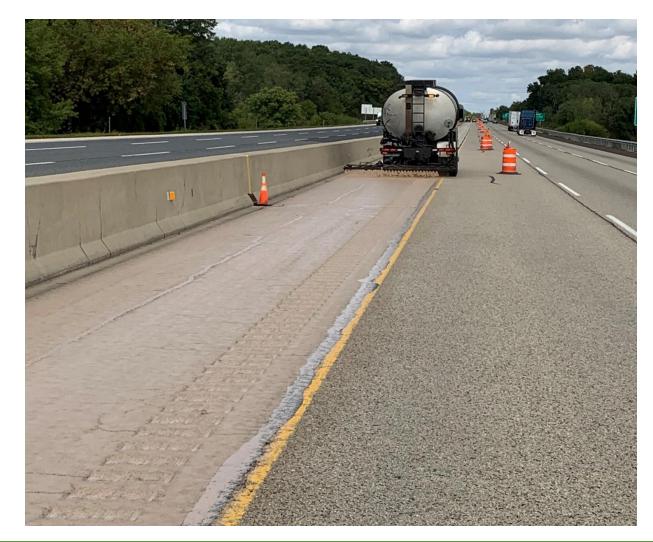
Evaluated several rejuvenators

Placed on shoulders in 2020 on 1-mile section of I-90 near Rockford

- Emulsified maltene-based sealer (petroleum oils and resins emulsified with water)
- Emulsified crack filler sealer (petroleum oils and asphalts emulsified with water
- Bio-based sealer and polymer binder (agriculture-based soy oil derivatives and other agricultural oils

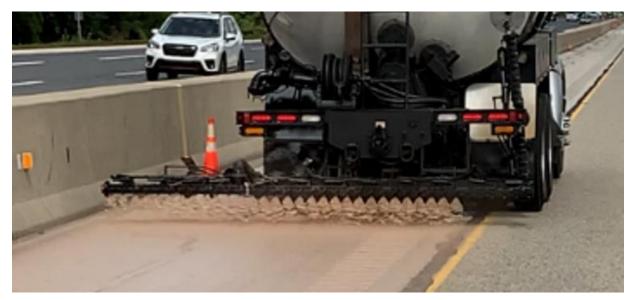
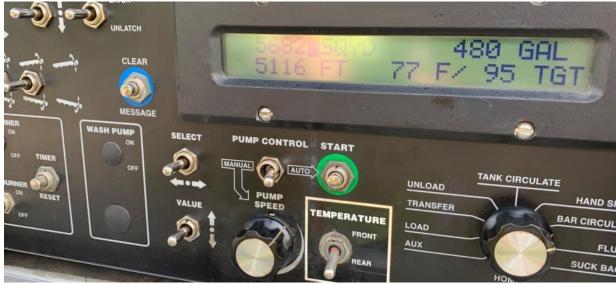
FIELD PLACEMENT EVALUATION

Placed fall 2020, 60s degrees F.

- 1-mile sections on shoulder N70 SC
- Shoulders swept
- Uniform spray nozzles
- Yield verified; application rates tested
- Maltene and bio-based sealer rapid placement
- **Crack filler sealer slower**

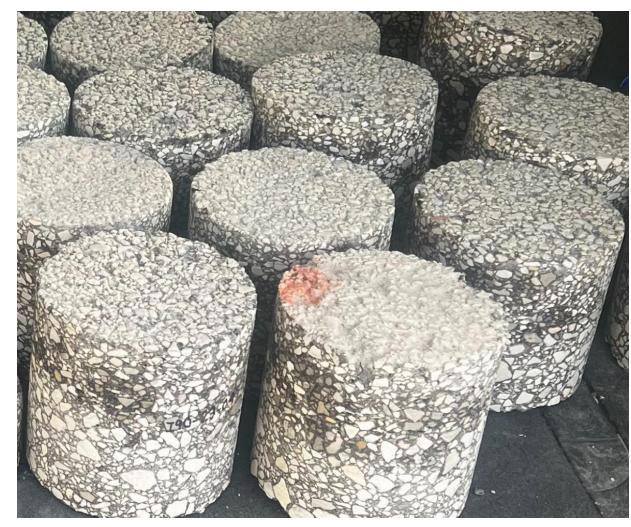
CORING AND TESTING

Coring for PG testing

- Most manufacturers claim 3/8-inch penetration
- Top 3/8 inch evaluated
- Eight cores per test
- Testing once per year per product, average of two tests
- Illinois Tollway Test Procedure 001 Recovered Asphalt Binders

Cored and evaluated yearly

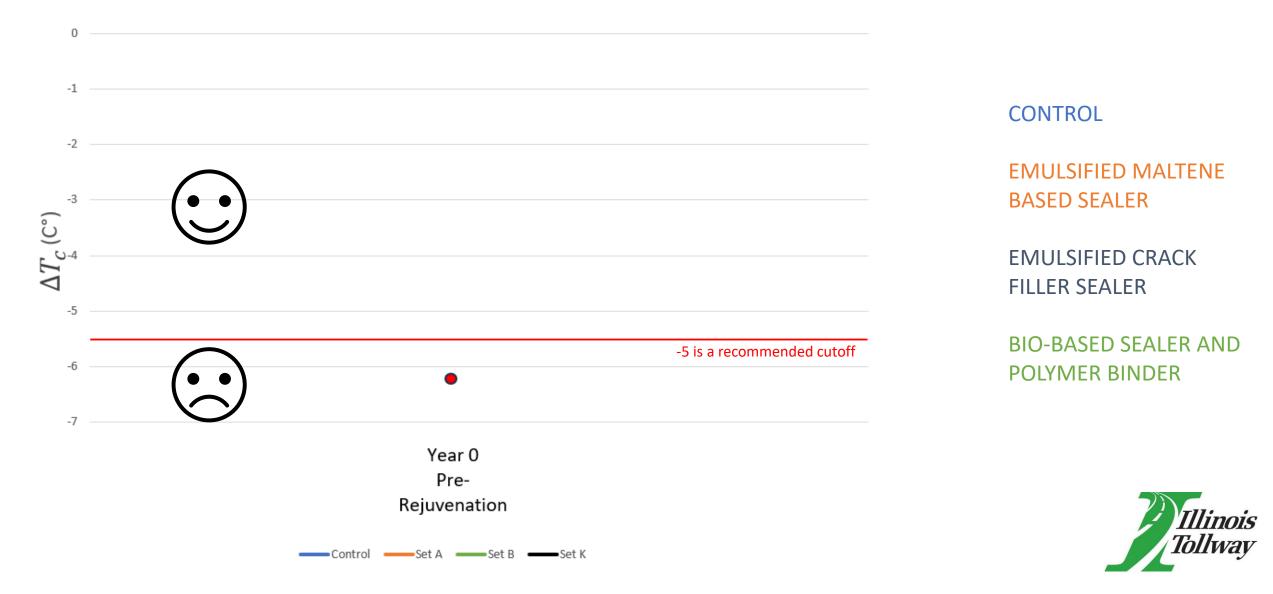
CONTROL

BASED SEALER

FILLER SEALER

EMULSIFIED MALTENE

EMULSIFIED CRACK

POLYMER BINDER

BIO-BASED SEALER AND
