PCC Pavement Rehabilitation with Hot Mix Asphalt

54th Annual Illinois Bituminous Paving Conference
December 11, 2013

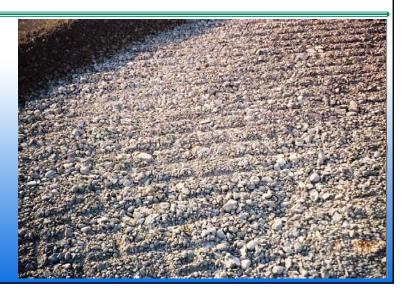
Rubblization

- Correct Drainage
- Test Strip/Pits
- Rubblize
- Roll
 - Final sizing
 - Lock in pieces
- Overlay with HMA

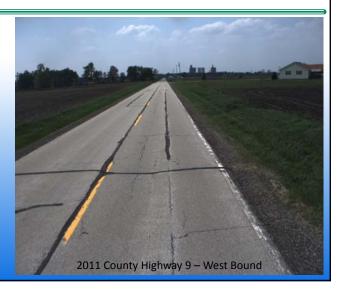
County Road 9 (East of Ludlow)

- Milled Both Sides
- Rubblized Concrete
- 4" HMA Overlay
- Poor Performance
 - Heavy Rain after Rubblization
 - No Drainage

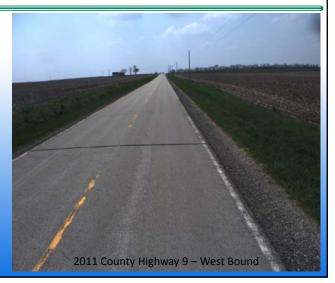
County Road 9 (West of Ludlow)

- Edge Drains Installed Prior to Rubblization
 - Concrete Side Only
- Milled PCC side
- Modified Rubblized PCC (Less Effort)
- 3" HMA Binder Lift Over Rubblized Base
- Milled 1" of Flexible Lane
- 2" HMA N50 Surface over Both Lanes
- Good Performance (Issues on Flexible Base Side)

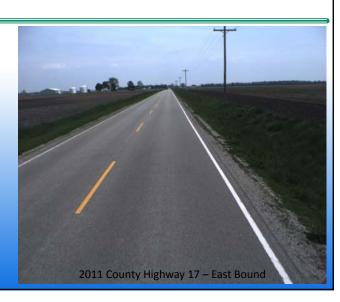
County Road 17

- Edge Drains Installed Prior to Rubblization
- Milled HMA on One side
- Rubblized PCC on One Side
 - Spec Modification 75% less than 12" in dimension – no fragment exceeding 16")
- 3" HMA Binder Lift Over Rubblized Base
- Milled 1" of Flexible Lane
- 2" HMA N50 Surface (Full Width)
- Excellent Performance
