# Tack Coat Effect on Field Performance

February 3rd, 2015  
NCAUPG/ICT Joint Meeting

# Bonded Pavement Experimentation

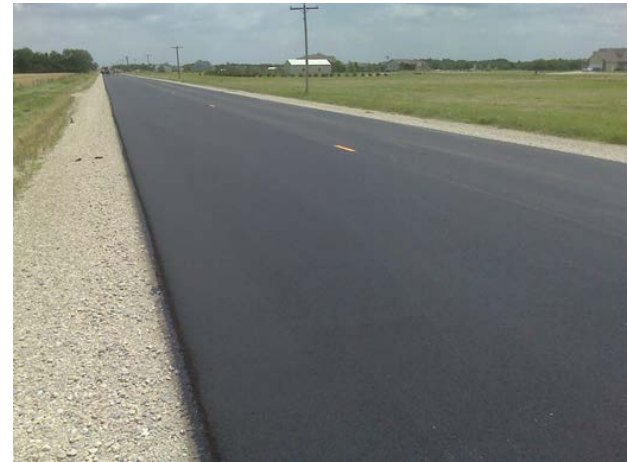
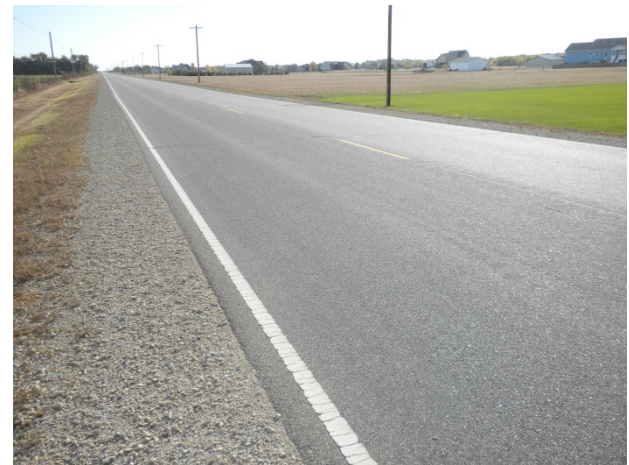
- What happens if significantly higher application rates are used?
- What forms of distress will appear or possibly be delayed?
- What effect does significantly different types of tack have on performance?
- Surface type effect on application rates (PCC, AC, milled)?

2008

2012

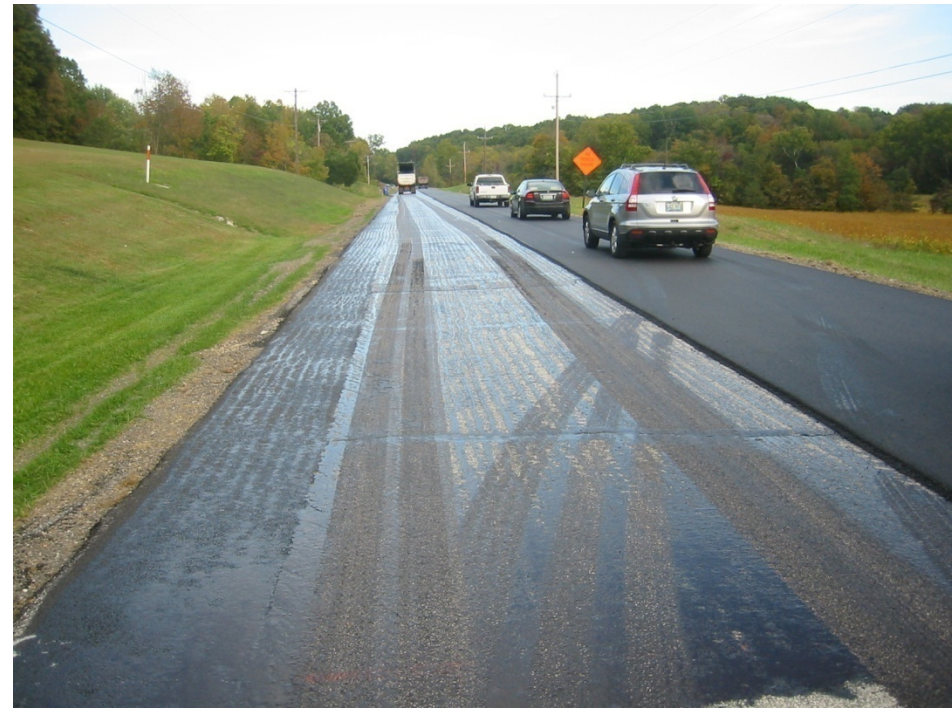
# What options are available to place tack uniformly without disturbing during construction?

- Modify the process to keep all construction equipment and trucks off the tack during construction
- Spray paver

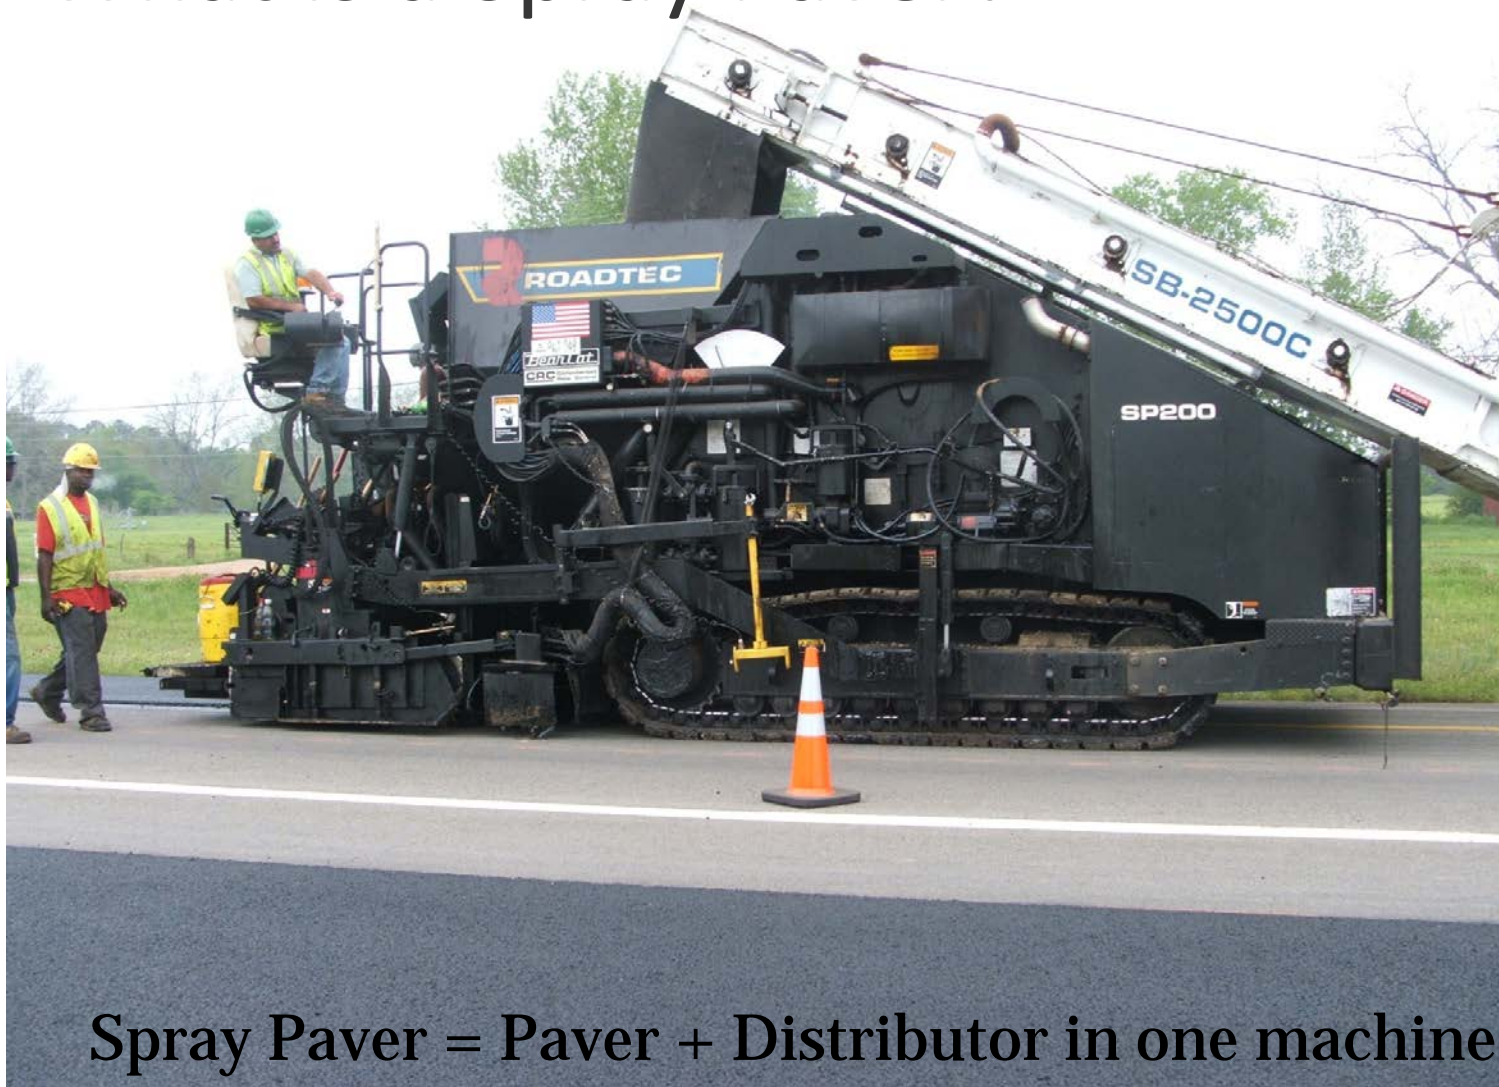
Spray Paver = Paver + Distributor in one machine

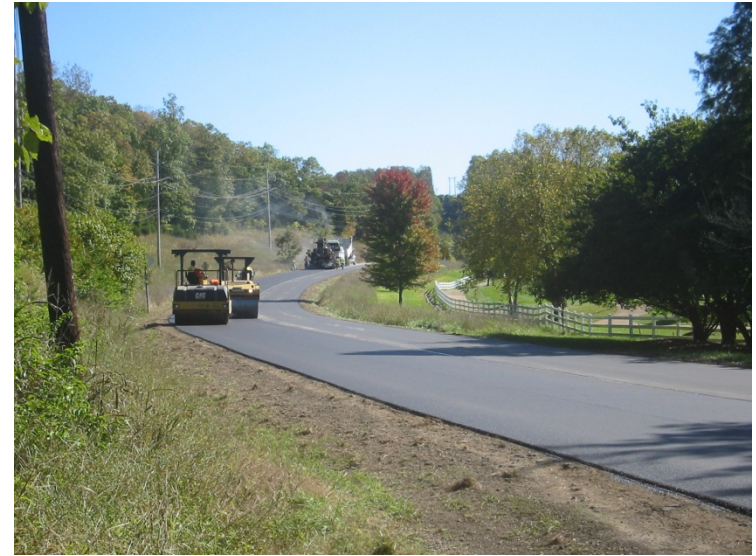
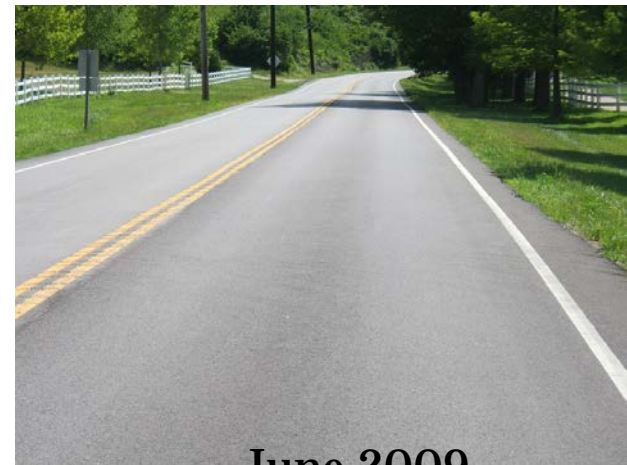
June 2009

# Route T, Franklin County, MO

- Constructed: October 2008
- Contractor: N.B. West
- Project length: 3.5 miles (test sections)
- Surface: Composite, HMA over PCC
- Mix: 1 ¾" Bonded BP-1 HMA w/ PG64-22
- Tack:
  - Test sections at 0.1, 0.15, and 0.2 gal/yd<sup>2</sup> PMAE at 65% AC
  - Test sections at 0.1 gal/yd<sup>2</sup> thru distributor and 0.1 and 0.15 gal/yd<sup>2</sup> CSS-1h thru SP-200
- Equipment: RoadTec SP-200 spray paver

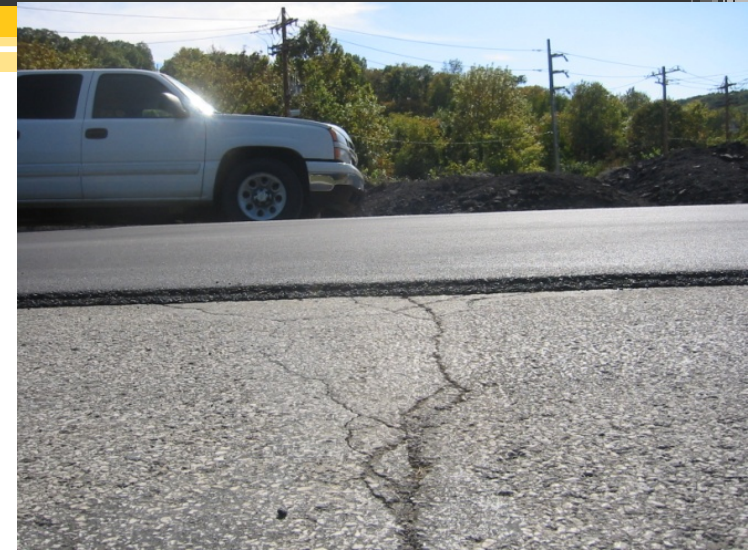
# MoDOT Route T Project – Oct 2008

## 1 3/4" BP-1 overlay over composite pavement

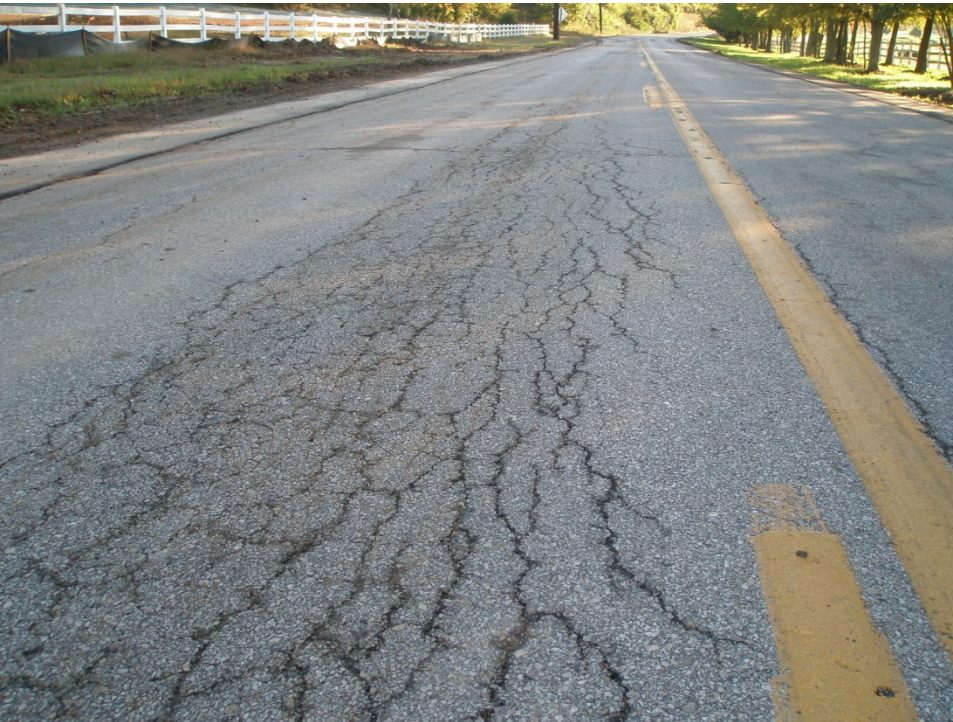
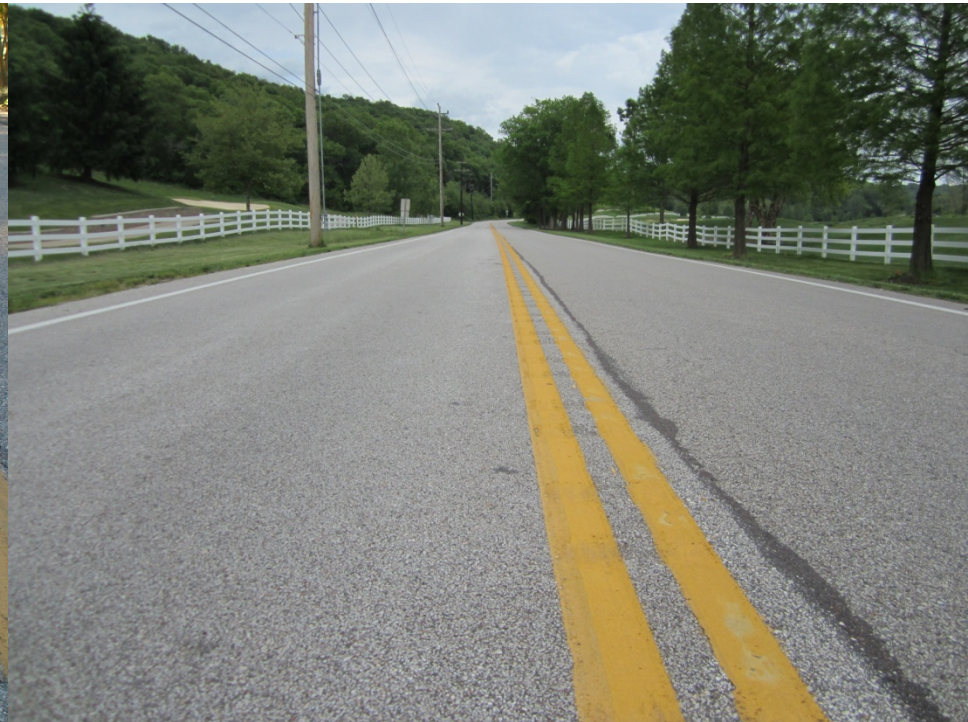
# Route T Franklin Co Test Sections 11/12

## Pre-paving and 4 years later

0.21 gal/yd<sup>2</sup> (0.14 res) PMAE Tack

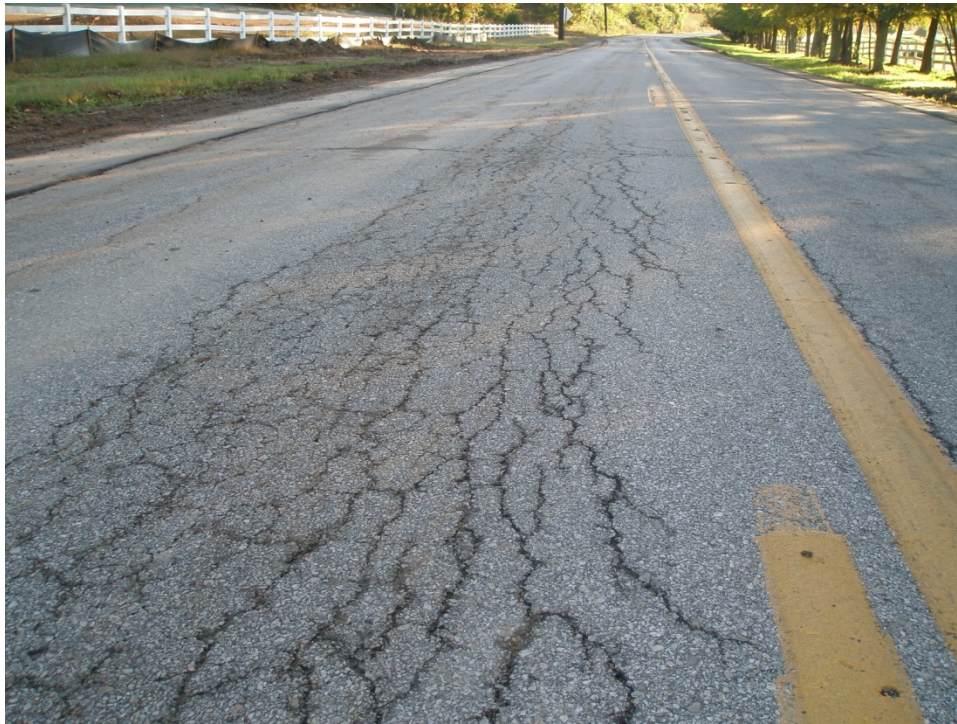
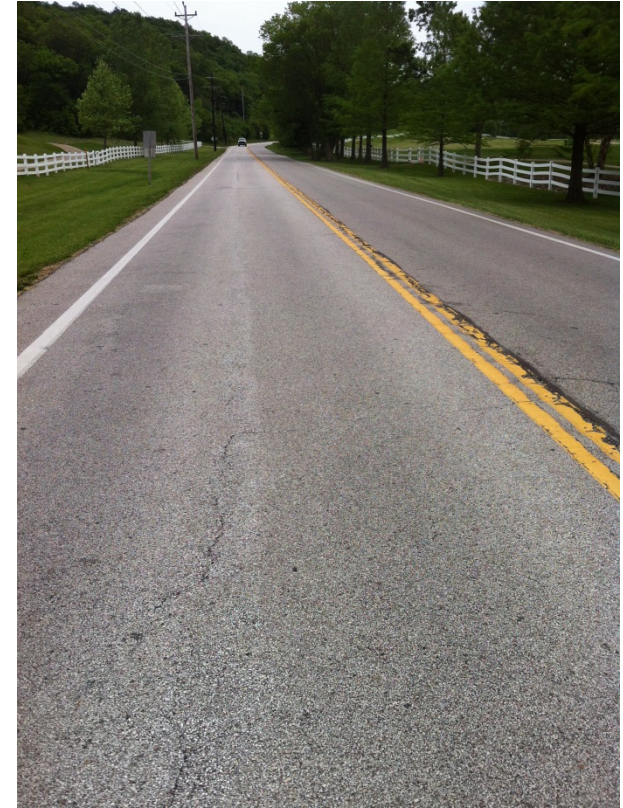
# Route T Franklin Co Test Sections 11/12 Pre-paving and 6 years later

0.21 gal/yd<sup>2</sup> (0.14 res) PMAE Tack

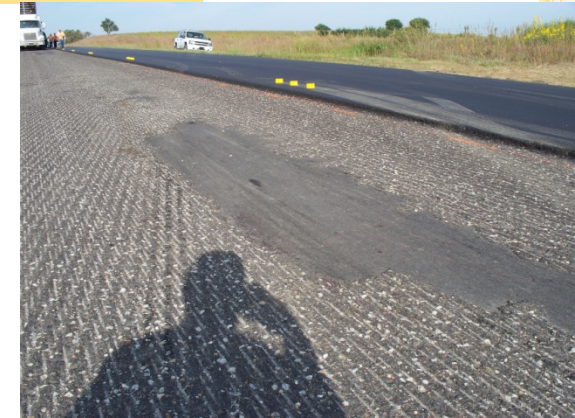
# KDOT US 36 Washington Co. Project – Sept 2009

## 1 1/2" SR-12.5A over a Milled Surface

<b>Test Section 11</b> 40% RAP 0.35 gal/yd <sup>2</sup> EBL	<b>Test Section 10</b> 40% RAP 0.25 gal/yd <sup>2</sup> EBL	<b>Test Section 9</b> 25% RAP 0.12 gal/yd <sup>2</sup> EBL	<b>Test Section 7</b> 25% RAP 0.20 gal/yd <sup>2</sup> EBL	<b>Test Section 5</b> 25% RAP 0.16 gal/yd <sup>2</sup> EBL	<b>Test Section 3</b> 25% RAP 0.08 gal/yd <sup>2</sup> EBL	<b>Test Section 1</b> 25% RAP No Tack
		<b>Test Section 8</b> 25% RAP 0.12 gal/yd <sup>2</sup> CSS-1h	<b>Test Section 6</b> 25% RAP 0.20 gal/yd <sup>2</sup> CSS-1h	<b>Test Section 4</b> 25% RAP 0.16 gal/yd <sup>2</sup> CSS-1h	<b>Test Section 2</b> 25% RAP 0.08 gal/yd <sup>2</sup> CSS-1h

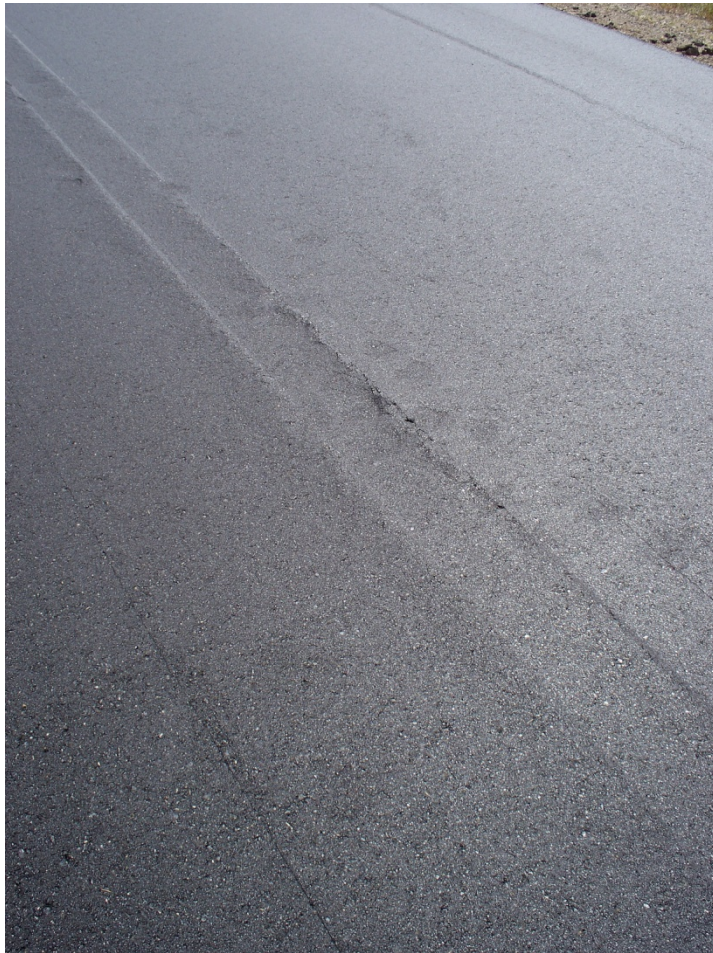
# No Tack over a Milled Asphalt Surface US 36 Washington Co. KS 2009

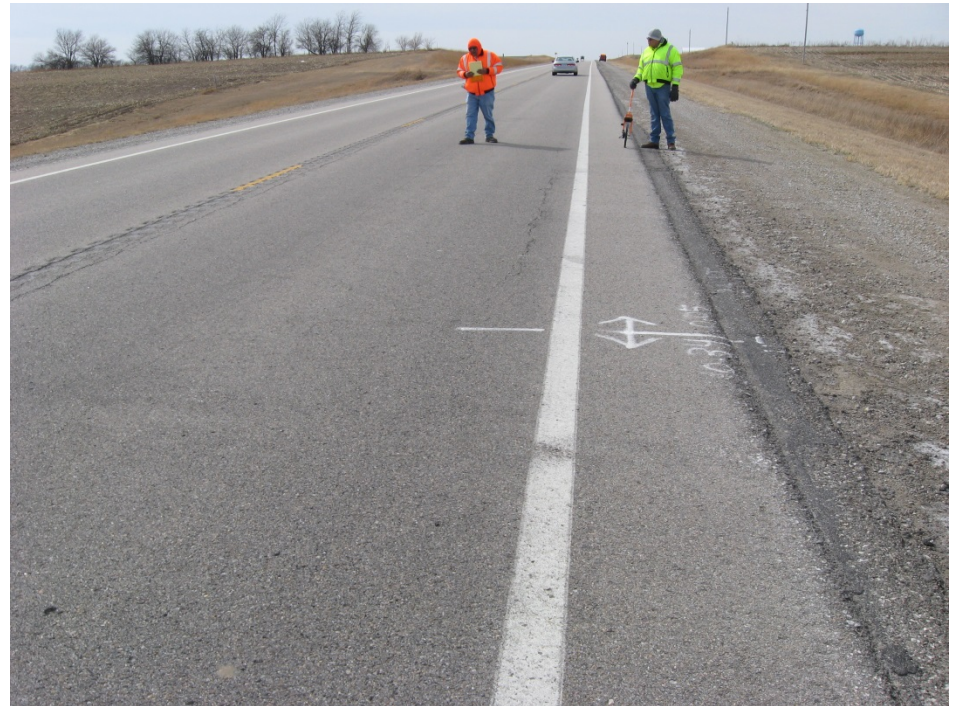
# KDOT US 36 Nemaha County 2010

- 4" CIR with emulsion
- 1 ½" SR12.5A
- PG70-22 binder
- 4 Test sections
  - 3 spray paver shot rates
    - 0.11 gal/yd<sup>2</sup> EBL
    - 0.22 gal/yd<sup>2</sup> EBL
    - 0.34 gal/yd<sup>2</sup> EBL
  - 1 distributor applied control section
    - 0.05 gal/yd<sup>2</sup> CSS-1h

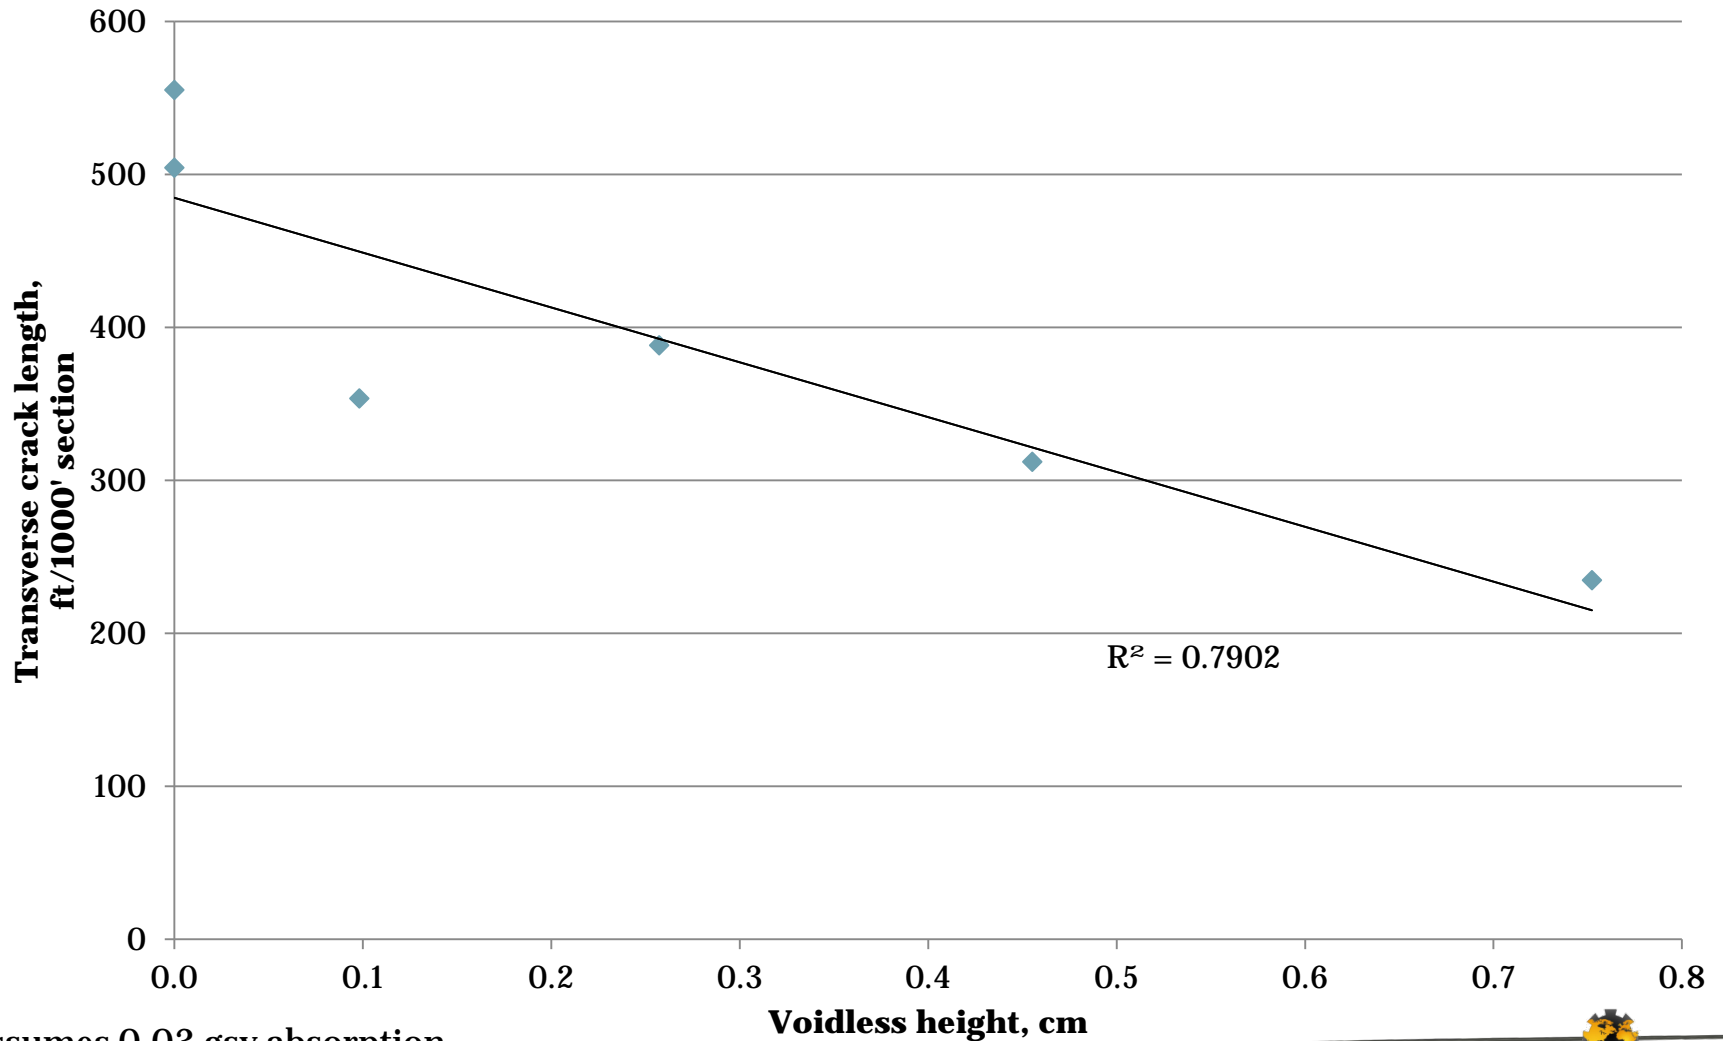
## MoDOT Route T @ 41 months Transverse Cracks vs Voidless Height

\*Assumes 0.03 gsy absorption

- Based on field project data,
  - Correlation of bond energy to longitudinal cracking resistance exists
  - Correlation of voidless height to transverse cracking exists
  - General trends favor higher application rates (than standard tack rates) and polymer modified tack
    - Improved mix performance; more resistance to transverse and longitudinal cracking
  - Field data from more projects are being gathered
