Geotechnical Problems Caused by the 2023 Kahramanmaras - Turkiye Earthquakes

Professor Tugce Baser, Dr. Ozgun Alp Numanoglu, and Professor Okan Ilhan

March 31st, 2023

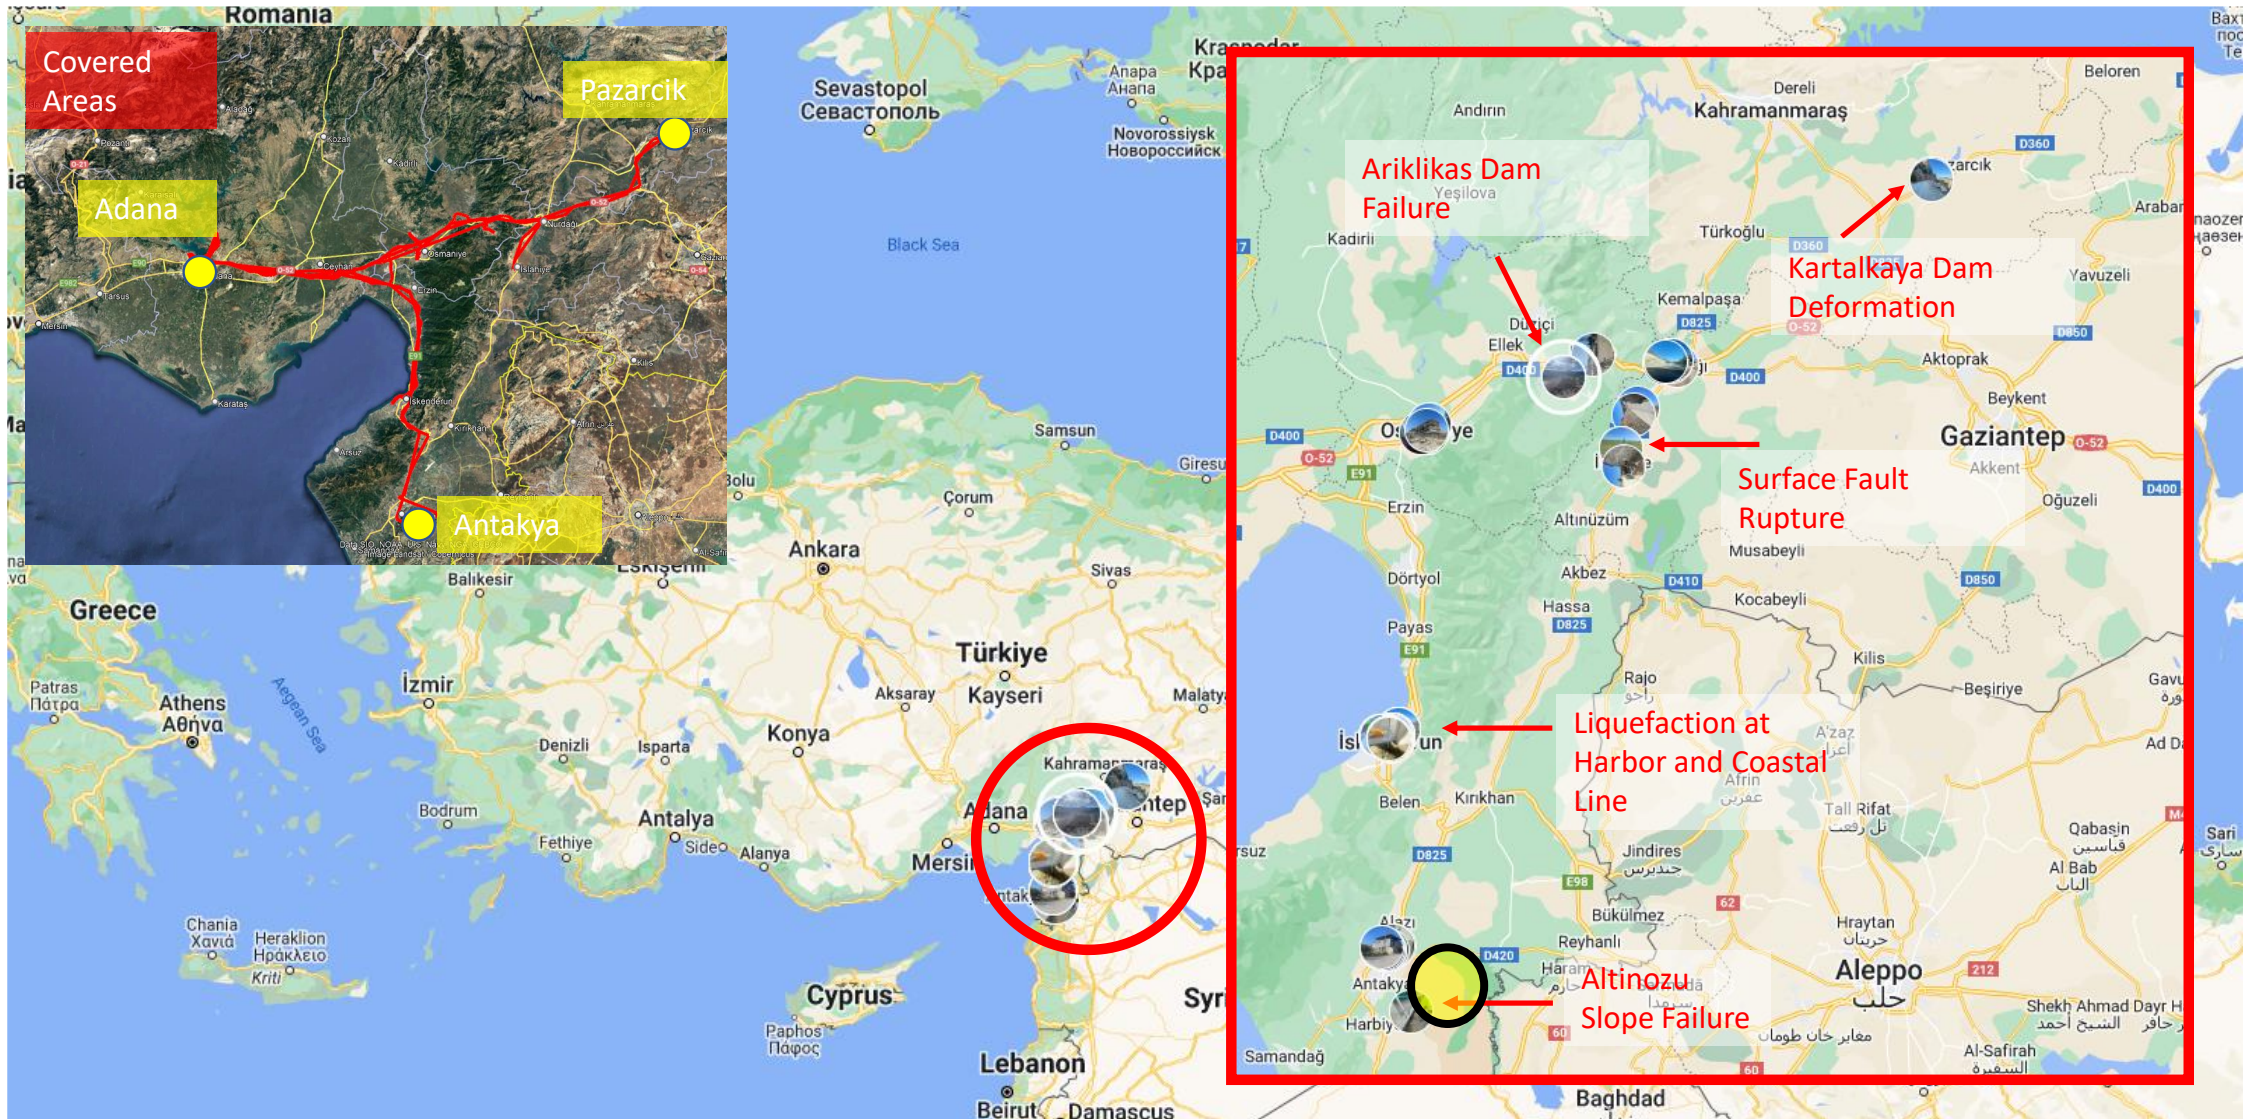
Yarseli Dam - Hatay

Relatively minor cracks at the crest

No sign of liquefaction or settlement

Although Hatay – Antakya experienced devastating impacts from the earthquake, the dam performed relatively well.

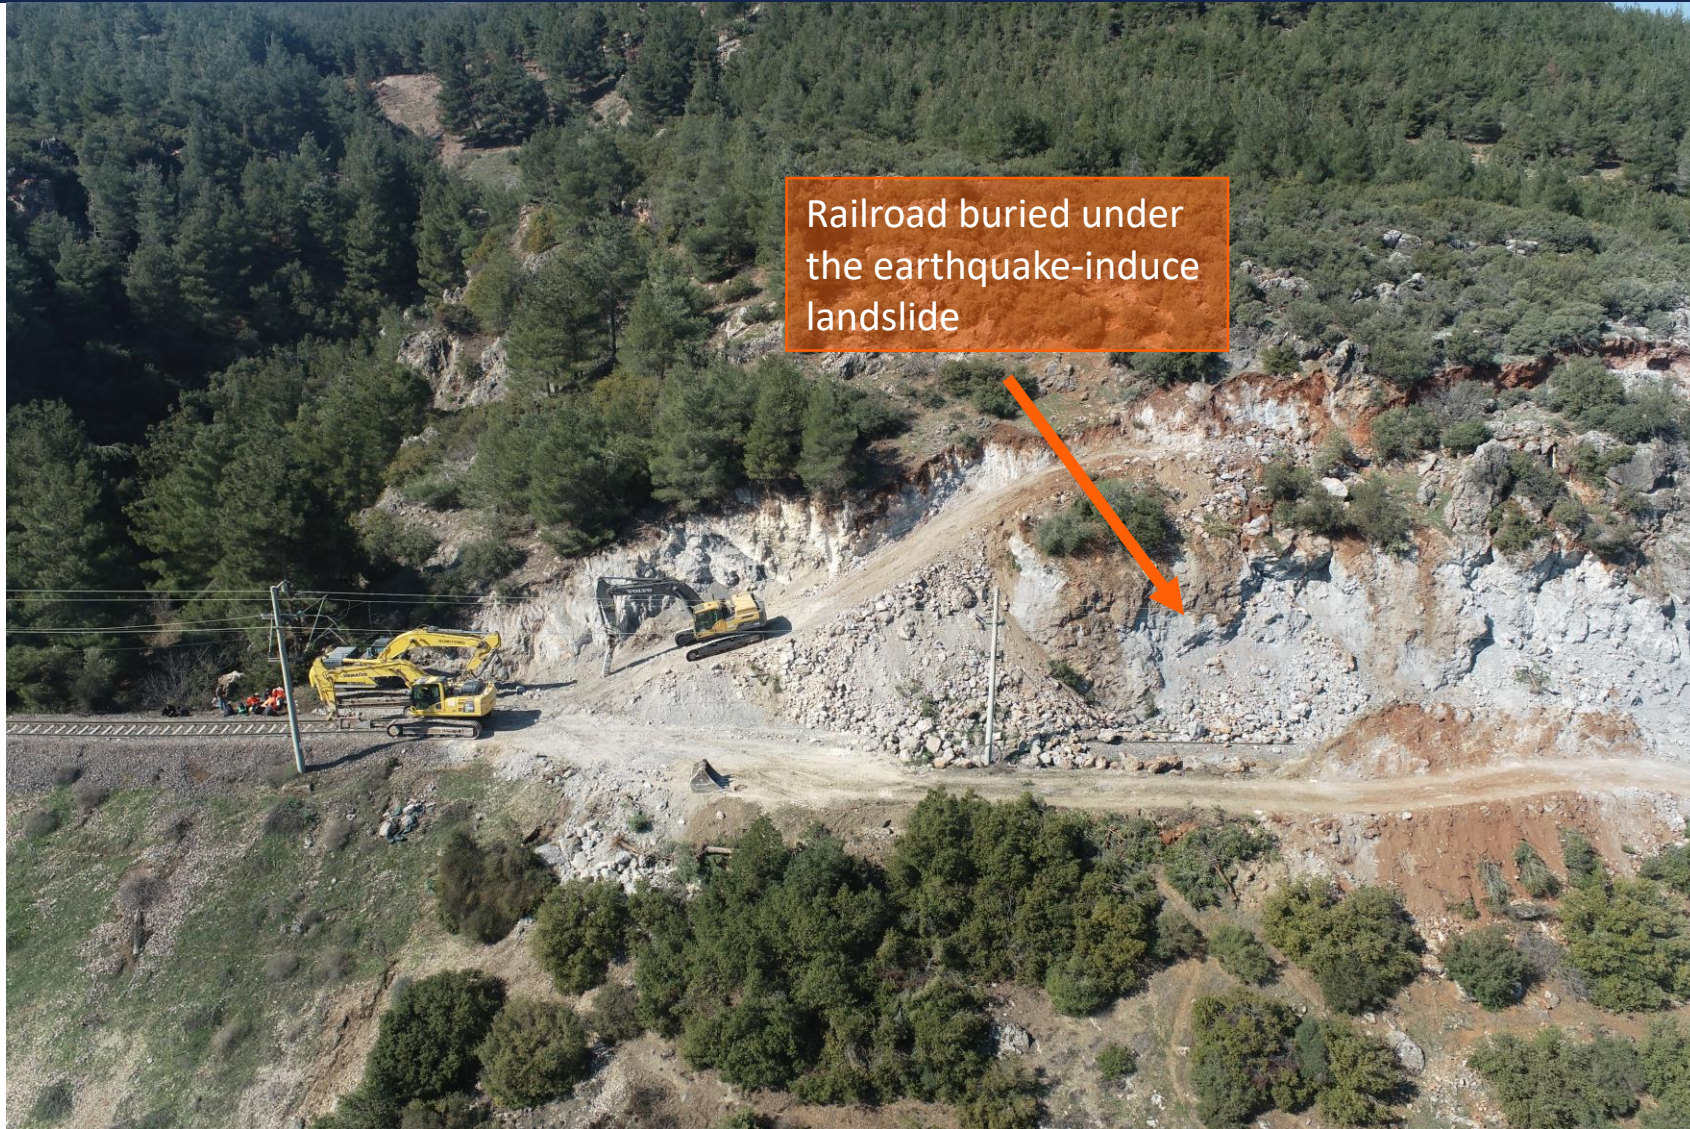
D825 Highway – Landslide near Railroad

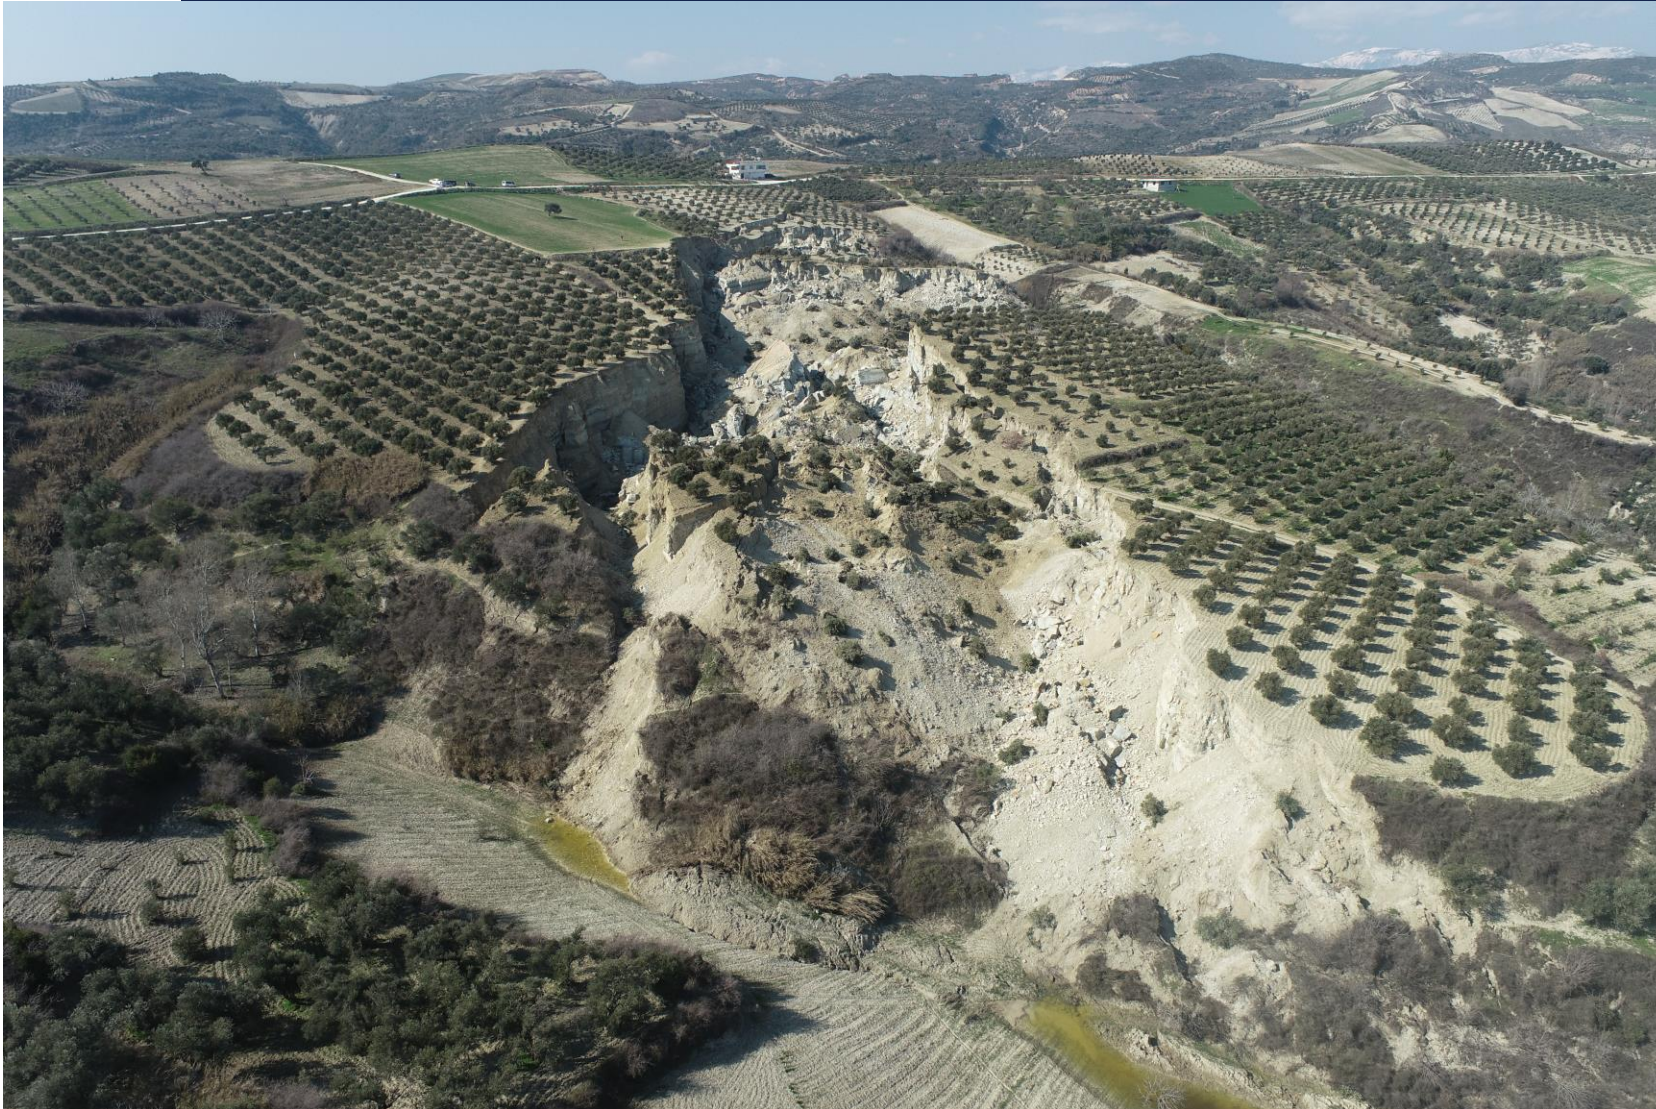
Altinozu Landslide

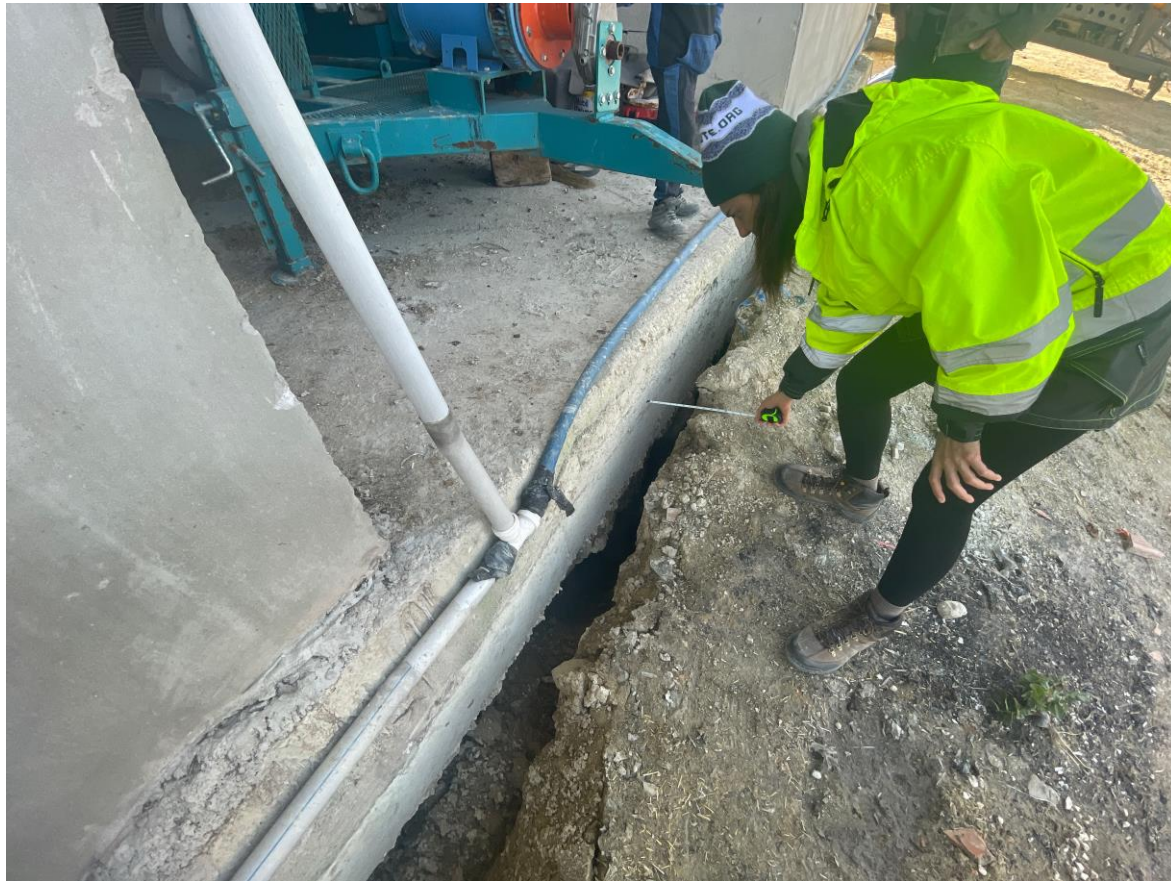
Village Houses Trapped between Two Landslides (or One?)

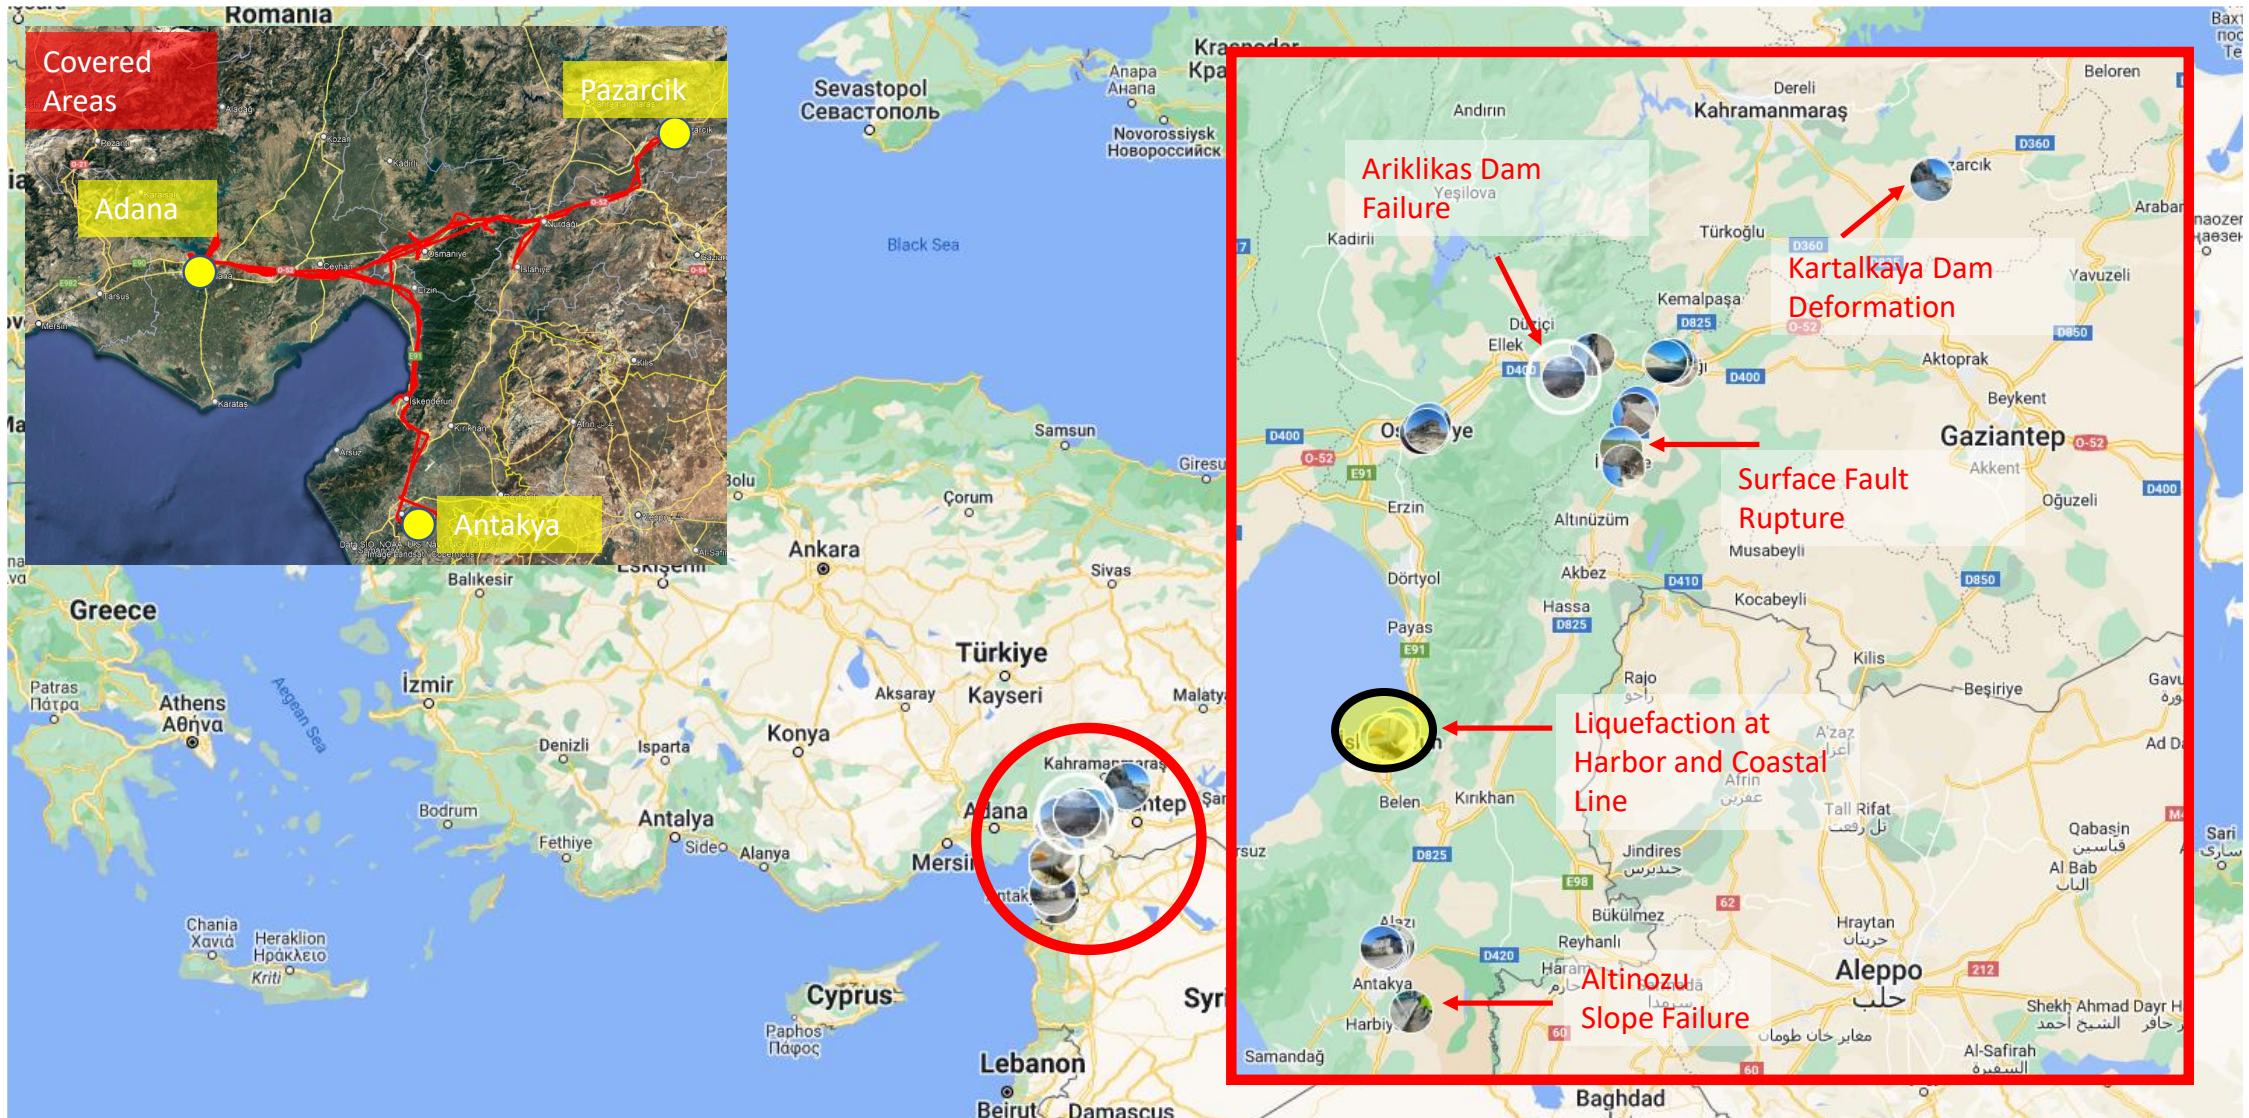
Ground Subsidence in Iskenderun

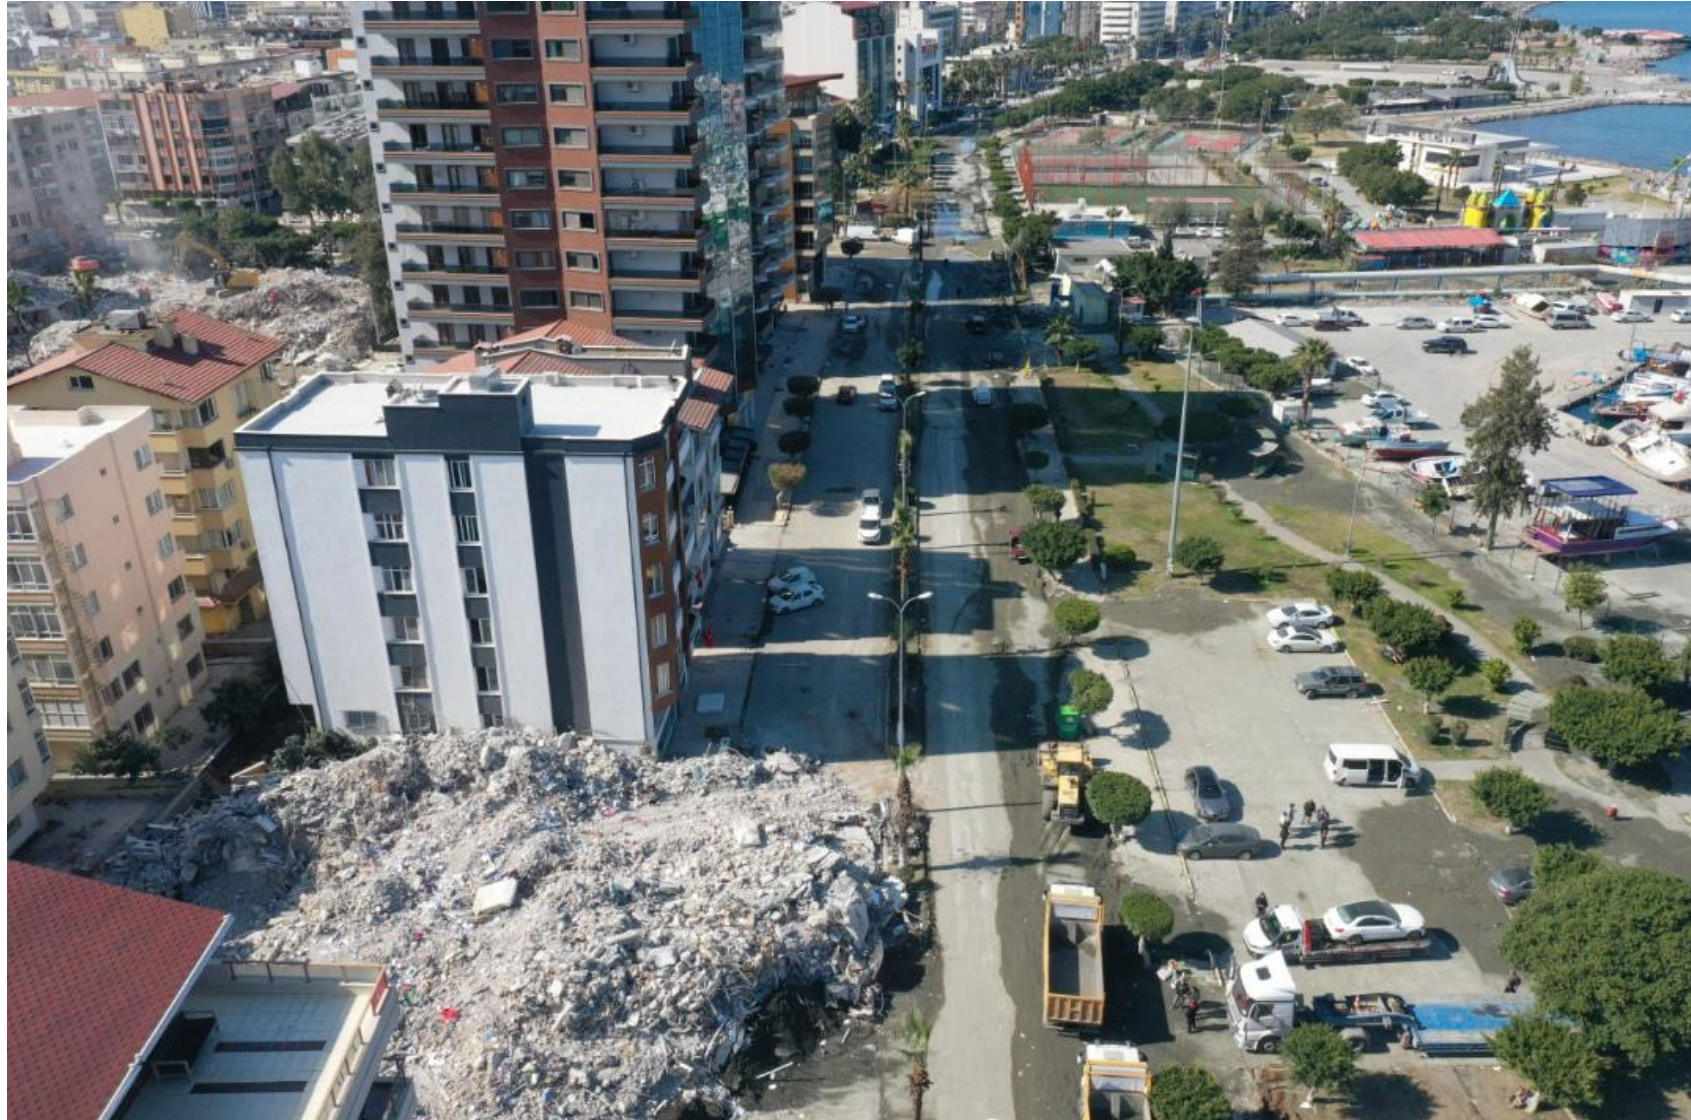
Iskenderun Coastal Line (Reclaimed Areas) – Liquefaction Manifestations

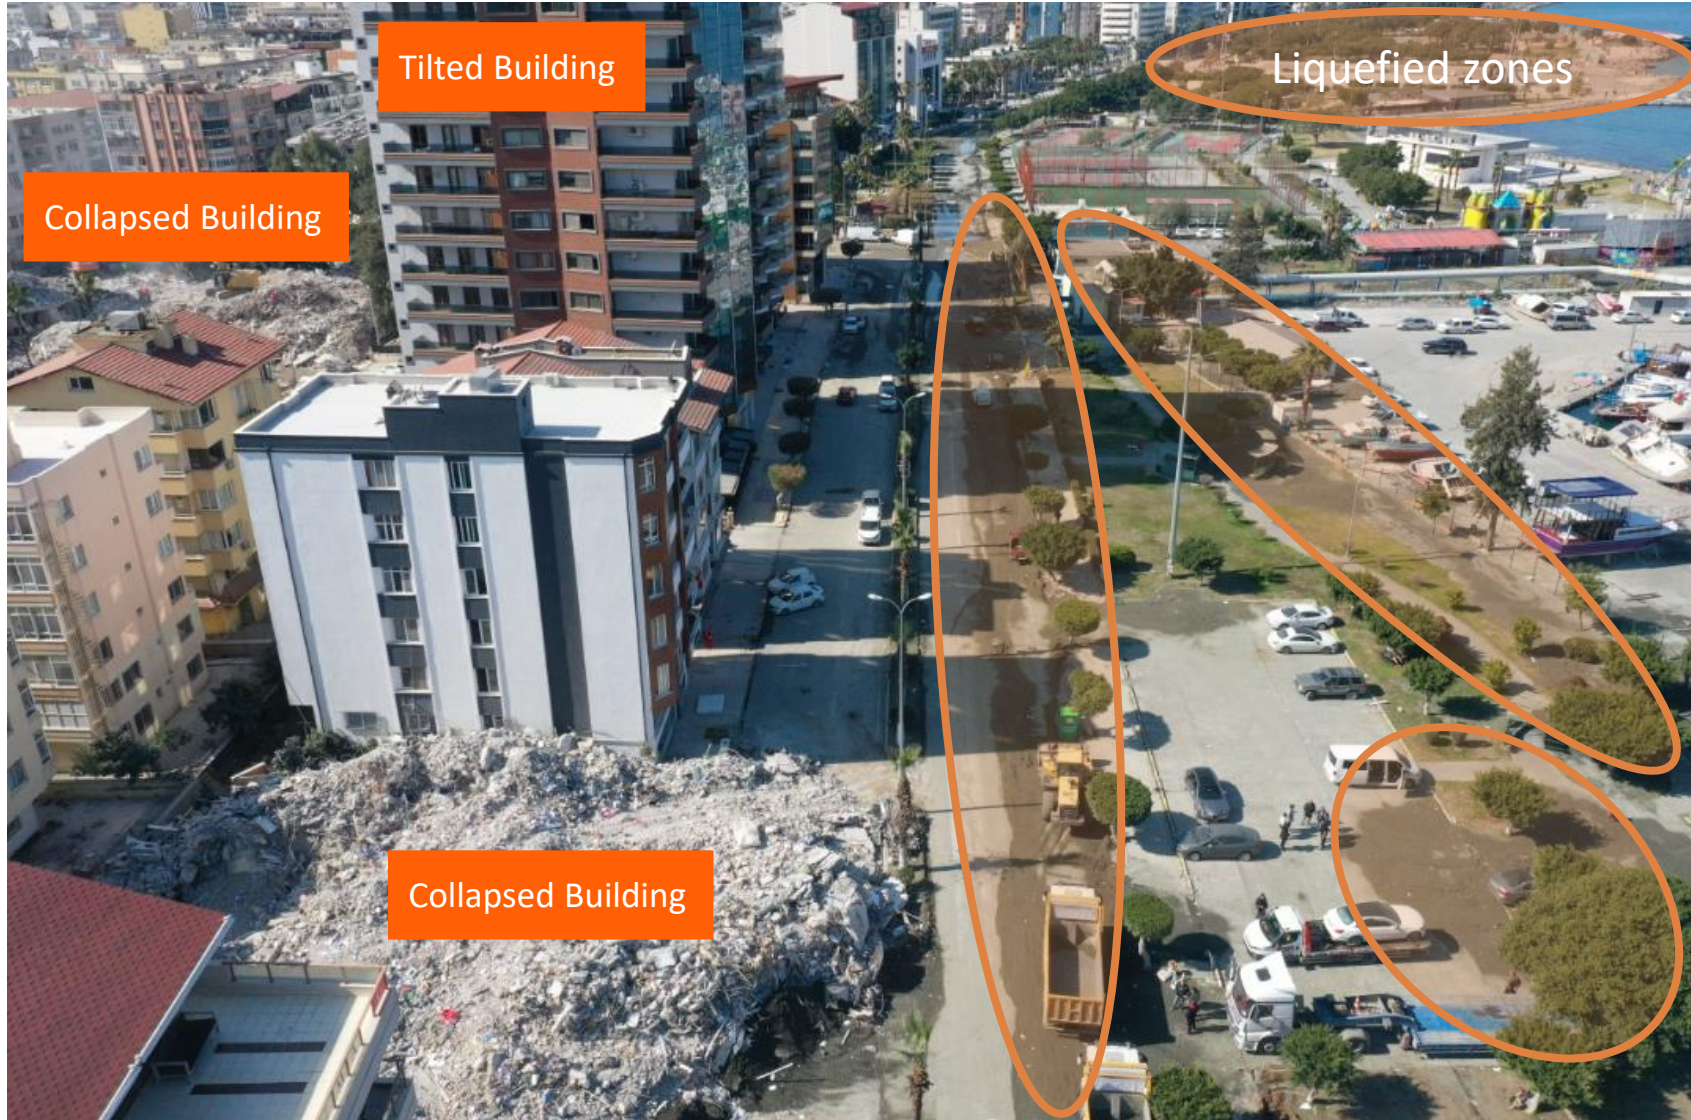
Iskenderun Coastal Line (Reclaimed Areas) – Liquefaction Manifestations

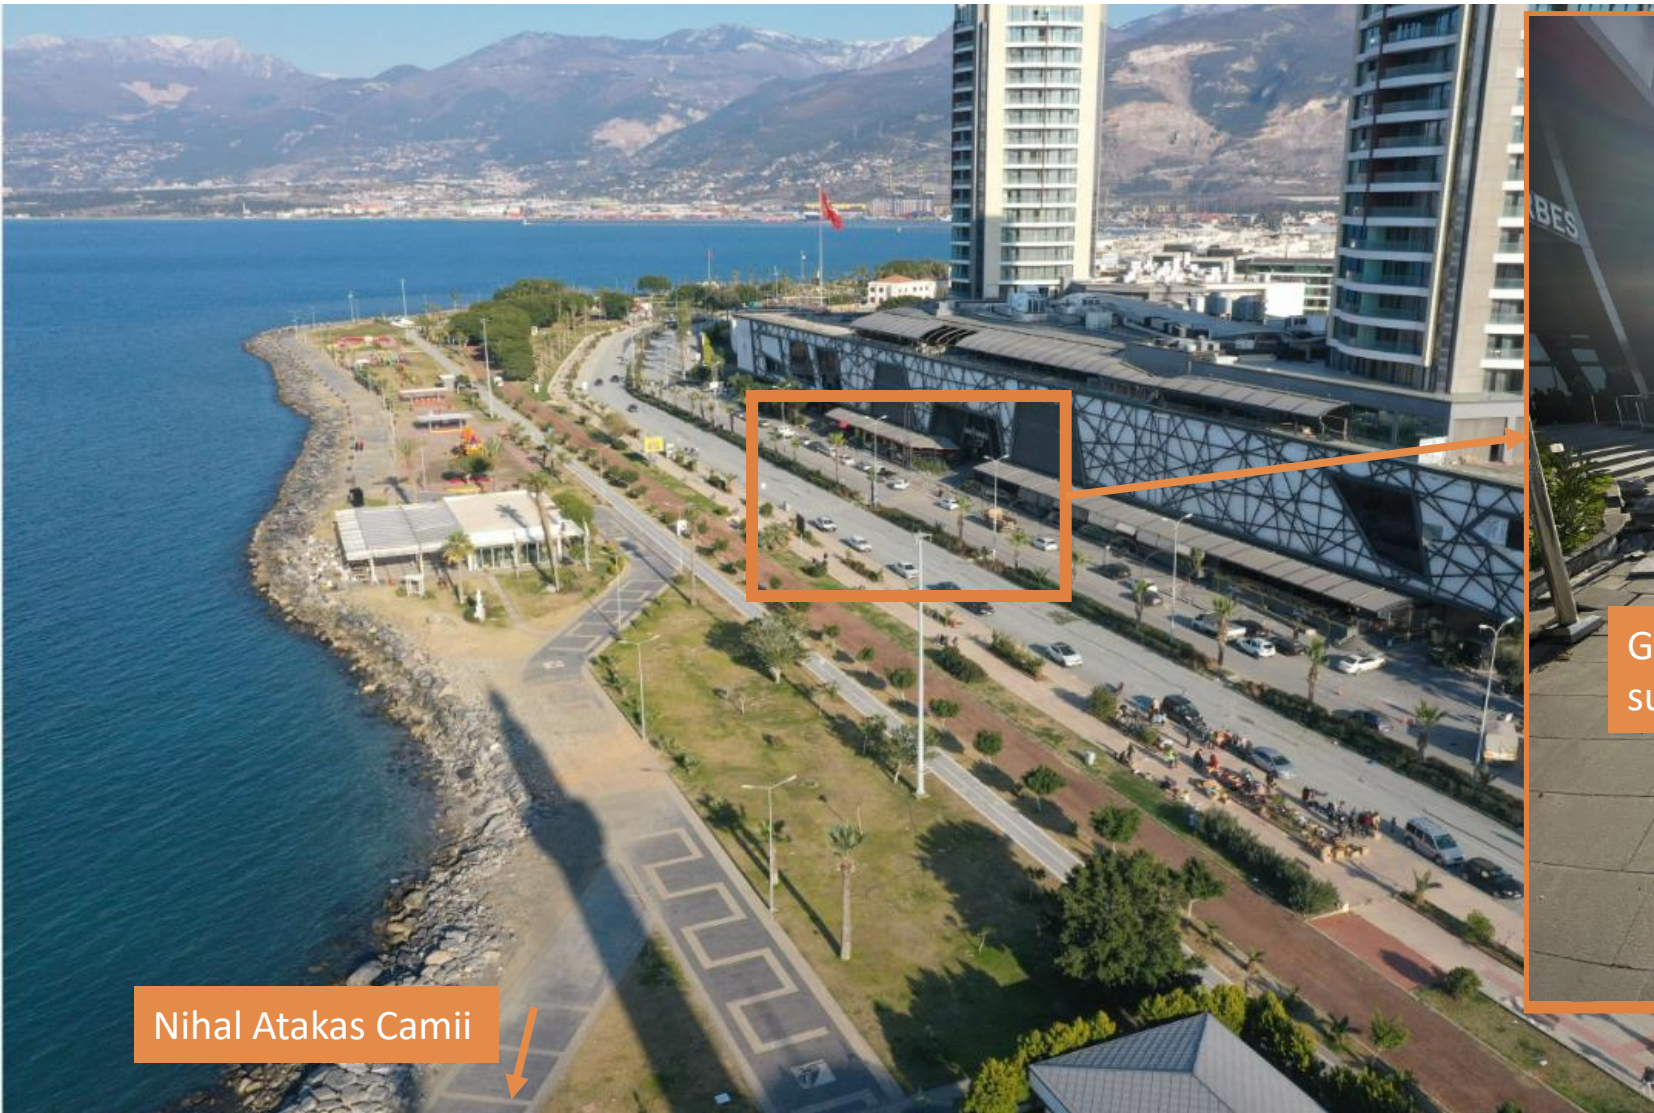
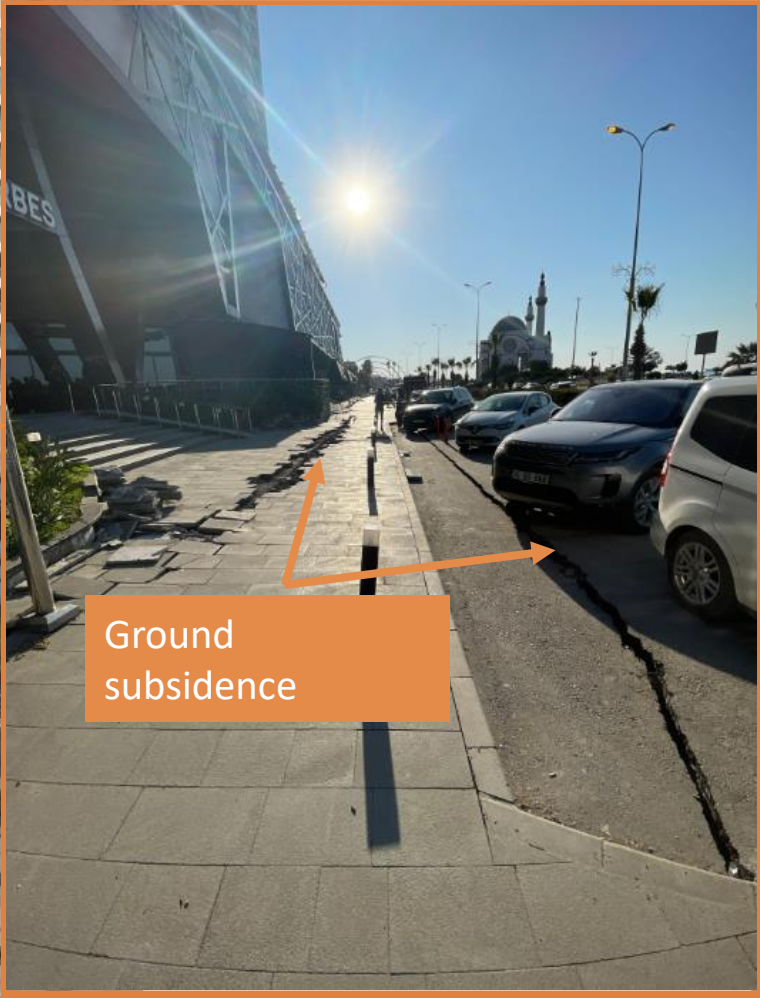
Nihal Atakas Camii

Iskenderun Coastal Line (Reclaimed Areas) – Differential Settlement

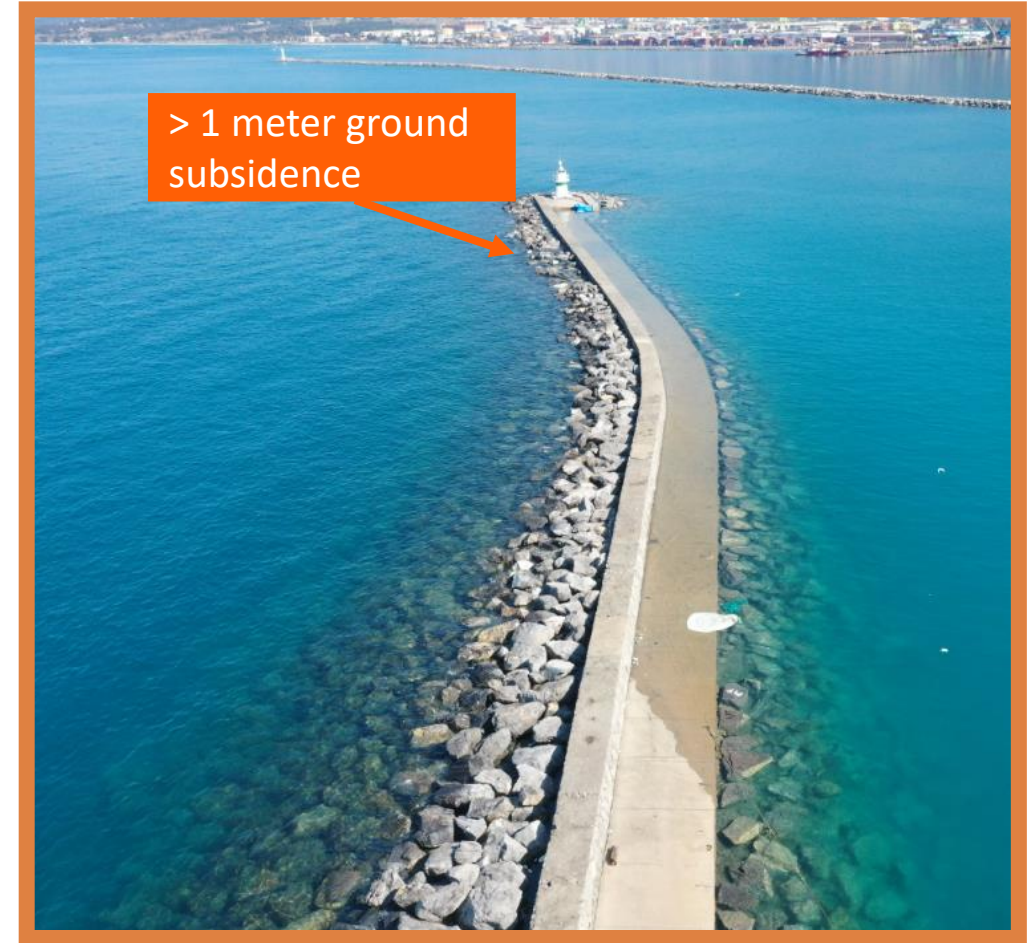
Iskenderun Coastal Line (Reclaimed Areas) – Iskenderun Dock

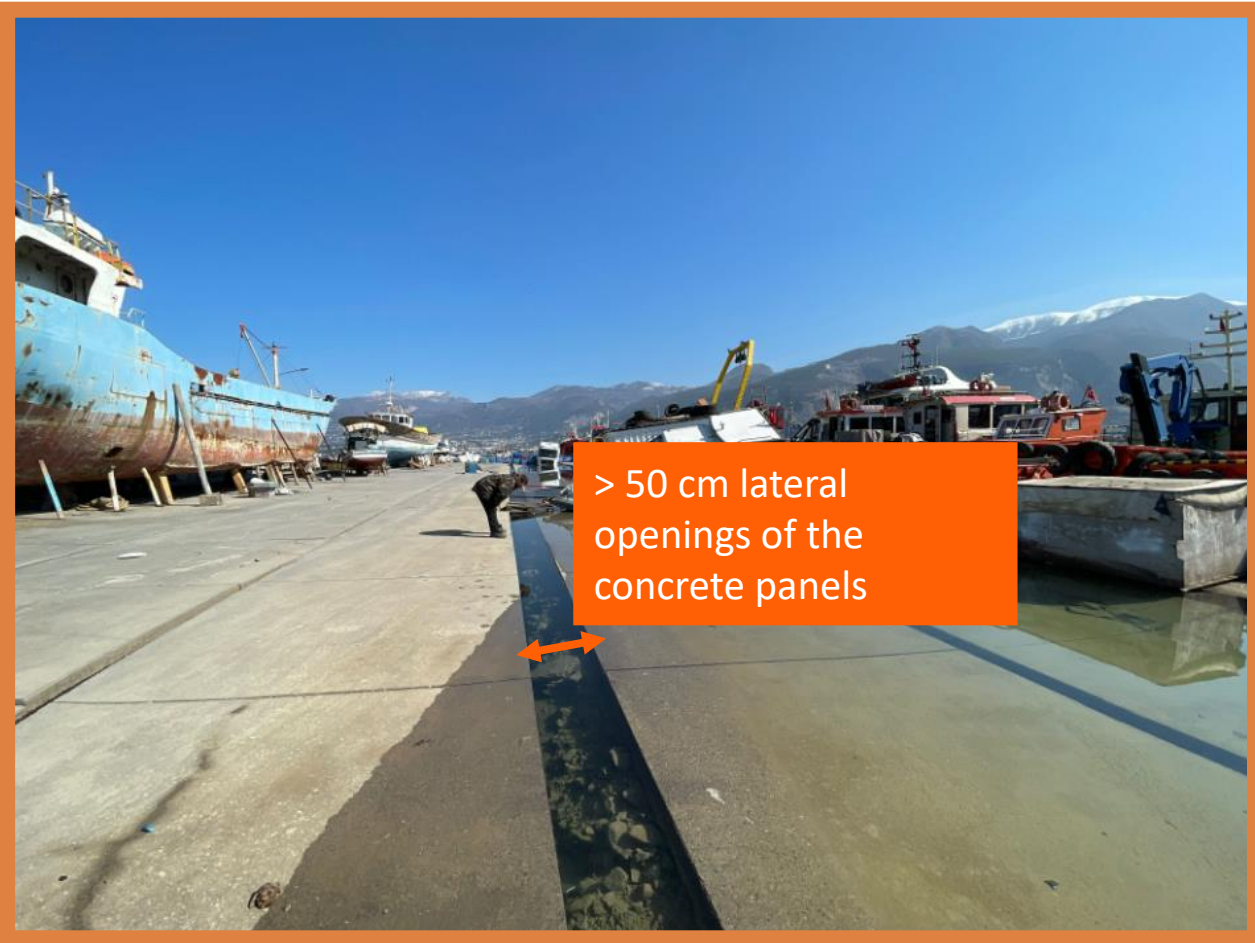
Iskenderun Coastal Line (Reclaimed Areas) – Iskenderun Dock

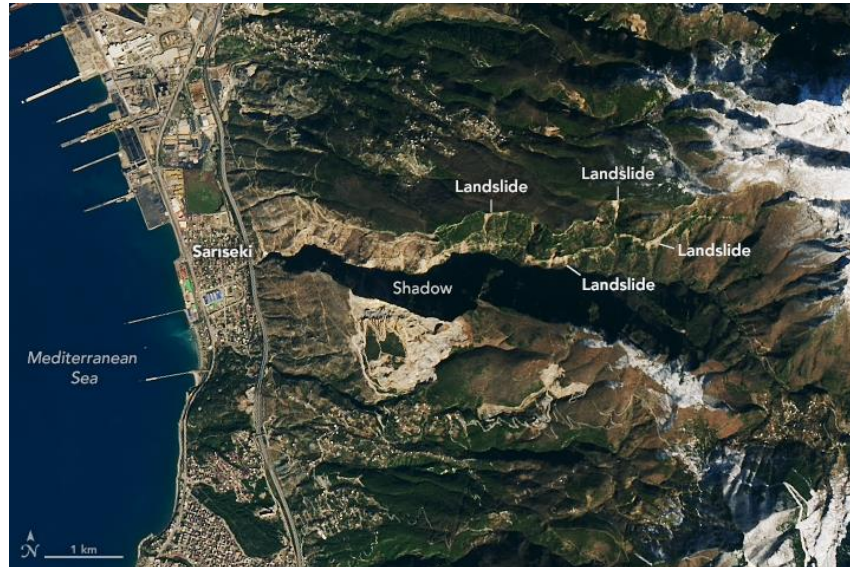
Flash floods in Sanliurfa, Adiyaman, Hatay Source of the mud?
